GROUP CHAIRMAN'S FACTUAL REPORT OF INVESTIGATION

CEN19FA119

Cockpit Voice Recorder

Location:	New Albany, Mississippi
Date:	April 13, 2019
Aircraft:	Rockwell Sabreliner, Registration N265DS
Operator:	Classic Aviation Inc
NTSB Number:	CEN19FA119

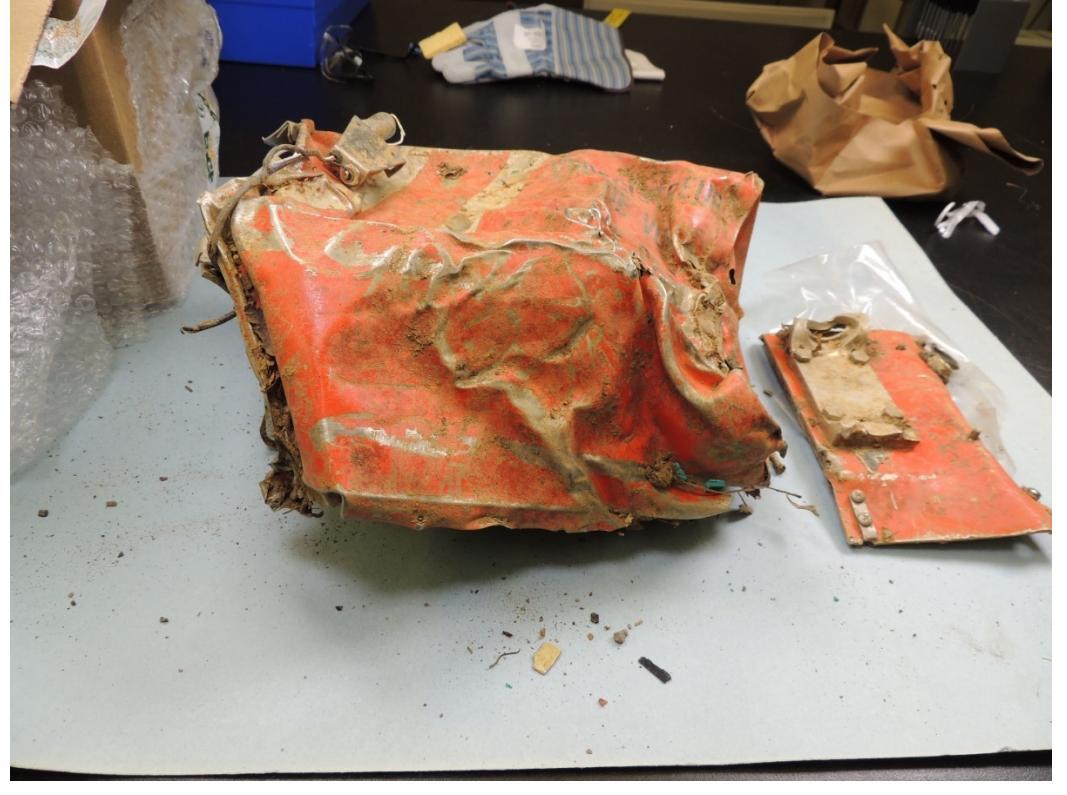
Figure 1. As-received condition of CVR showing significant impact structural damage.

Upon arrival at the laboratory, it was evident that the exterior of the CVR had sustained significant impact structural damage. The outer case was removed and it was found that the interior crash-protected case also sustained significant structural damage (see Figures 1 and 2). The tape reel was shattered, and the magnetic tape had bits of the metal reel embedded, along with mold growing on the tape. The magnetic tape was retrieved from within the crash-protected case and was meticulously cleaned and ultimately was successfully read out.

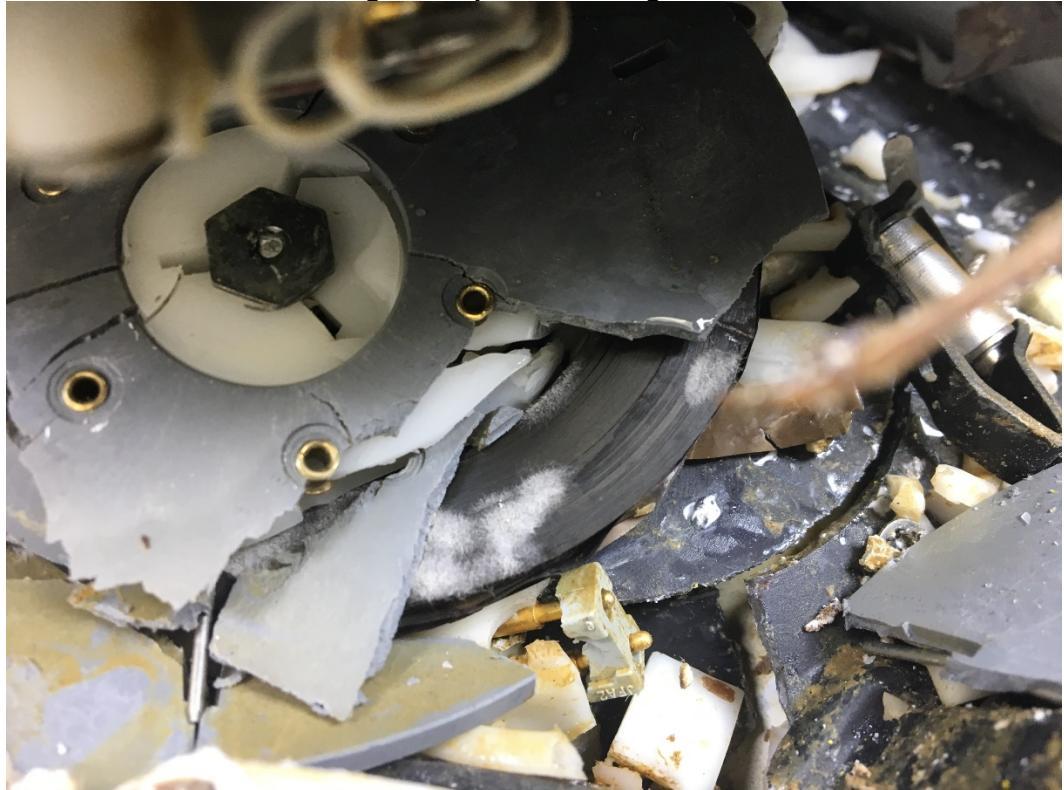
Figure 2. Photo taken during disassembly of the recorder showing the shattered tape reel and magnetic tape with mold growth.

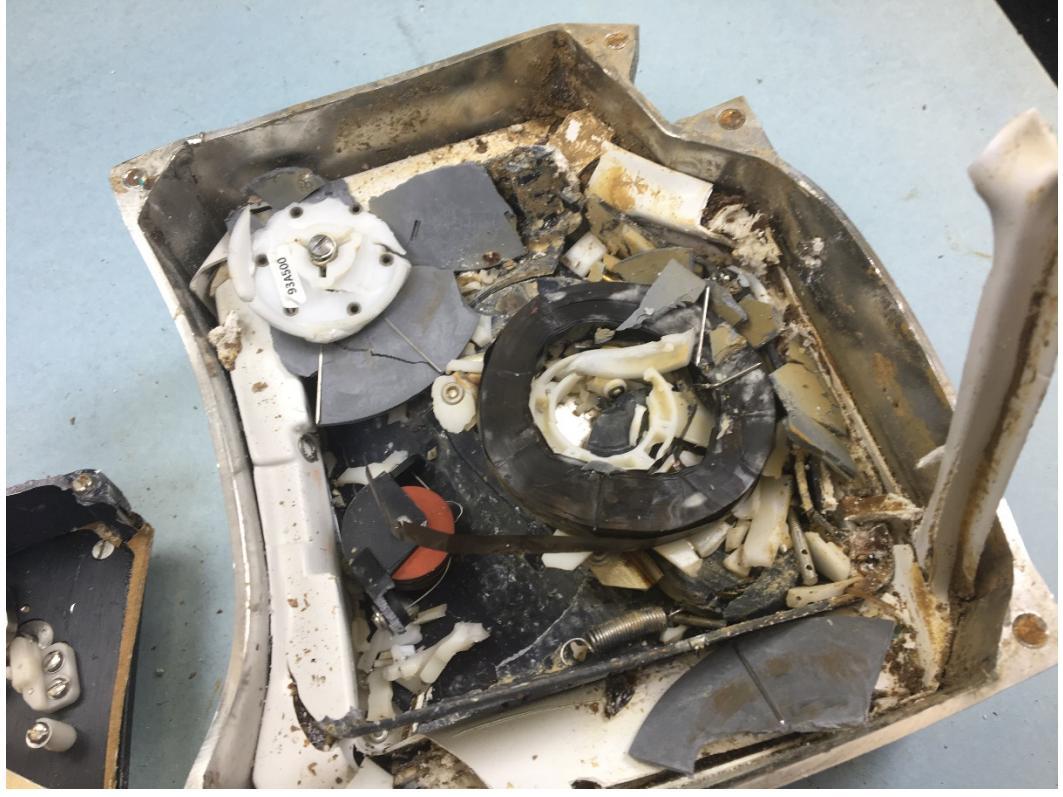
Figure 3. Photo of disassembled crash case and exposed magnetic tape showing extreme damage and deformation.
