NATIONAL TRANSPORTATION SAFETY BOARD

Weather Study Report

METEOROLOGY

WPR19FA075

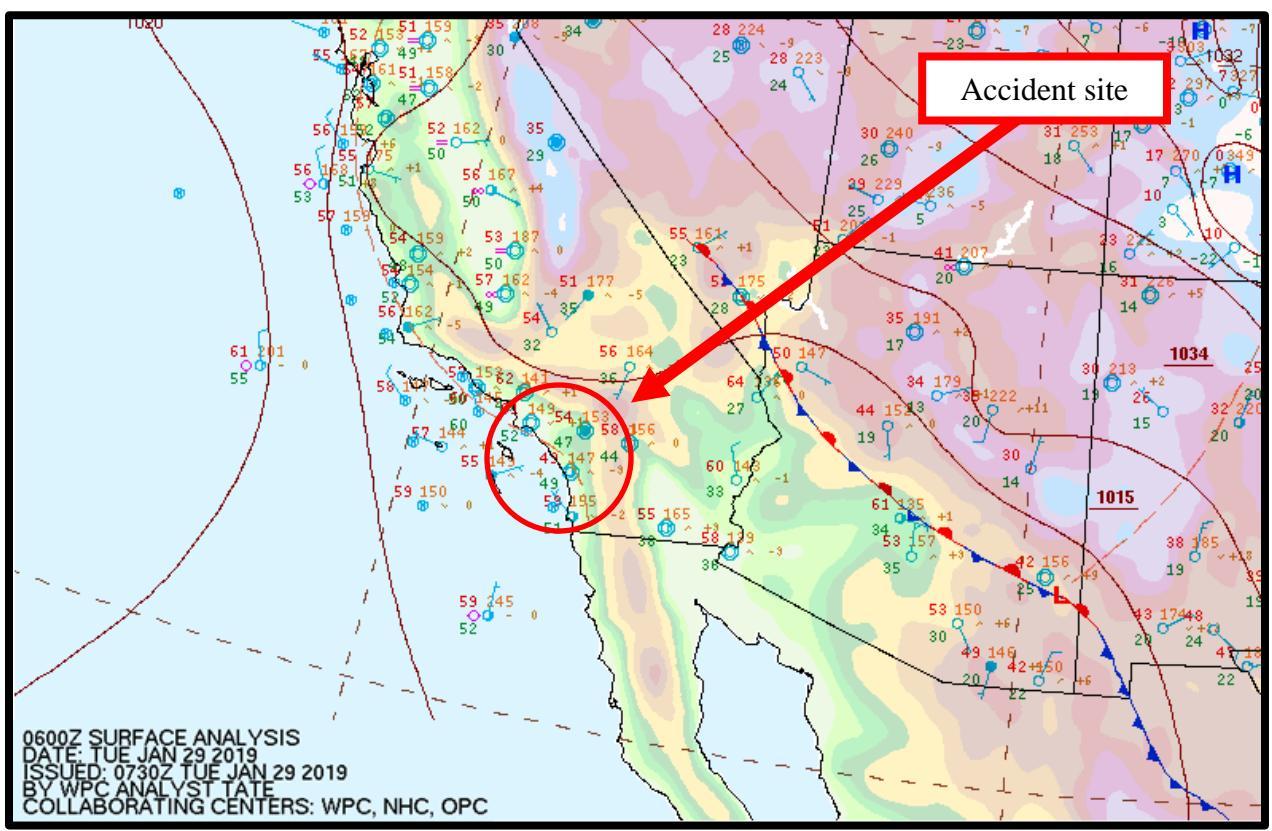
Figure 1 – NWS Surface Analysis Chart for 2200 PST

The southwestern United States section of the NWS Surface Analysis Chart for 2200 PST is provided as figure 1 with the approximate location of the accident site marked within a red circle. The chart indicated a stationary front stretching from southern Nevada southeastward into Arizona, southwestern New Mexico, and northern Mexico, northeast of the accident site. A low pressure center was located along the stationary front in southeast Arizona with a pressure of 1015hectopascals (hPa). A surface trough² was also depicted stretching from near San Francisco, California southward to San Diego, California, along the coast and was in the immediate vicinity of the accident site. Troughs can act as lifting mechanisms to help produce clouds and precipitation if sufficient moisture is present.

The station models around the accident site depicted air temperatures in the upper 40's to mid 50's degrees Fahrenheit (°F), dew point temperatures in the upper 40's °F with no temperaturedew point spread near the accident site, calm winds, mostly clear skies reported along the coast and overcast skies reported northeast of the accident site inland.

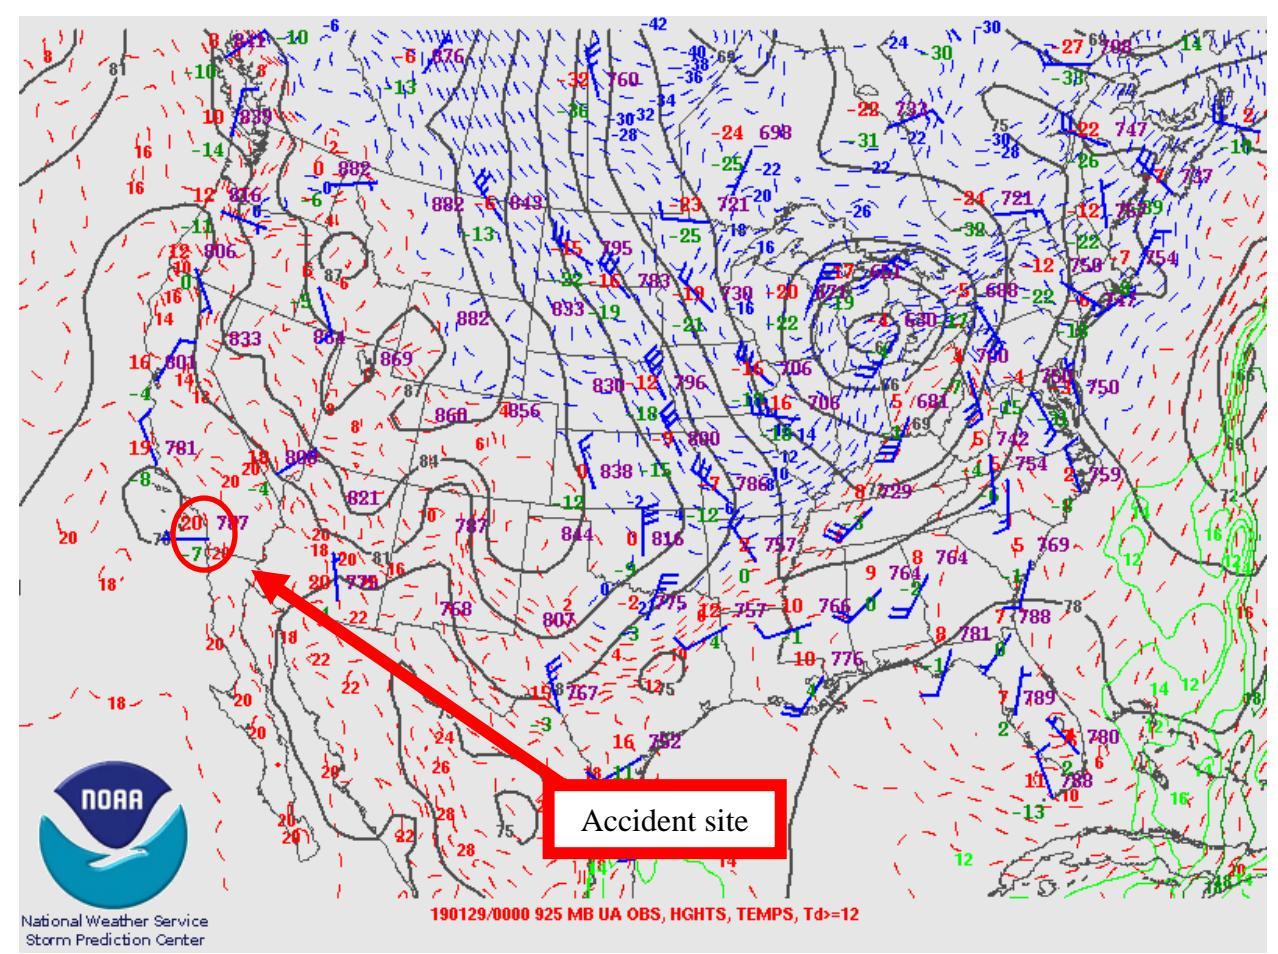
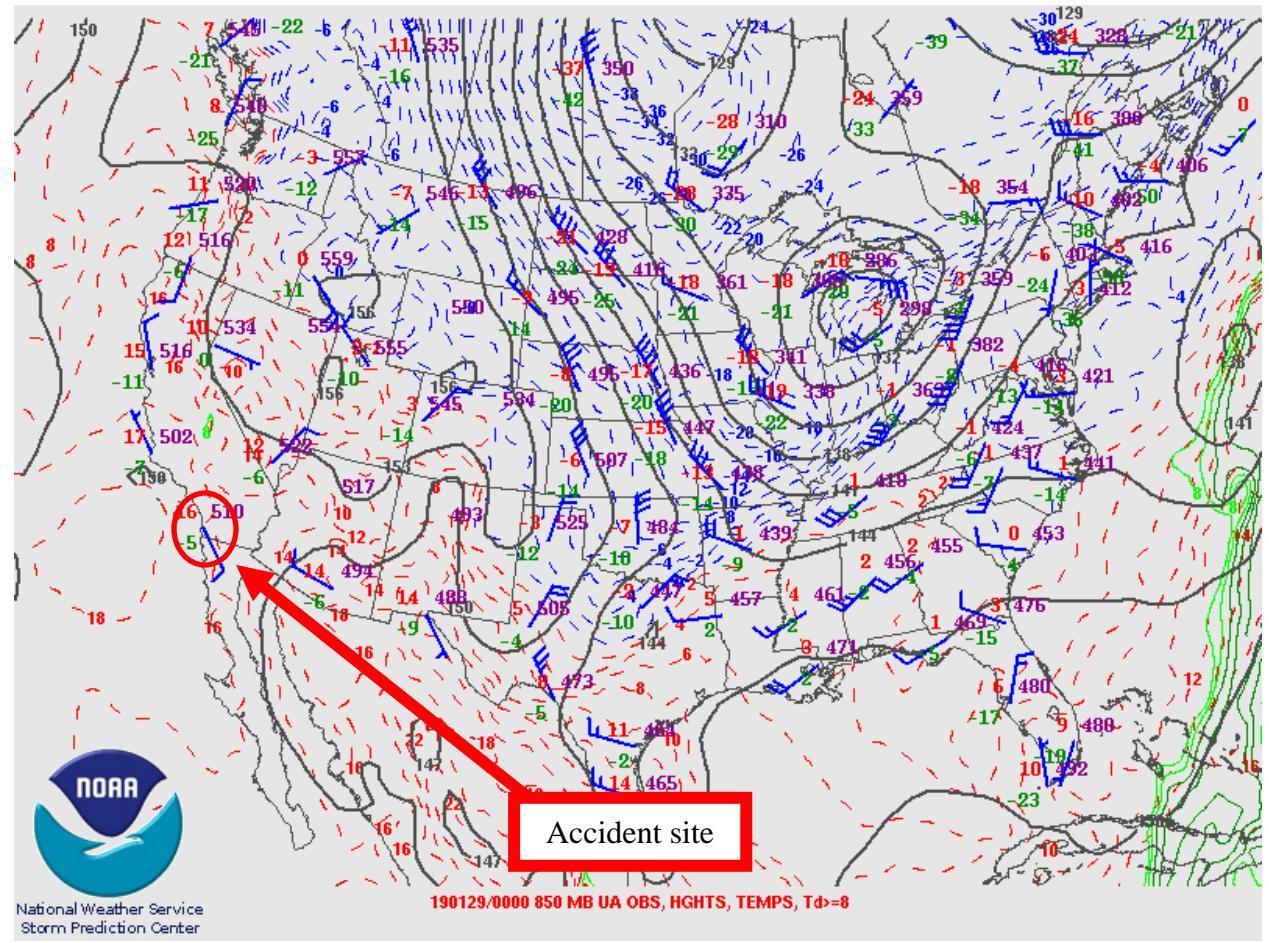
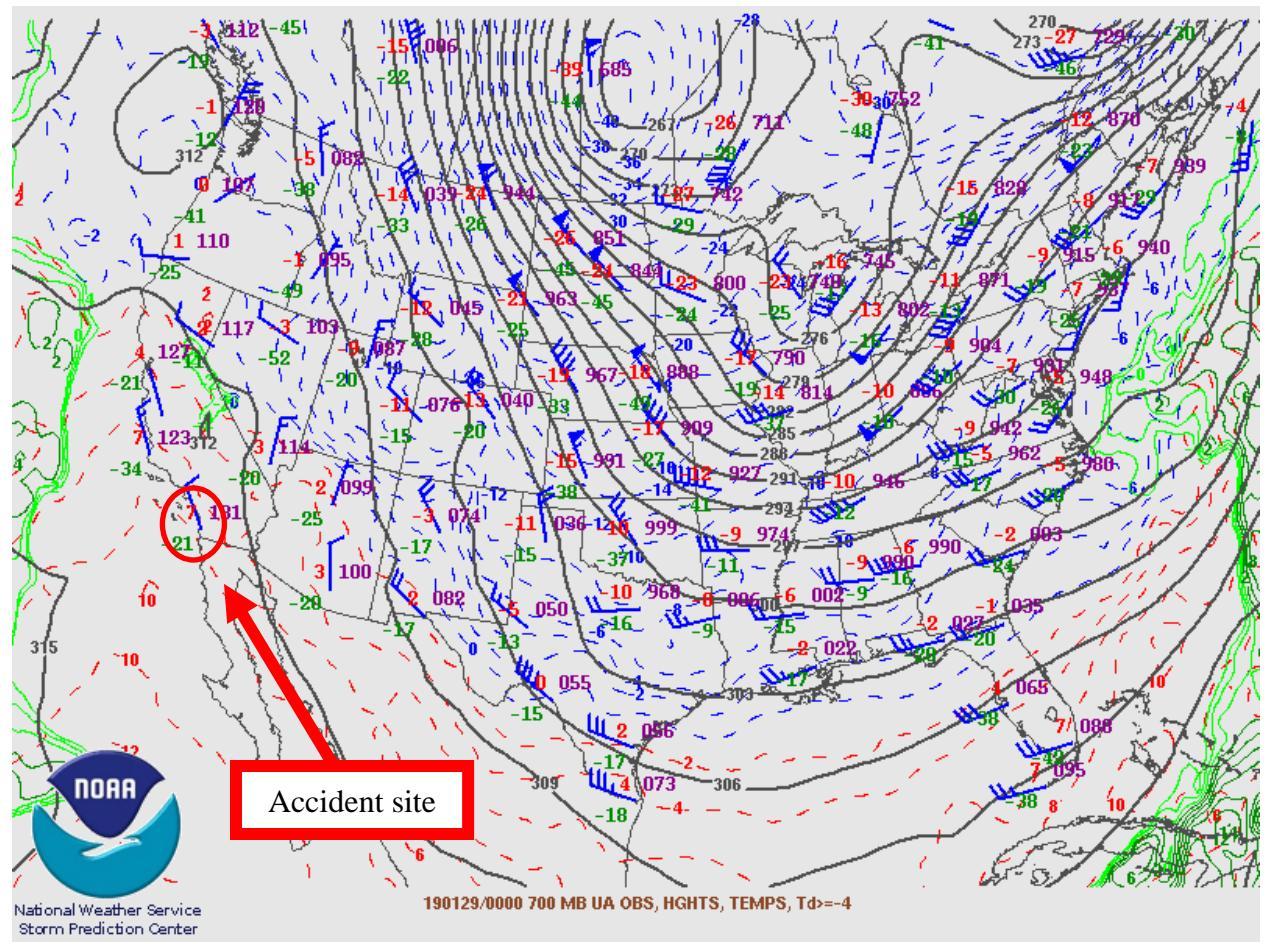
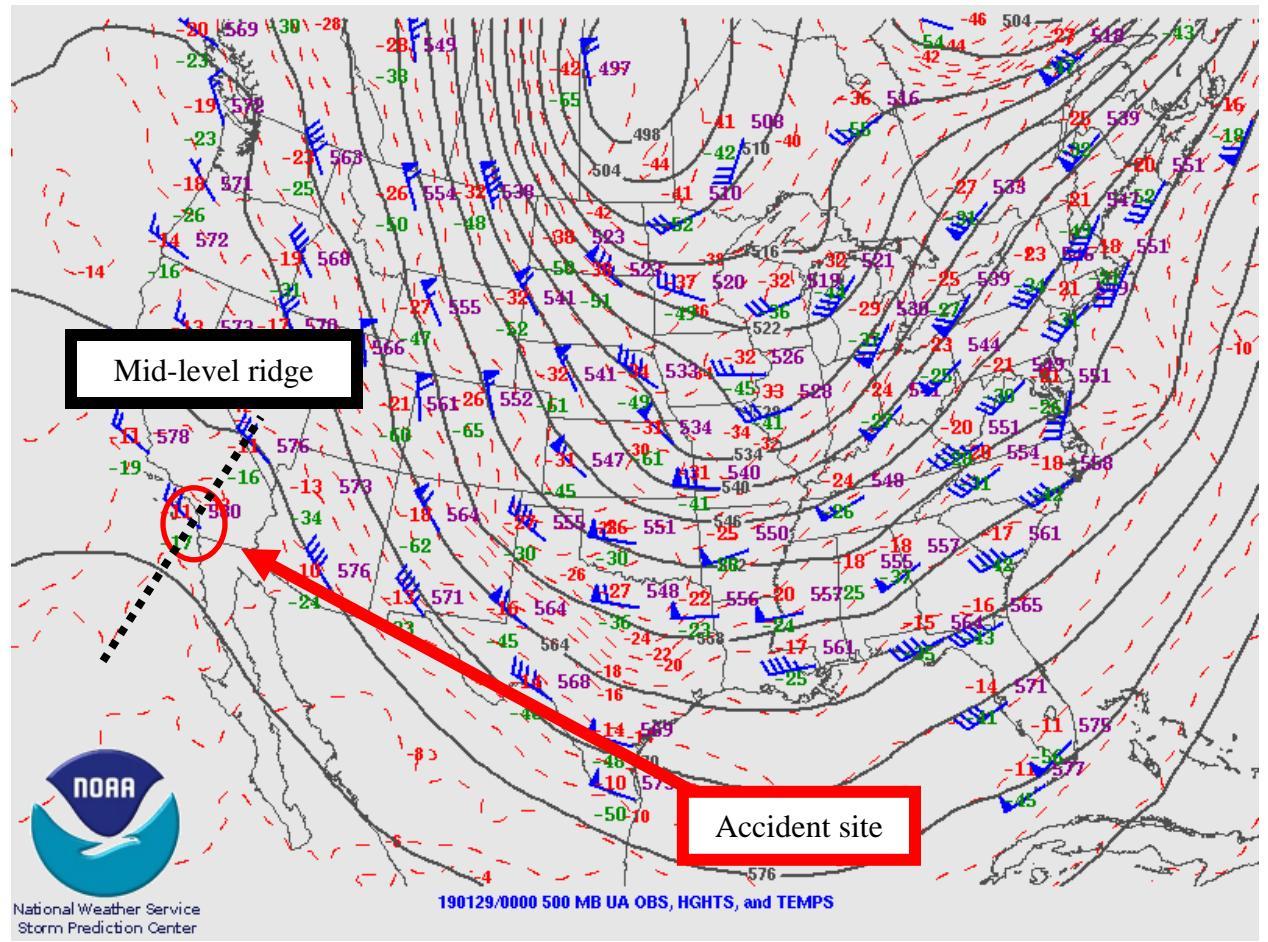
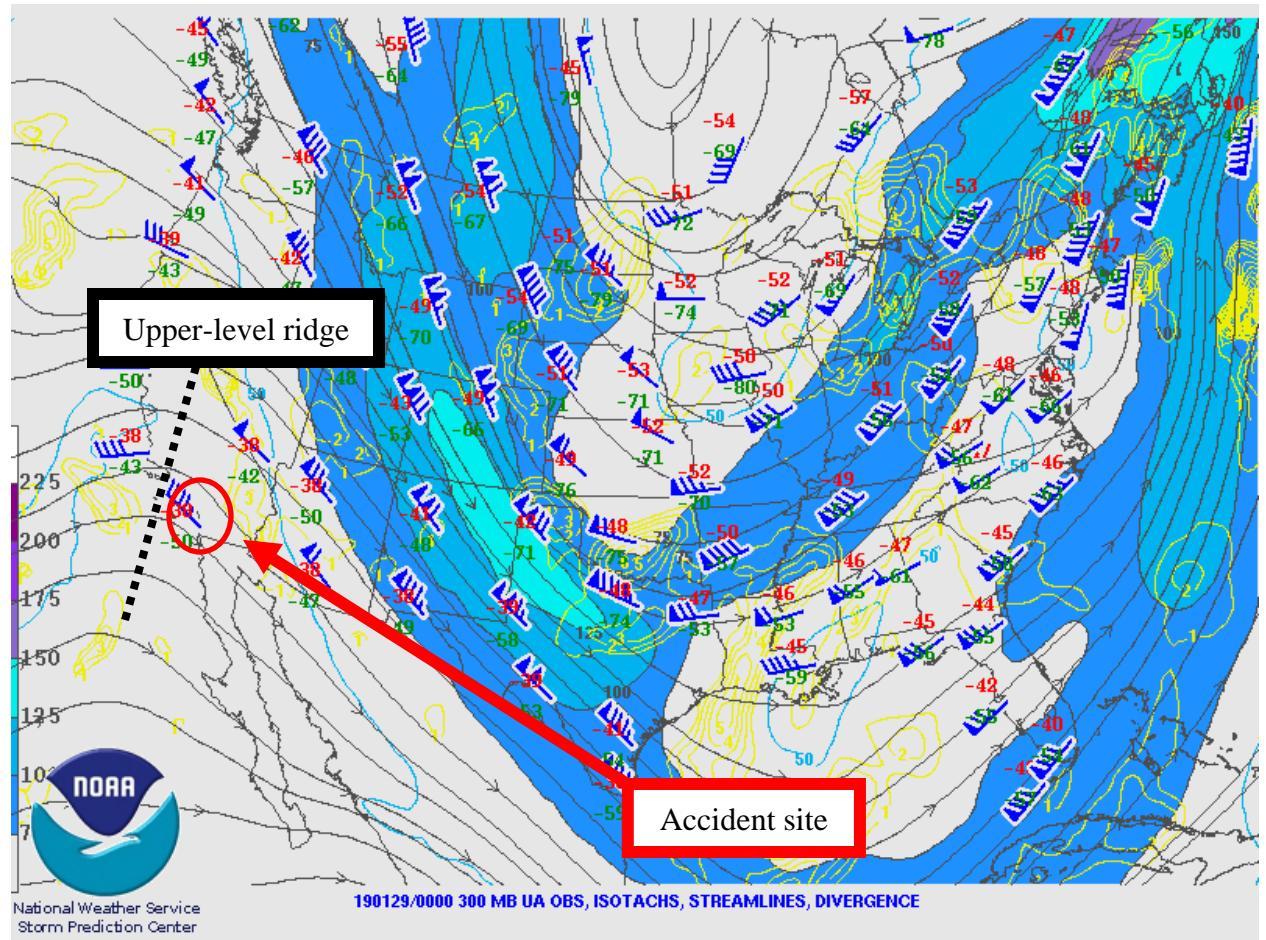
Figure 2 – 925-hPa Constant Pressure Chart for 1600 PST

The NWS Storm Prediction Center (SPC) Constant Pressure Charts for 1600 PST at 925-, 850-, 700-, 500-, and 300-hPa are presented in figures 2 through 6. There were mid- and upper-level ridges³ above the accident site at 500- and 300-hPa (figures 5 and 6) with the surface and low-level environment conducive for California marine stratus conditions.⁴ The wind was from the west at 5 knots at 925-hPa with the wind becoming northwesterly at 10 knots by 700-hPa (figure 4). At 300-hPa, the wind was from the northwest at 40 knots (figure 6).

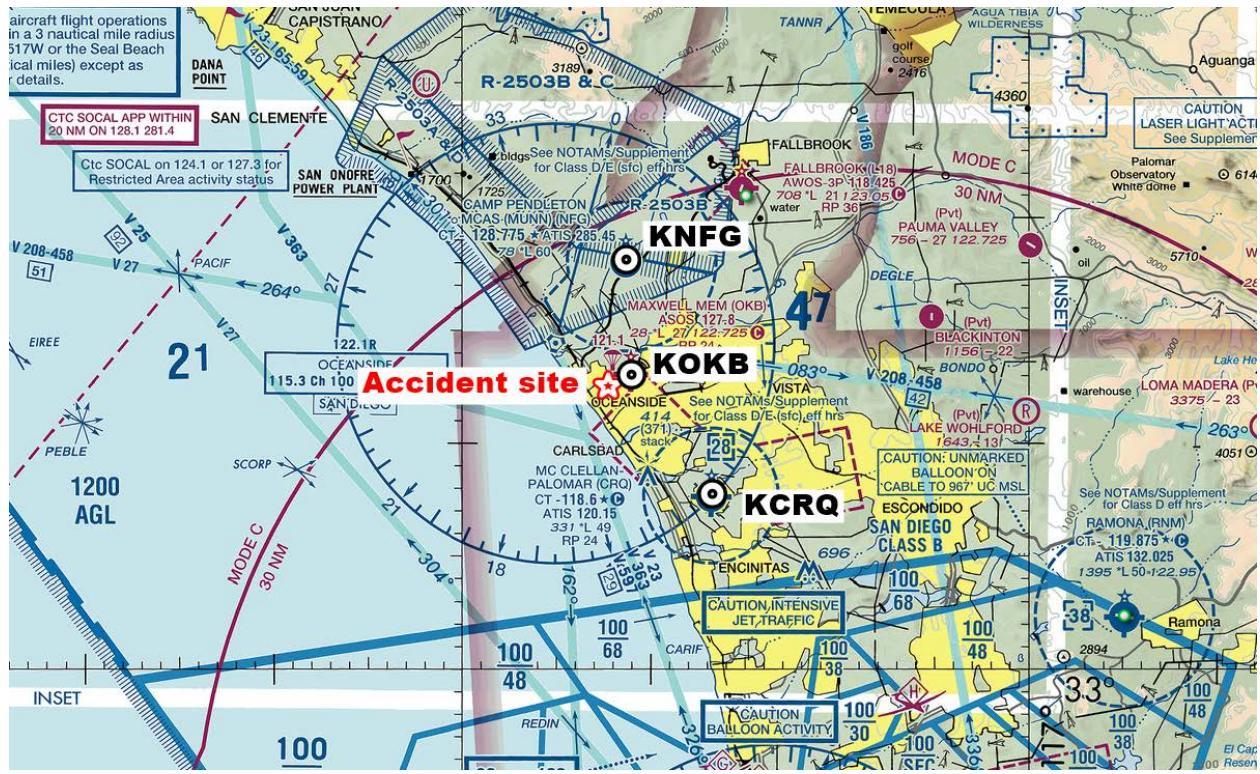
Figure 7 – Sectional chart of accident area with the location of the accident site and the closest surface observation sites

The area surrounding the accident site was documented using official Meteorological Aerodrome Reports (METARs) and Specials (SPECIs). Figure 7 is a sectional chart with the accident site and the closest weather reporting locations to the accident site marked.

Mc Clellan-Palomar Airport (KCRQ) was the closest site with a NWS Terminal Aerodrome Forecast (TAF). KCRQ was located 7 miles southeast of the accident site (figure 7). The KCRQ TAF valid at the accident time was issued at 1525 PST and was valid for a 24-hour period beginning at 1600 PST. The 1525 PST TAF for KCRQ was as follows:

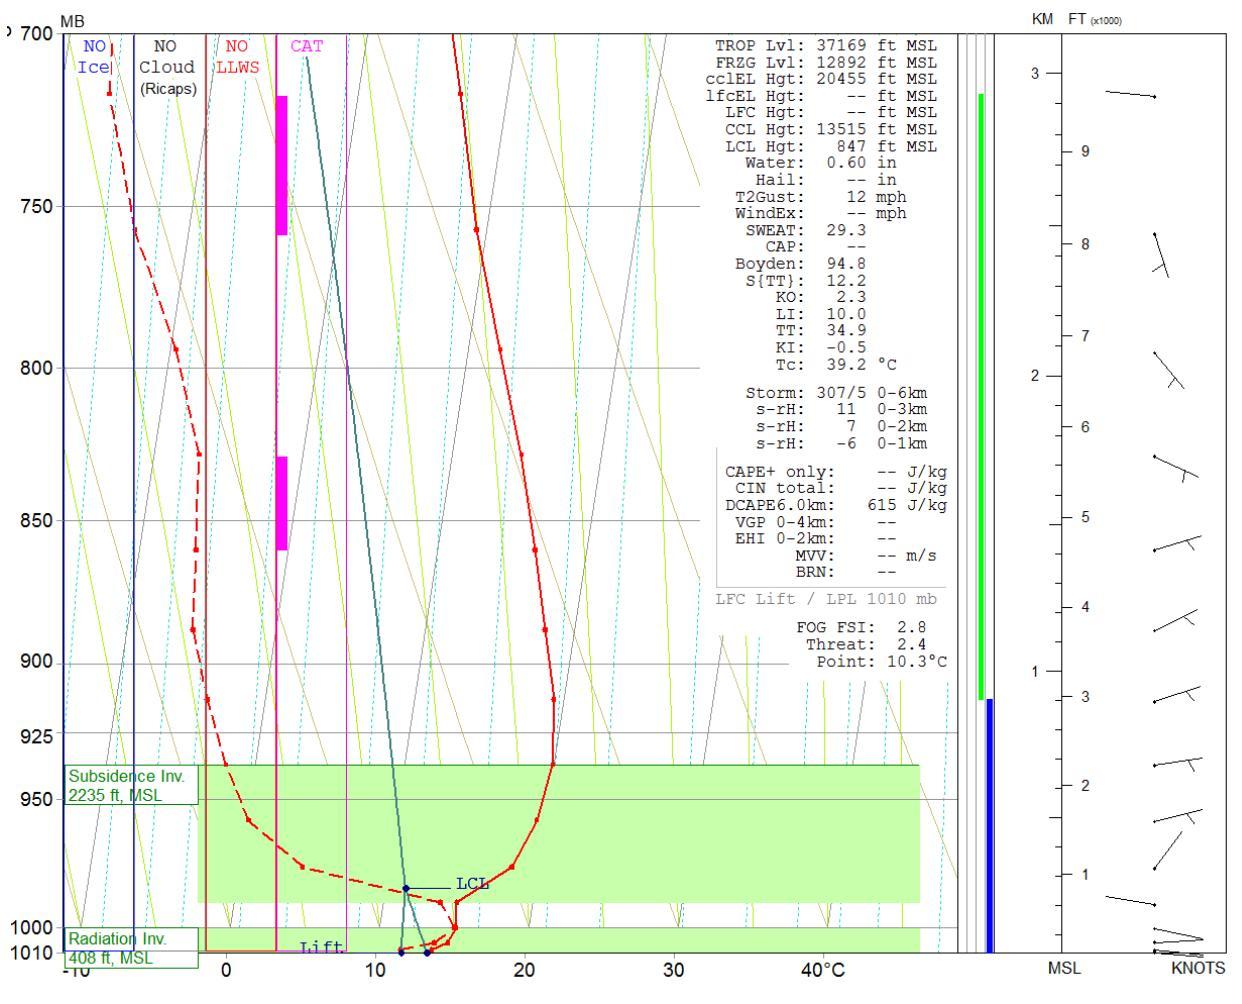
Figure 8 – 2200 PST HRRR sounding for the accident site

A High-Resolution Rapid Refresh (HRRR)¹⁰ model sounding was created for the accident site for 2200 PST¹¹ with station elevation of 131 ft.¹² The 2200 PST HRRR sounding was plotted on a standard Skew-T Log P diagram¹³ with the derived stability parameters included in figure 8 with data from the surface to 700-hPa (or approximately 10,000 ft msl). This data was analyzed using the RAOB¹⁴ software package. The sounding depicted the lifted condensation level (LCL)¹⁵ at 716 ft agl (847 ft msl) and the convective condensation level (CCL)¹⁶ at 13,384 ft agl (13,515 ft msl). The sounding had a greater than 90% relative humidity from the surface through 700 ft msl. The freezing level was located at 12,892 ft msl. Based on the accident aircraft's flight altitudes there were no icing issues in this accident. The precipitable water value was 0.60 inches.

The 2200 PST HRRR sounding for the accident site indicated stable environment from the surface through 3,000 ft. RAOB did not identify the possibility of clouds between the surface and 10,000 ft msl. An inversion¹⁷ due to radiational cooling was noted at 408 ft msl and a subsidence inversion was noted at 2,235 ft msl. An inversion near the surface with close temperature and dew point, lights winds, and no other large scale weather factors, creates an environment favorable for fog or low stratiform cloud formation.

The 2200 PST HRRR sounding wind profile indicated a surface wind from 095° at 2 knots with the wind remaining variable and less than 10 knots through 10,000 ft. RAOB did not indicate the possibility of low-level wind shear (LLWS). RAOB indicated a small chance of clear-air turbulence existed between 5,000 ft msl and 10,000 ft msl.

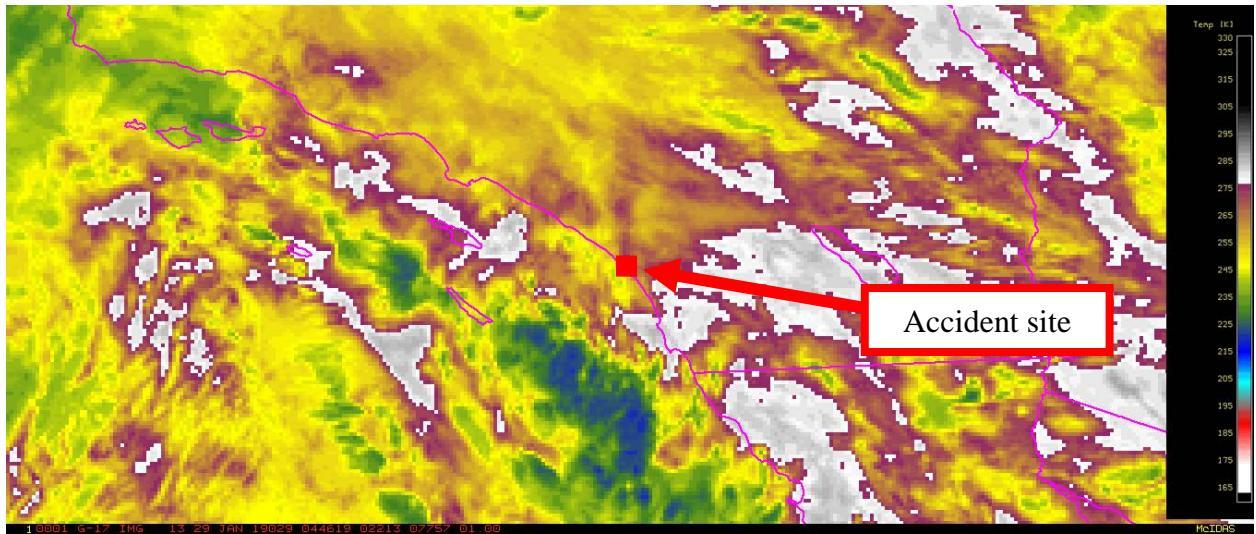
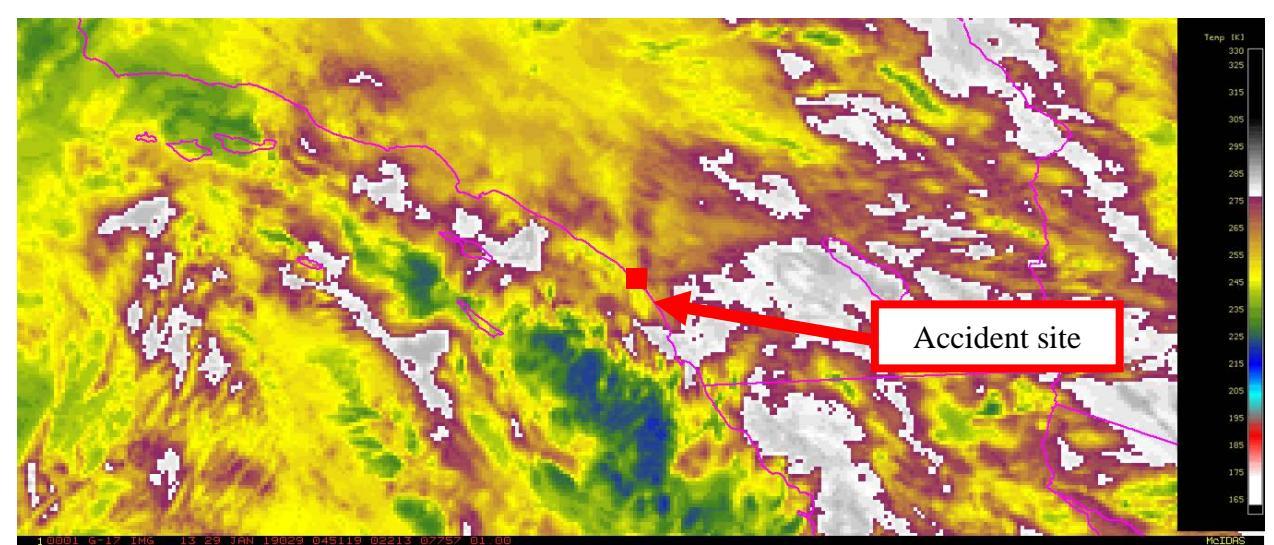
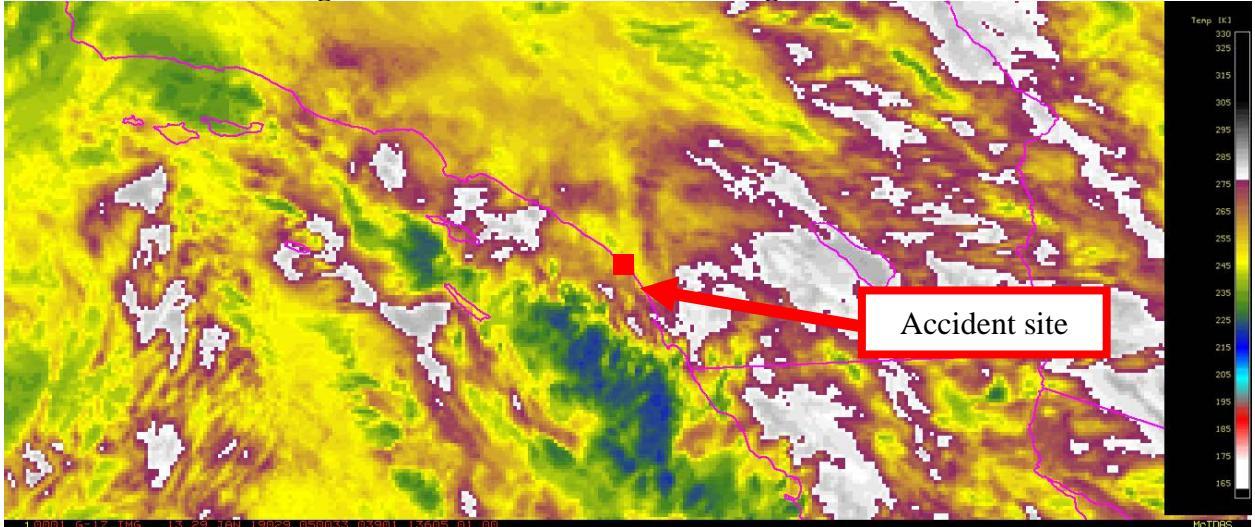
Figure 9 – GOES-17 infrared image at 2046 PST

Figures 9, 10, and 11 present the GOES-17 infrared imagery from 2046, 2051, and 2100 PST at 4X magnification and with a temperature enhance curve applied with the accident site highlighted with a red square. Inspection of the infrared imagery indicated abundant cloud cover over the accident site at the accident time, with the cloud cover moving from west to east. The lower brightness temperatures (blue and green colors; higher cloud tops) were located south and west of the accident site at the accident time. Based on the brightness temperatures above the accident site (255° Kelvin) and the vertical temperature profile provided by the 2200 PST HRRR sounding, the approximate cloud-top heights over the accident site were 23,000 ft at 2051 PST. It should be noted these figures have not been corrected for any parallax error.

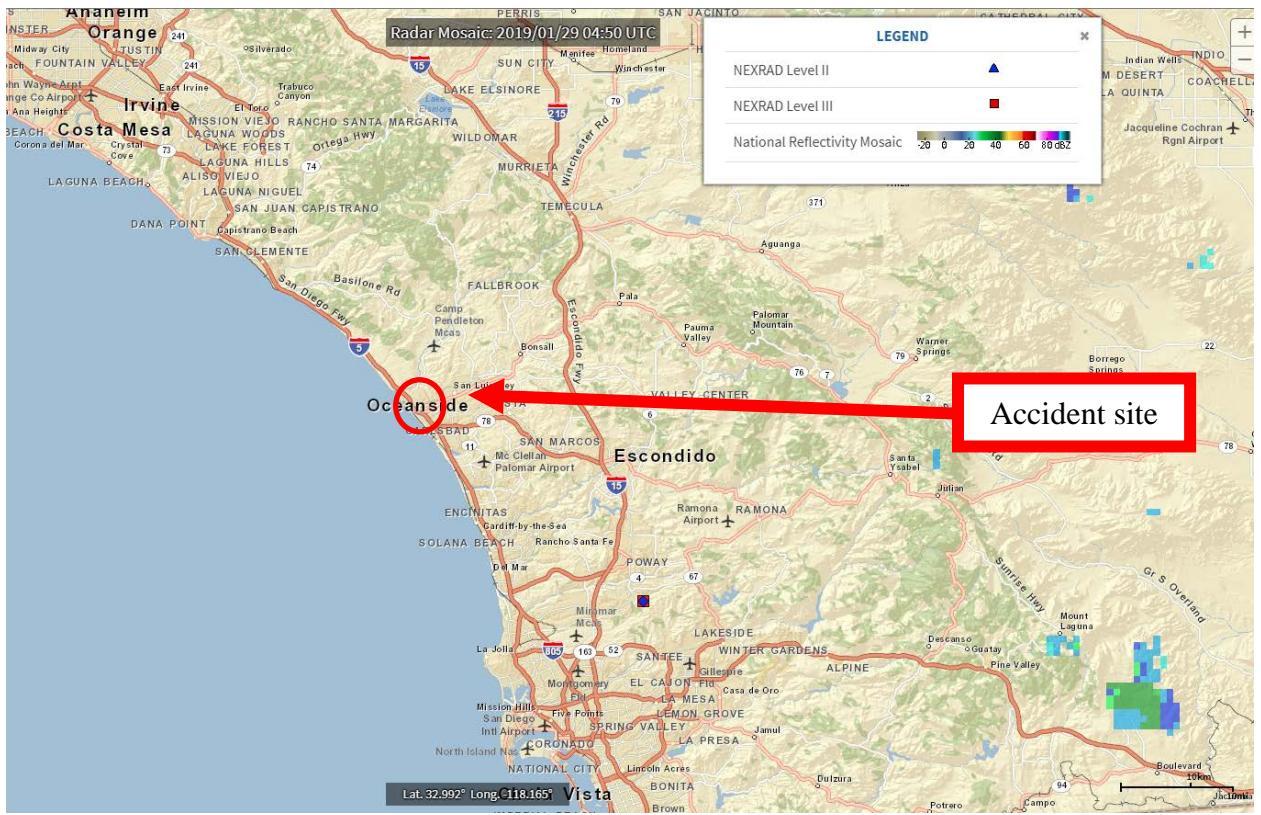
Figure 12 – Regional Composite Reflectivity image for 2050 PST

A regional view of the NWS national composite radar mosaic is included as figure 12 for 2050 PST with the approximate accident site marked by a red circle. The image depicted no echoes above the accident site at the accident time.

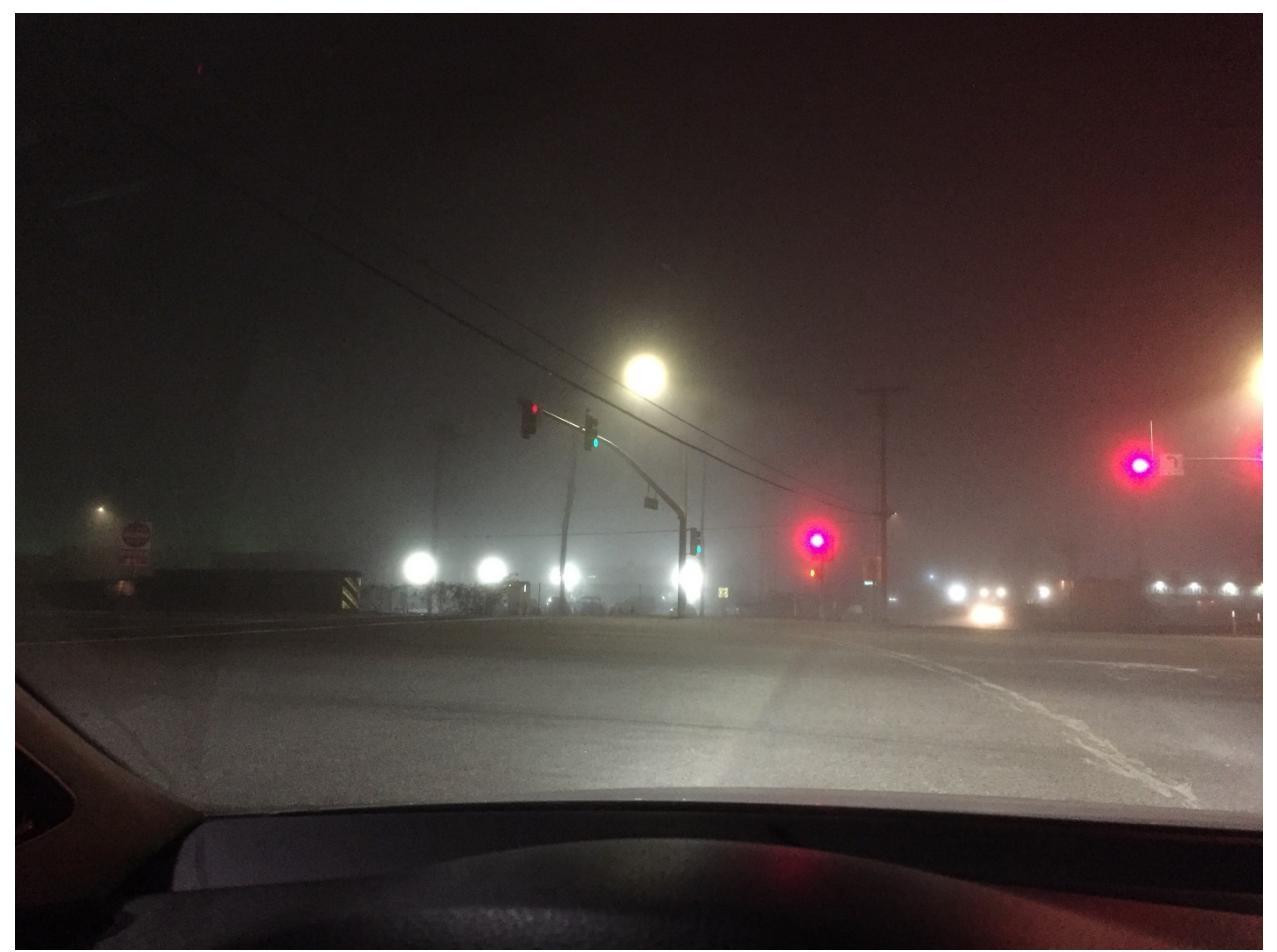
Two pilots arrived at KOKB between 1935 and 1940 PST to log some approaches between Carlsbad and Oceanside, California. As the pilots were pre-flighting their aircraft they noticed a significant amount of condensation on the aircraft along with low-level fog rolling inland from the west. At that point (approximately 1947 PST), the pilots called the KOKB ASOS for updated weather and the ASOS reported one and three quarter miles visibility. The pilots then noticed another aircraft coming in to land from the east as it was still more clear in that direction. After the aircraft landed, they watched this same aircraft depart with what appeared to be about a half mile visibility, before the departing aircraft was submerged in fog at about 400 to 500 ft agl with the departing plane only visible by their nav lights. Afterwards the fog continued to develop towards the field. Due to the lowering visibility conditions, the pilots decided to cancel their flight and departed KOKB by car at approximately 2005 PST and captured the low visibility conditions via imagery at the intersection of airport road and highway 76 within a quarter mile of the KOKB runway as seen in figure 13. Figure 13 was facing the southeast. For more information please see attachments 2 and 3.

Figure 13 – Witness image taken at 2005 PST driving away from KOKB at the intersection of airport road and highway 76 with the image facing southeast
