NATIONAL TRANSPORTATION SAFETY BOARD

Engine Data Monitor (EDM)

Specialist's Factual Report By Sean Payne

| Location: | McAlester, Oklahoma |
|---|---|
| NTSB Number: | CEN17LA357 |

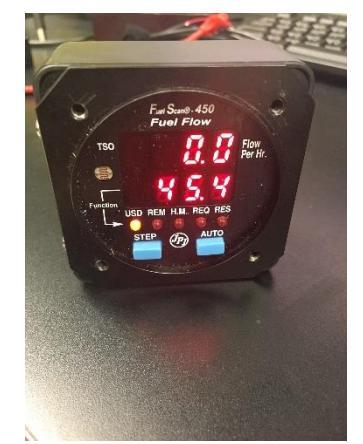
Figure 1. The FS-450 powered to show the amount of fuel used.

The recorder was in good condition and the data were extracted normally from the recorder by simply powering the device and observing the display. Figure 1 shows the amount of gallons used, 45.4 gallons. Figure 2 shows the amount of fuel remaining, 66.6 gallons.

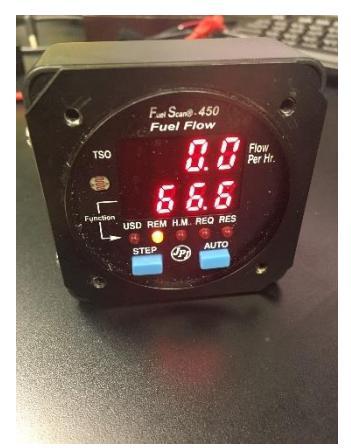
Figure 2. The FS-450 powered to show the amount of fuel remaining.
