National Transportation Safety Board

Interview Summary – DCA18FM019

Case: Anchor contact with submarine cables in straits of Mackinac

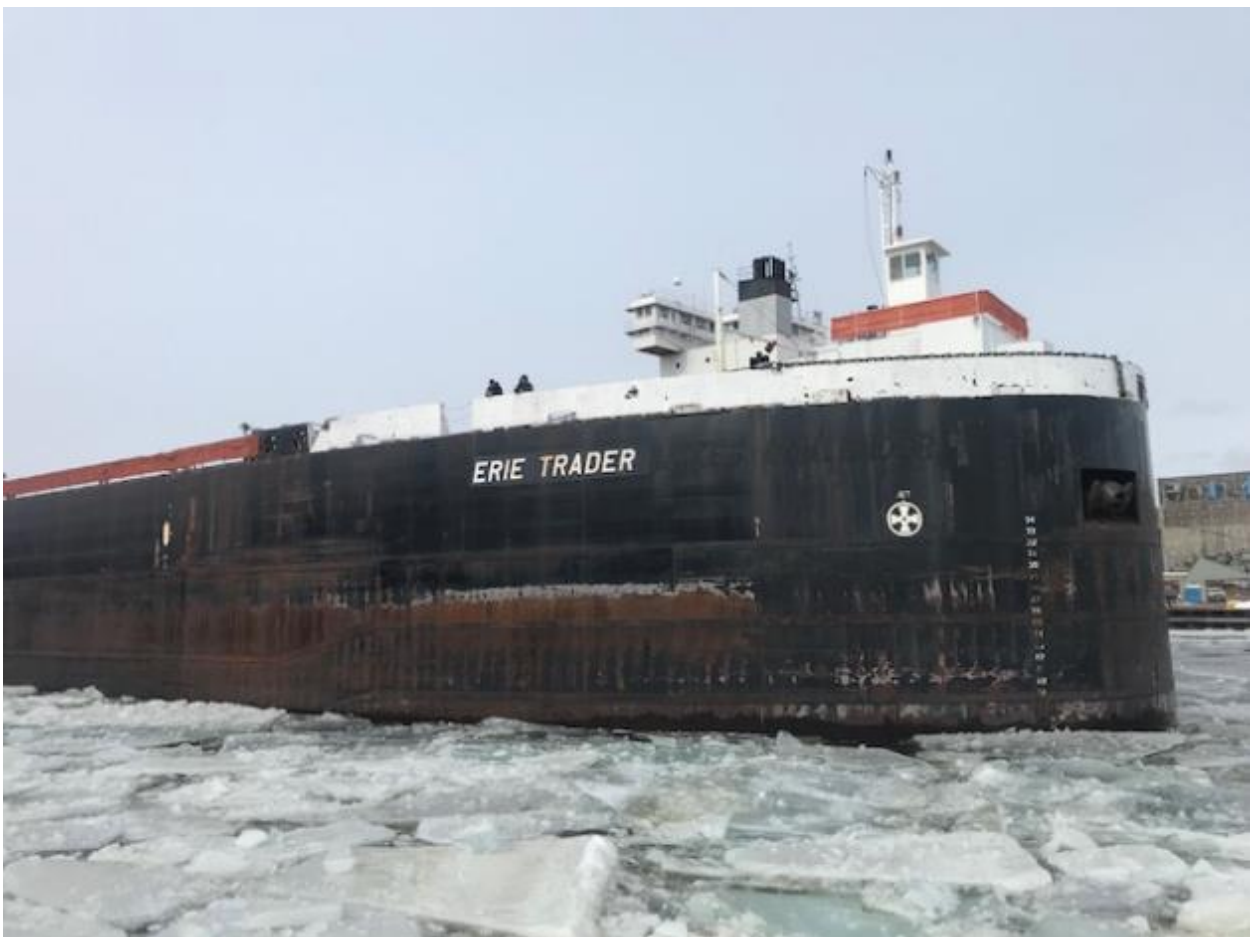
- Mr. Shambo provided investigators with a picture he took of the vessel departing Duluth on March 20 at 1226. He stated the anchor looked fully seated at the time.

Photo taken of the Erie Trader departing Duluth, MN on March 20, 2018 at 1226 local time. (Photo by Mr. Shambo)
