-- CEN12FA083 --  
**Accident Site Diagram**

November 5, 2011

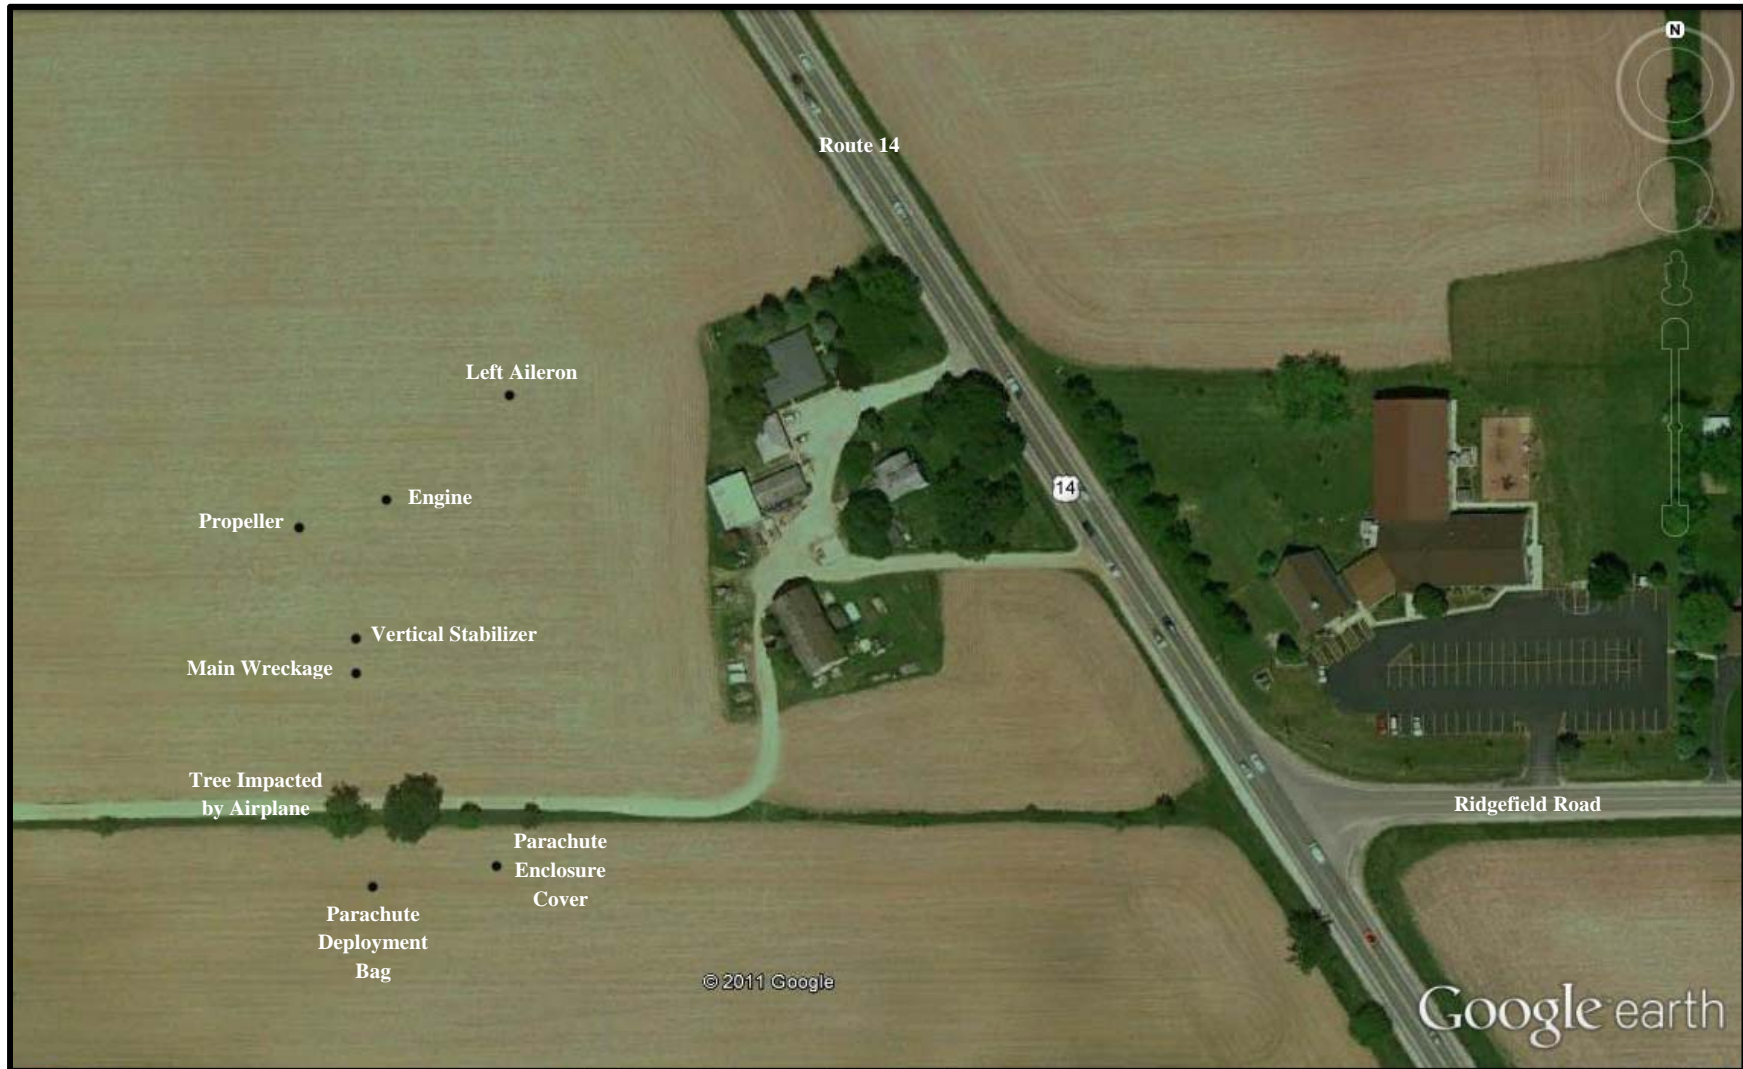
- 1) Diagram depicts the vicinity of Route 14 and Ridgefield Road in Crystal Lake, Illinois.
- 2) Component locations obtained by NTSB during the on-scene investigation (except for parachute components).
- 3) Parachute component locations are approximate and are based on first responder photographs and FAA observations.
