June 20, 1995
B-U01B-15291-ASI

Subject: Kinematic Analysis Update USAir 737-300 N513AU Accident
Near Pittsburgh - September 8, 1994

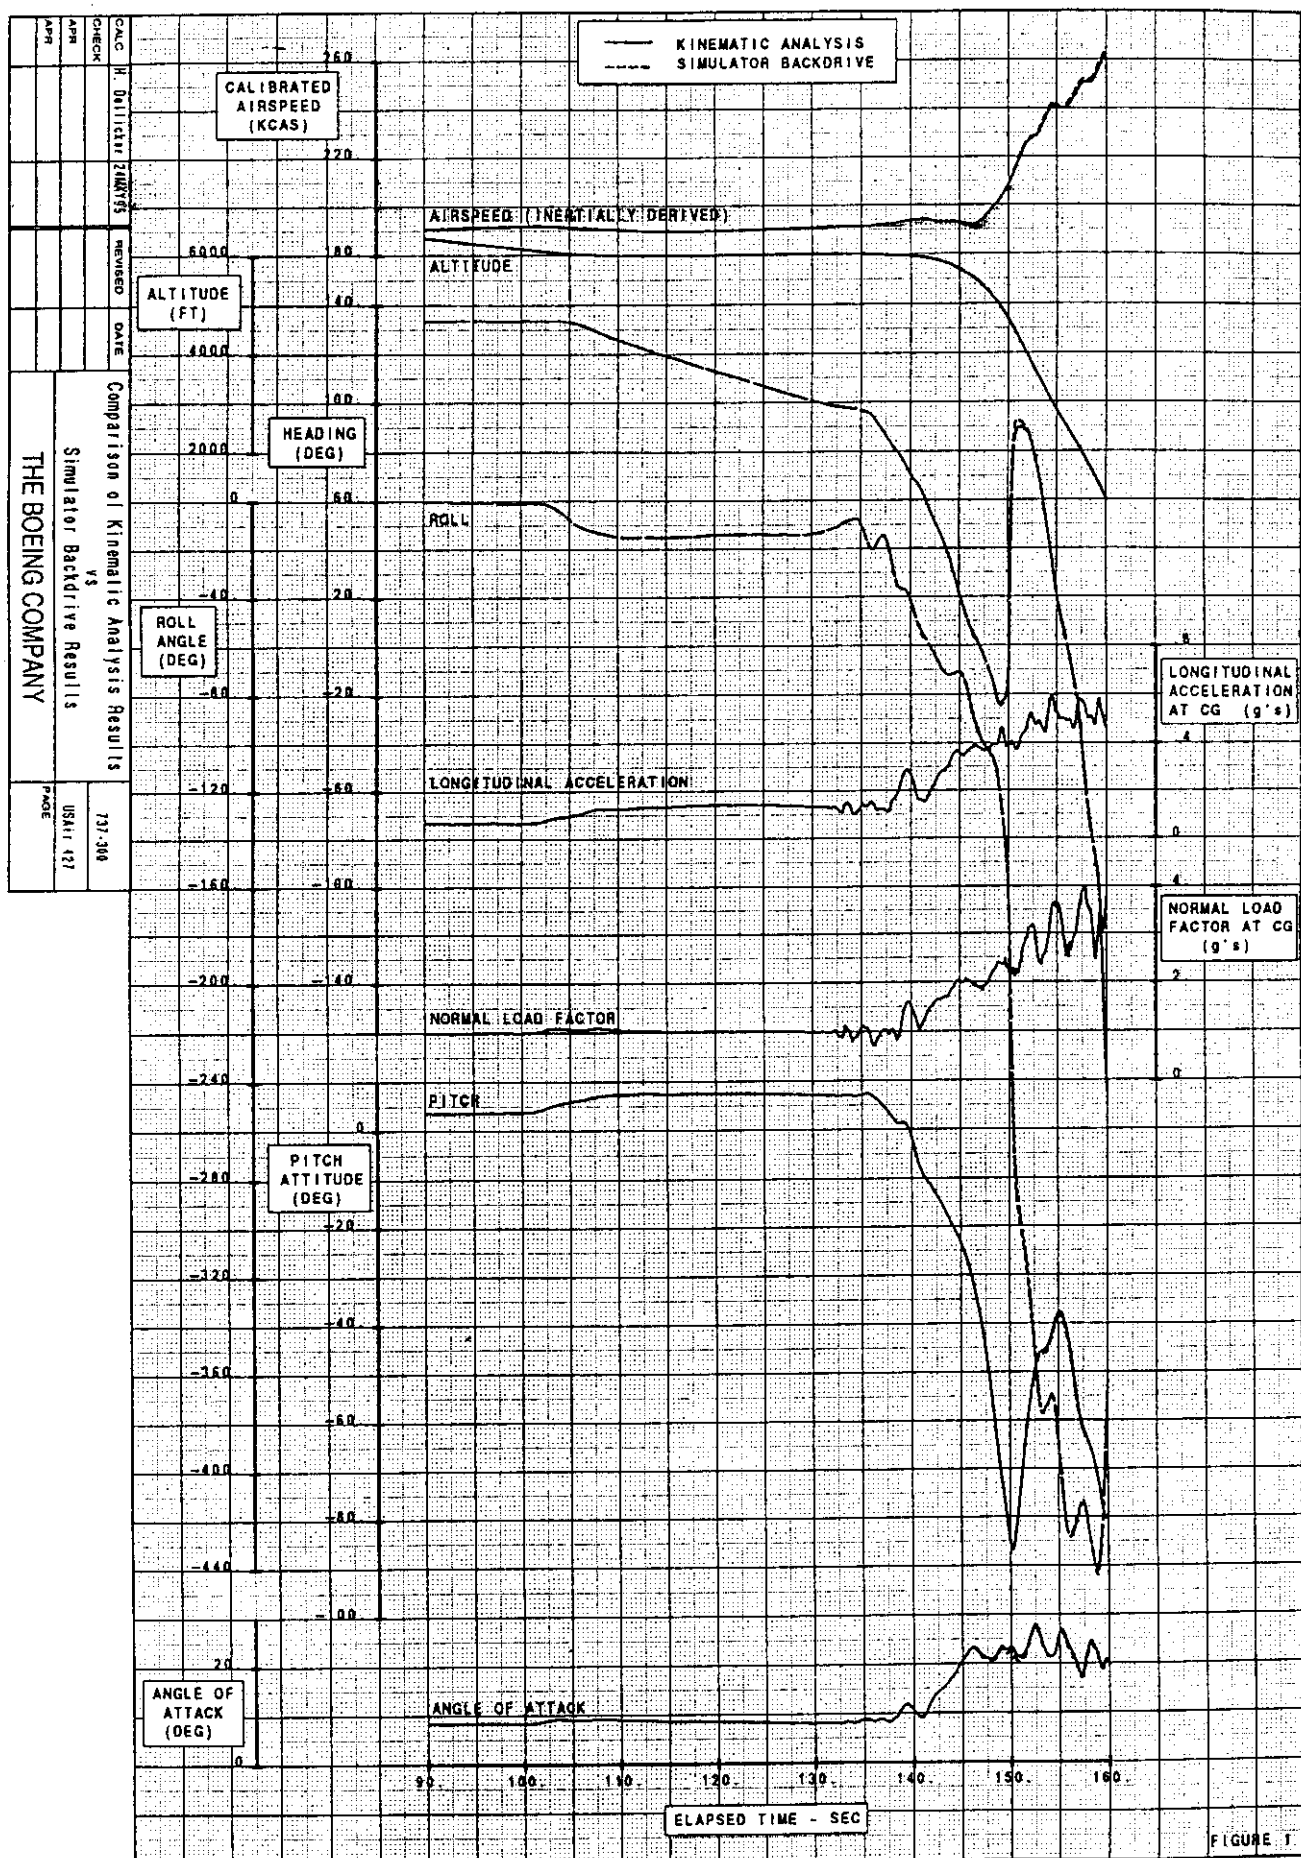
The procedure involves two distinct steps: Data from the kinematic processor are used, together with a special back-drive technique to achieve a high quality match of the motion data using the airplane simulation (See Figure 1). The results of the simulation back-drive provide an improved estimate of the sideslip angle (assuming calm air) which may then be used as the starting point for the next iteration beginning again with the kinematic analysis. Convergence on a final solution is rapid (only two or three iterations are required), starting with an assumed value of zero for sideslip angle.

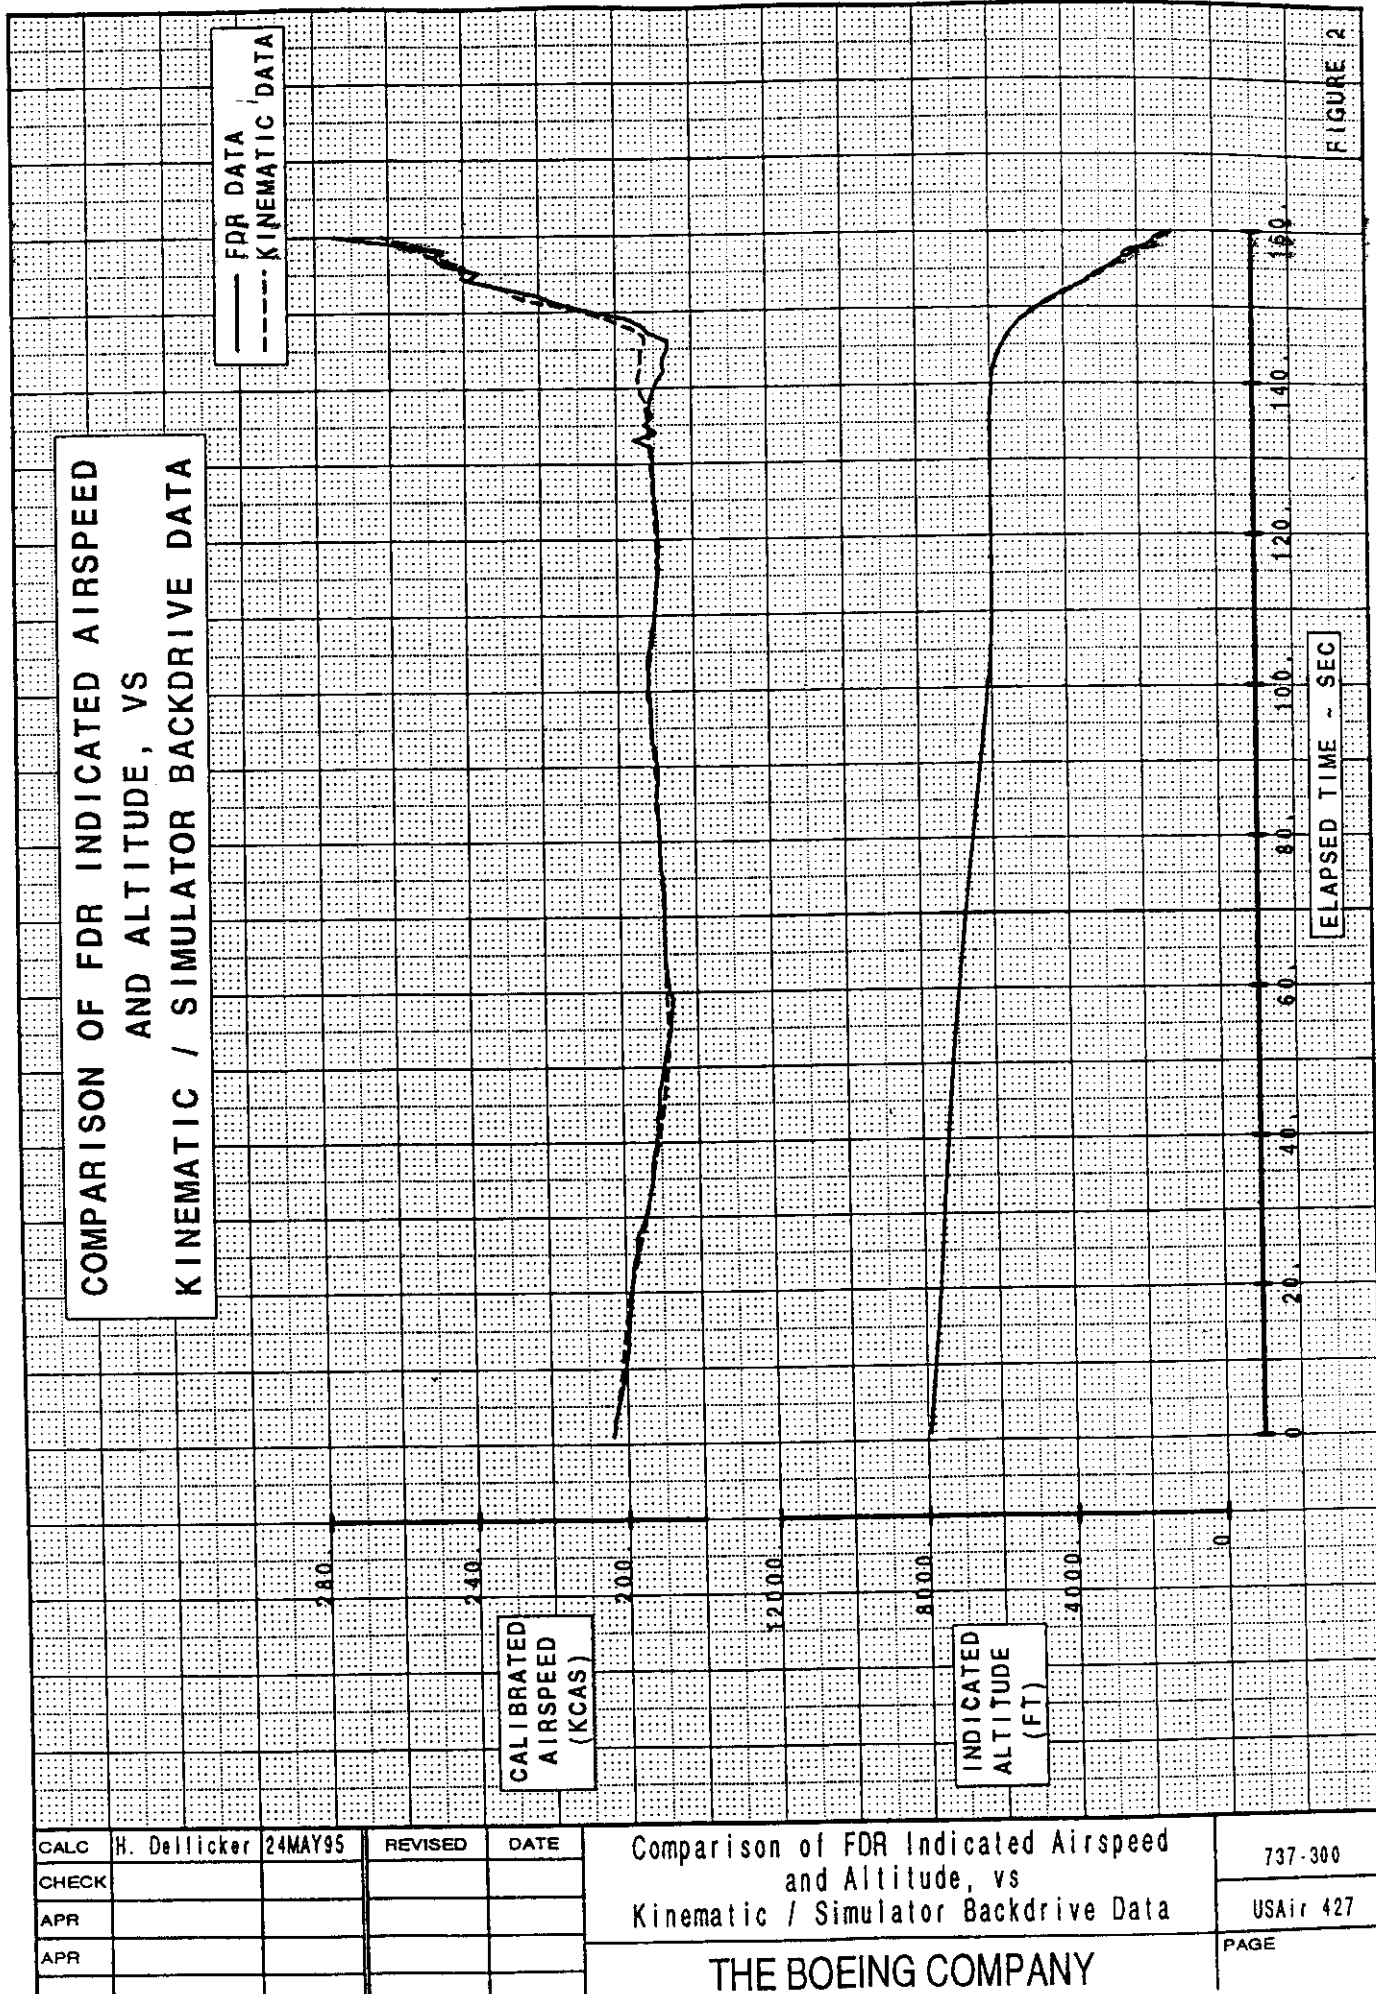
FIGURE 2

The simulation back-drive technique mentioned above computes incremental aerodynamic coefficients to produce a match of the calculated linear and angular accelerations of the aircraft. This, in turn, results in an excellent match of airspeed and altitude as shown in comparisons of the FDR, kinematic analysis, and simulation back-drive data in Figure 2.

Comparison of FDR Indicated Airspeed
and Altitude, vs
Kinematic / Simulator Backdrive Data

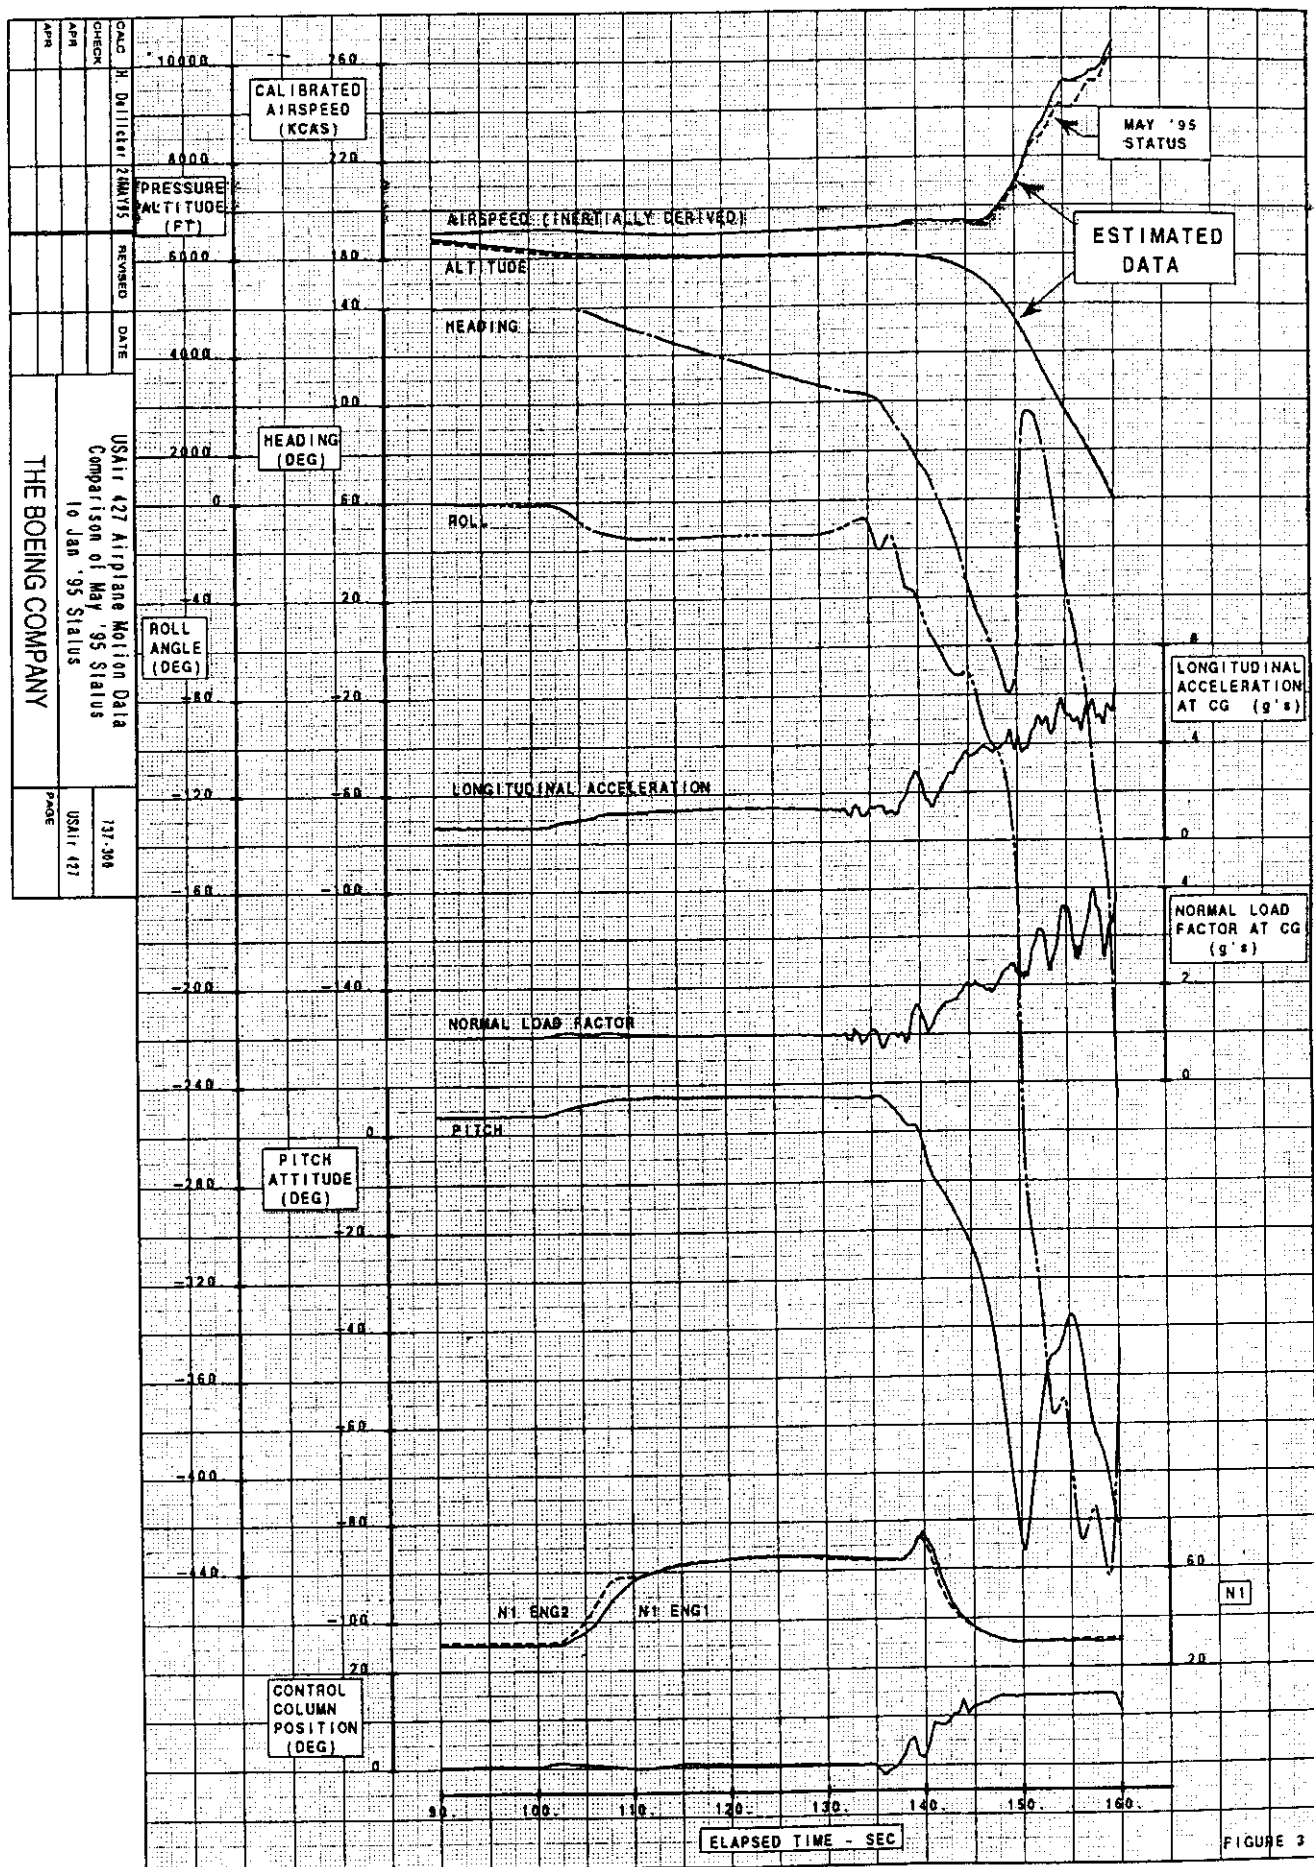
Figures 3 and 4 show the basic FDR data and a comparison of the kinematically derived data presented in the reference, vs the current estimates. The current data show the expected Dutch Roll activity in sideslip at 139 seconds, as well as generally larger peak sideslip values throughout the final 25 seconds of flight. Also, the current prediction of stall warning (stick shaker) shows intermittent activity in the final 3 seconds of flight, consistent with the cockpit voice recorder, as will be noted in forthcoming corrections to the CVR transcript. This is consistent with the expected airplane response to elevator blow-down at this point in the accident sequence.

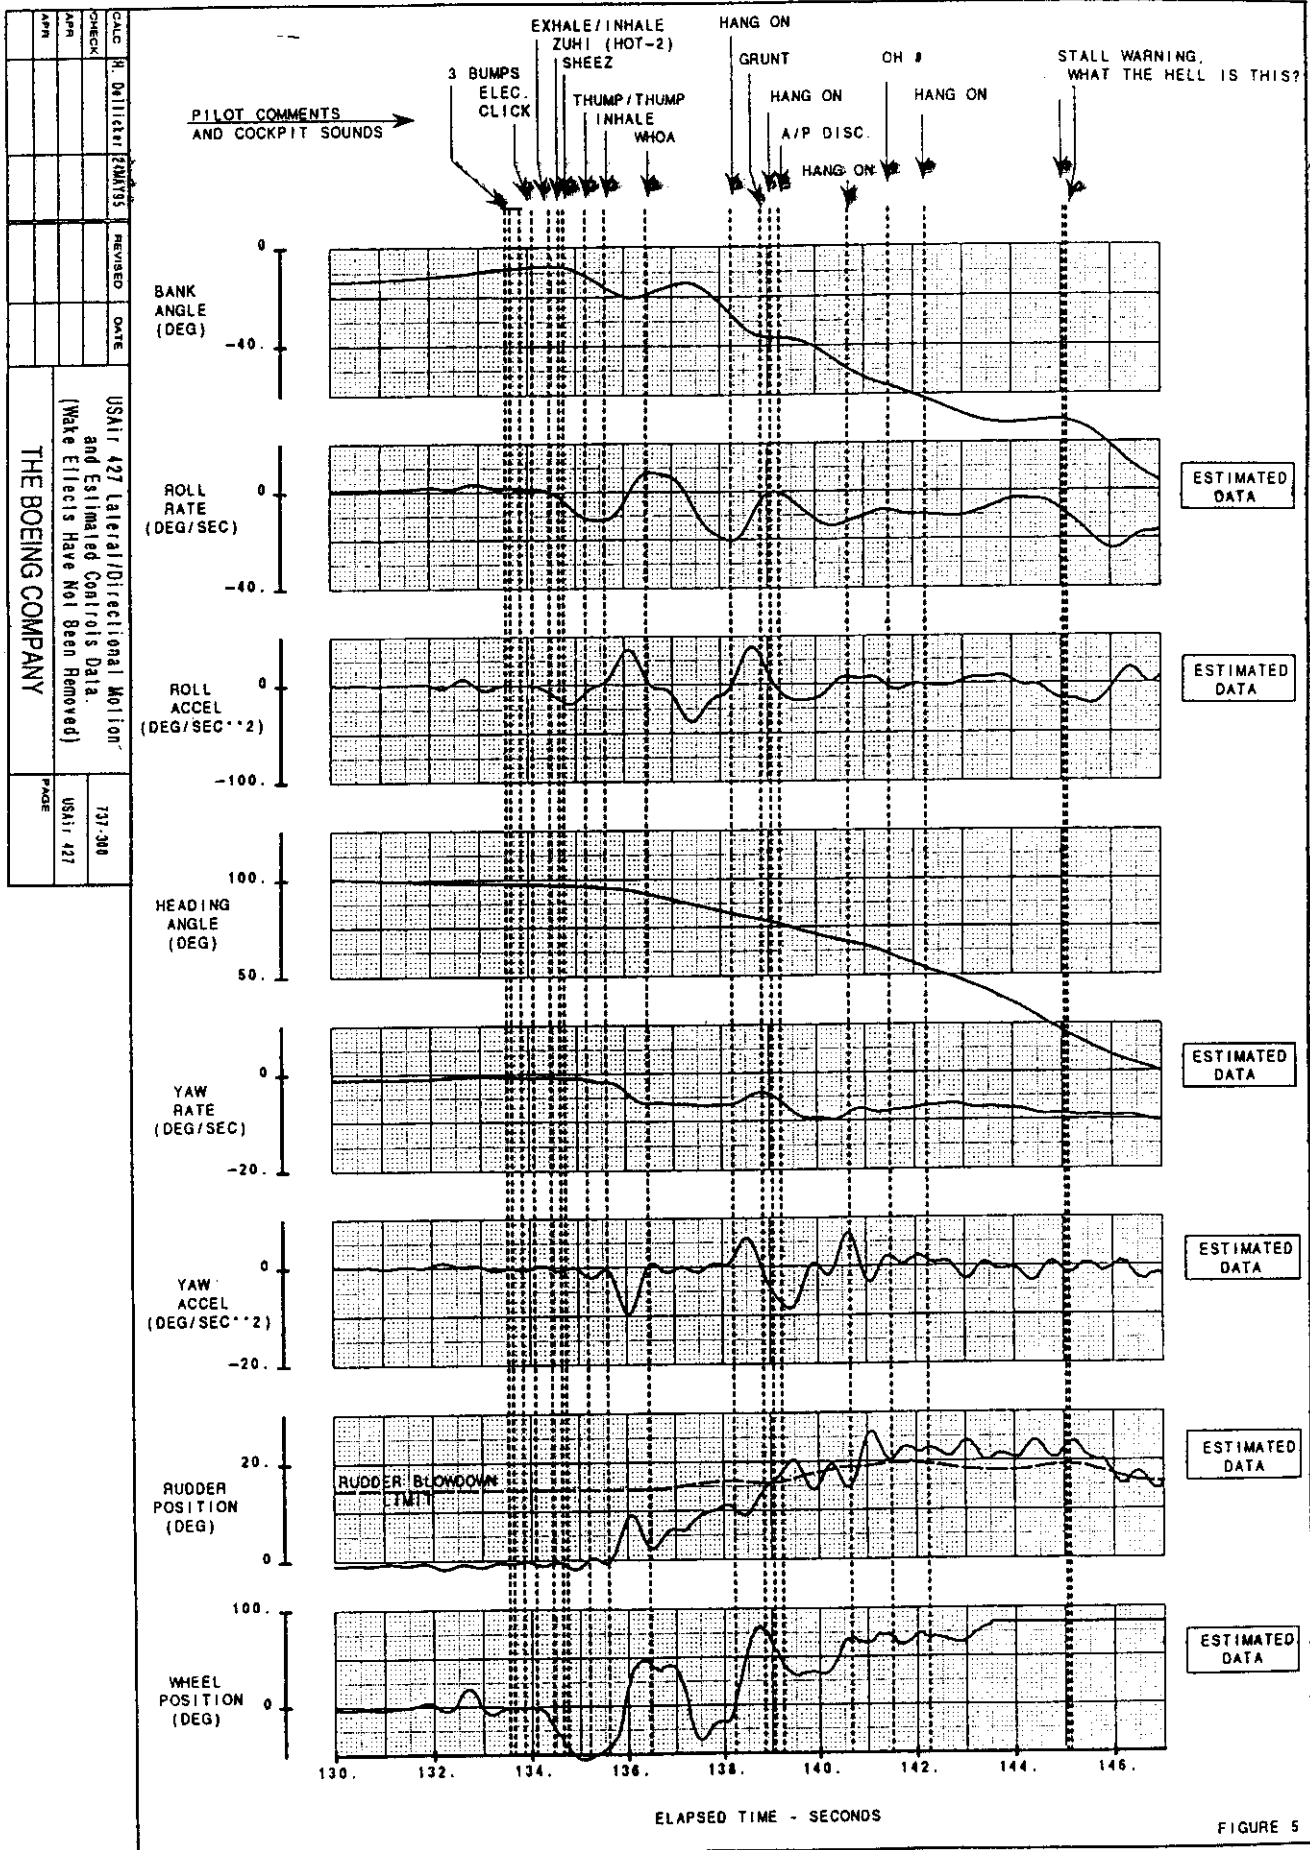
FIGURE 5

As noted in reference (b), except for column, the actual control deflections from USAir 427 are unknown. To aid in the understanding of the flight scenario, the estimated yawing and rolling moment coefficients have been converted to equivalent rudder and wheel deflections, using the flight characteristics of the 737-300. Figure 5 shows these data, along with relevant roll and yaw motion variables and CVR events. These data represent the total combined effects of actual control deflections, plus the unknown effects of the wake, FDR errors, possible structural damage, deficiencies in the simulator aerodynamic model, etc.

Figure 14 shows the rudder and wheel position data which result from subtracting out the predicted yaw and roll effects of the wake. As in Figure 5, these data are shown together with the relevant roll and yaw motion variables and CVR events.

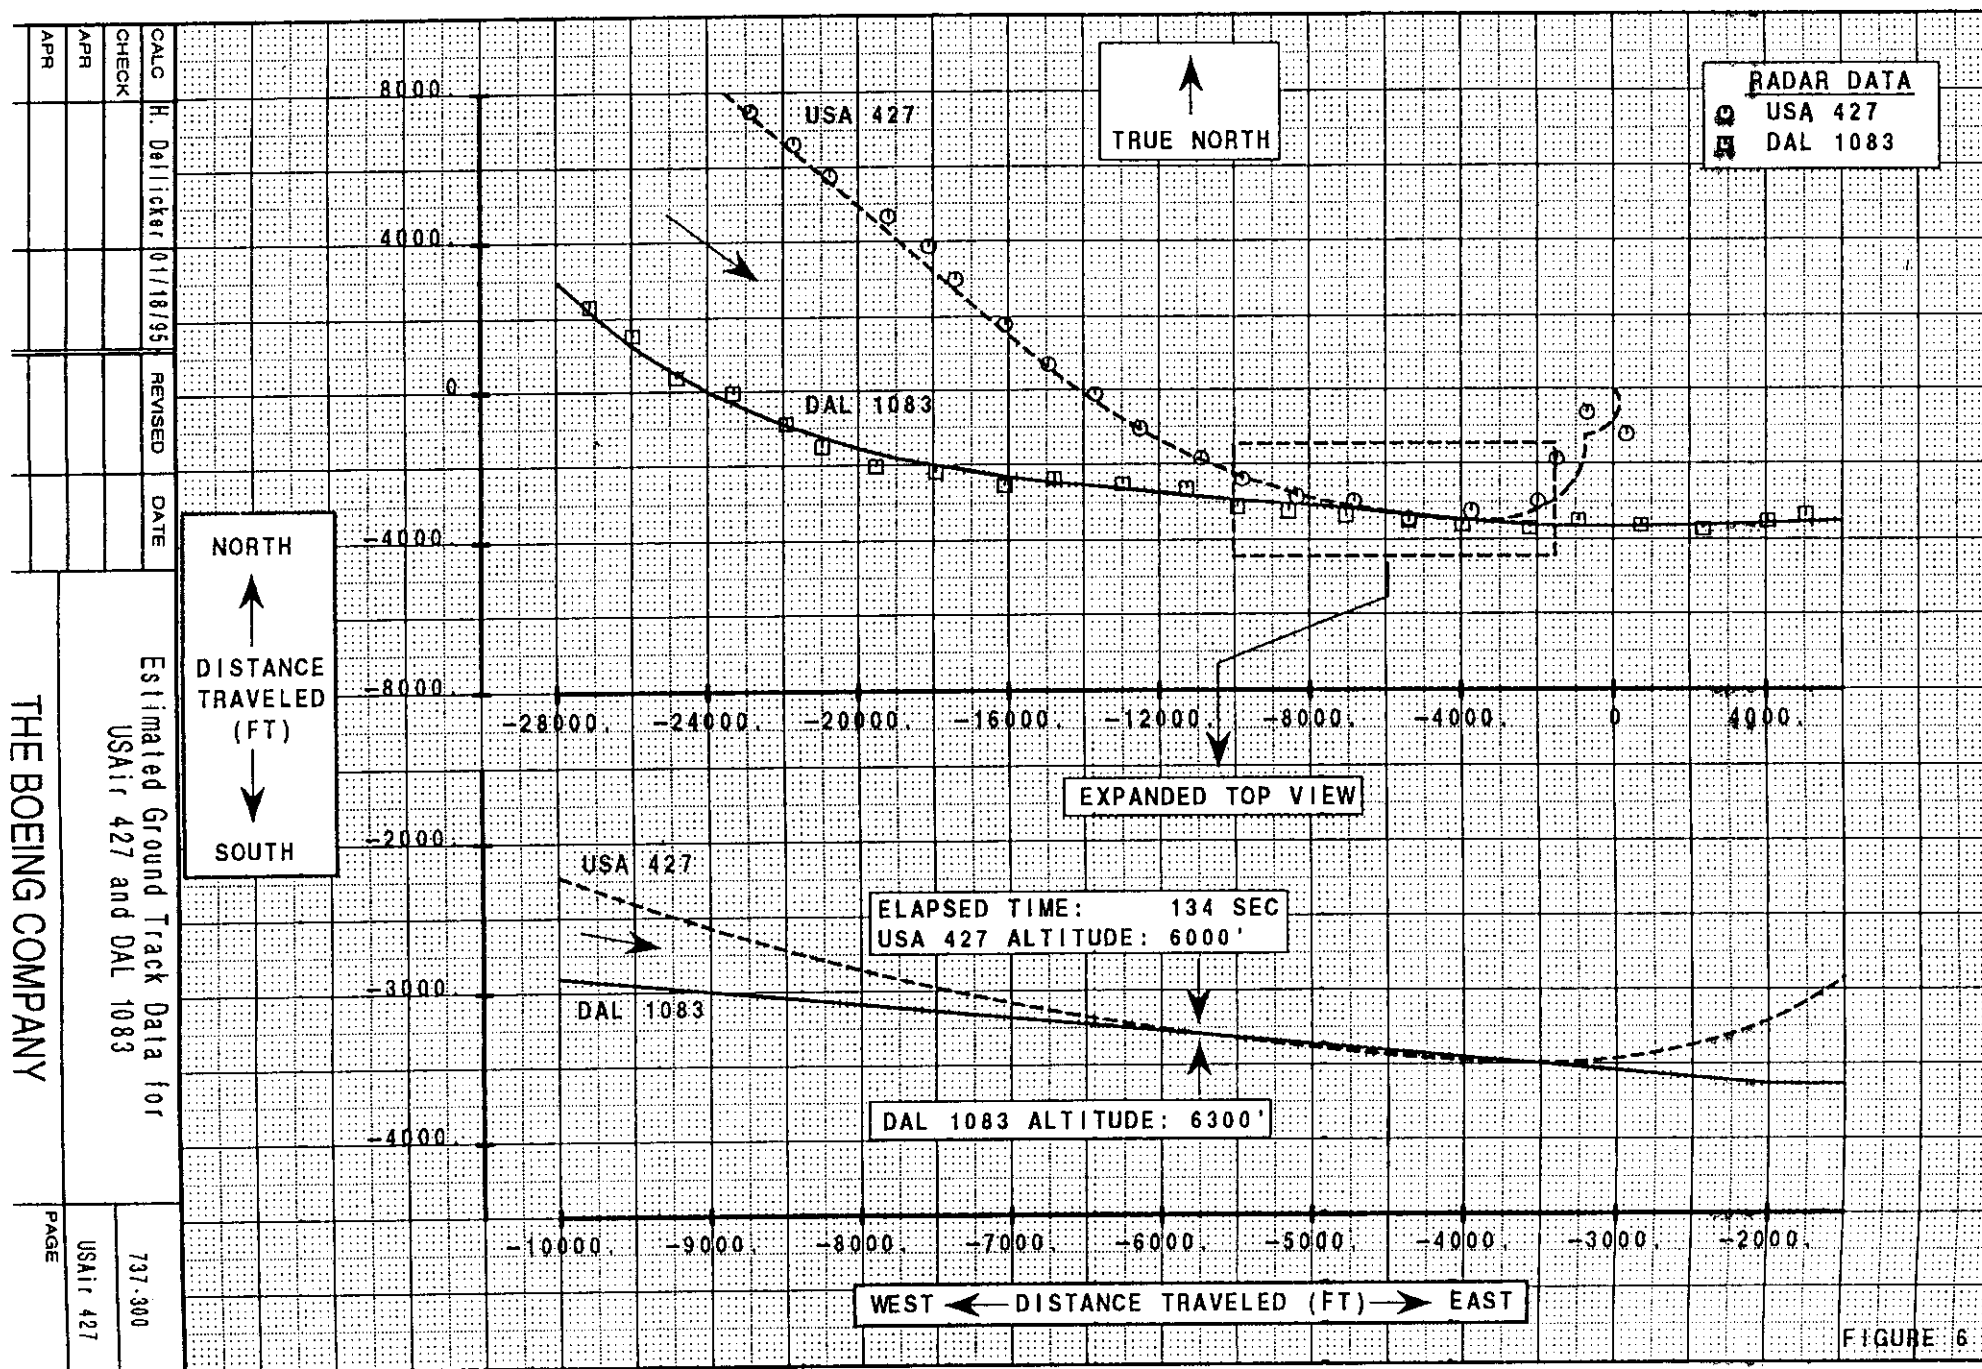
FIGURE 6

- Tower radar data indicate probable intersection of the ground tracks of the two aircraft at the right point in space and time (Figure 6). Also, the vertical separation of the aircraft (based on transponder data recorded by the tower for both aircraft) is reasonably consistent with the distance the wake would be expected to drop in 69 seconds. (Note: The dashed line representing the path of USAir 427 is kinematically derived data, overlaid on the radar data to achieve best fit. The solid line representing DAL 1083 is a simple curve fit through the radar data.)

For the purpose of this analysis, it was decided that the aforementioned radar data in Figure 6, the initial positive roll and yaw associated with Figure 7, and the lift and pitching moment data in Figure 8 would serve as the primary guide in the development of the wake encounter scenario.

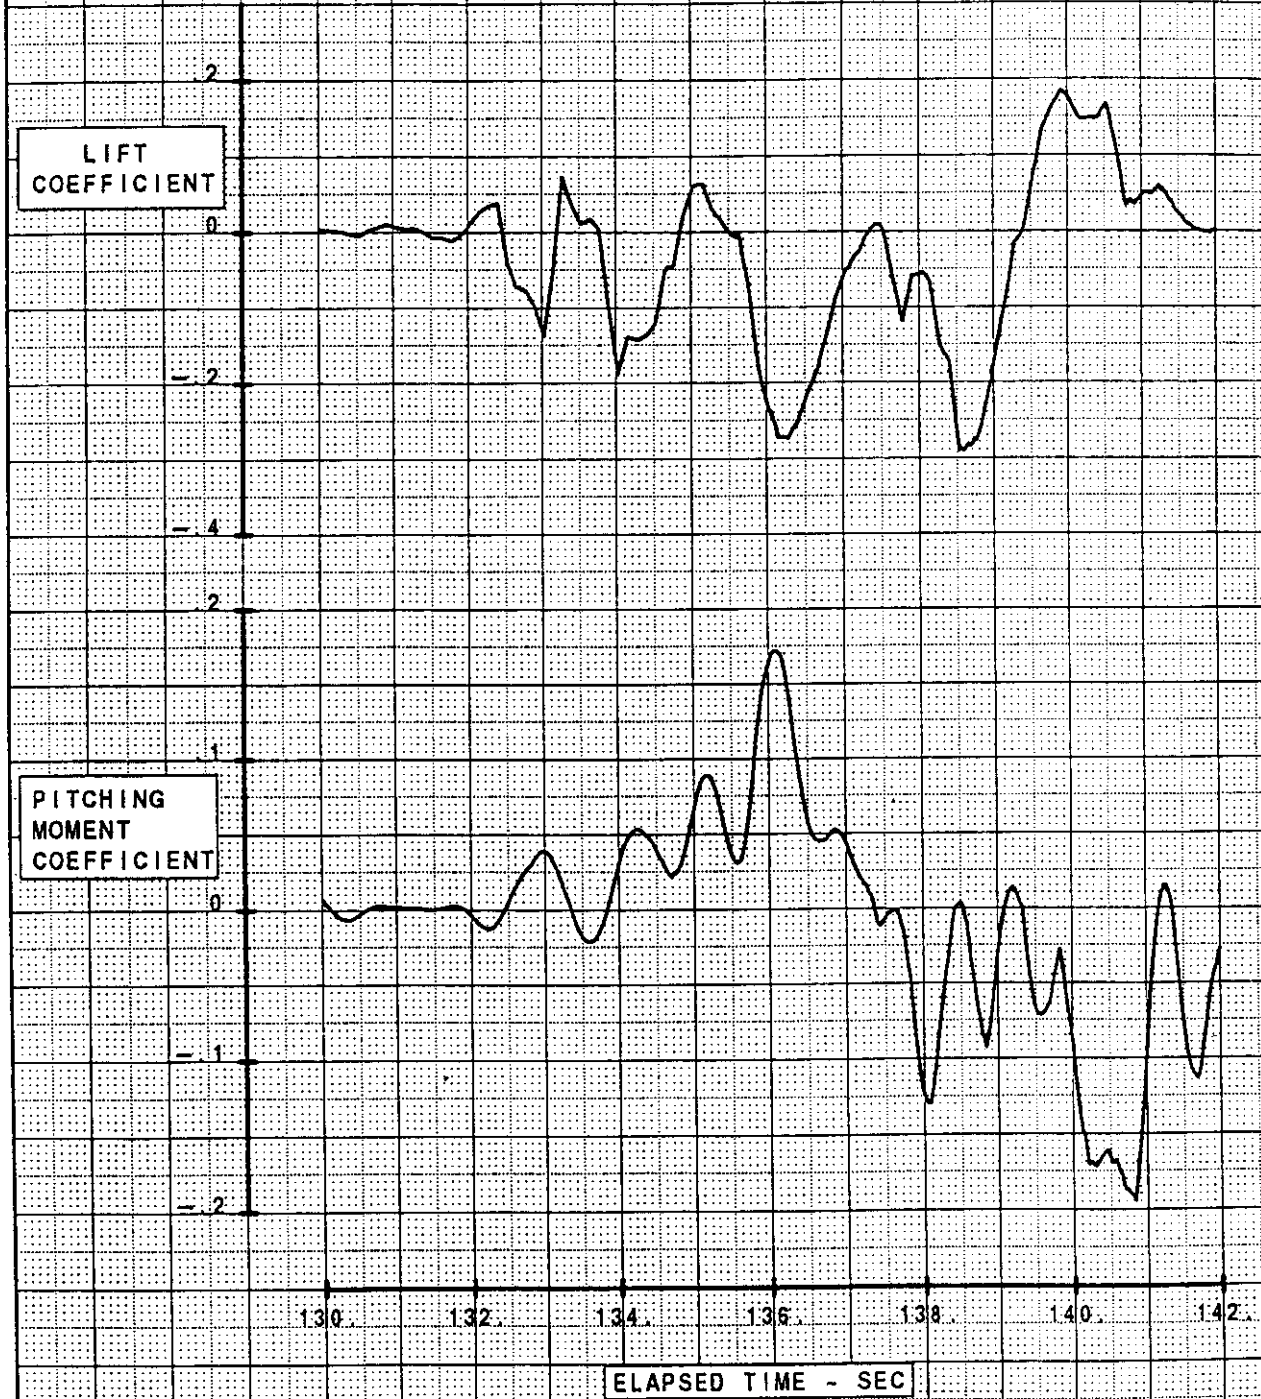
FIGURE 8

- Abnormalities in the lift and pitching moment coefficients (Figure 8) required to match the predicted airplane flight path are also consistent with a wake encounter. The coefficients show a loss of lift and a tendency to pitch up, as well as the effects of a sudden increase in turbulence. These symptoms are all consistent with the effects of a wake acting on an aircraft located generally between the two vortex cores; a region of strong downwash.

Anomalies In USAir 427 Lift and Pitch Coefficients During Wake Encounter

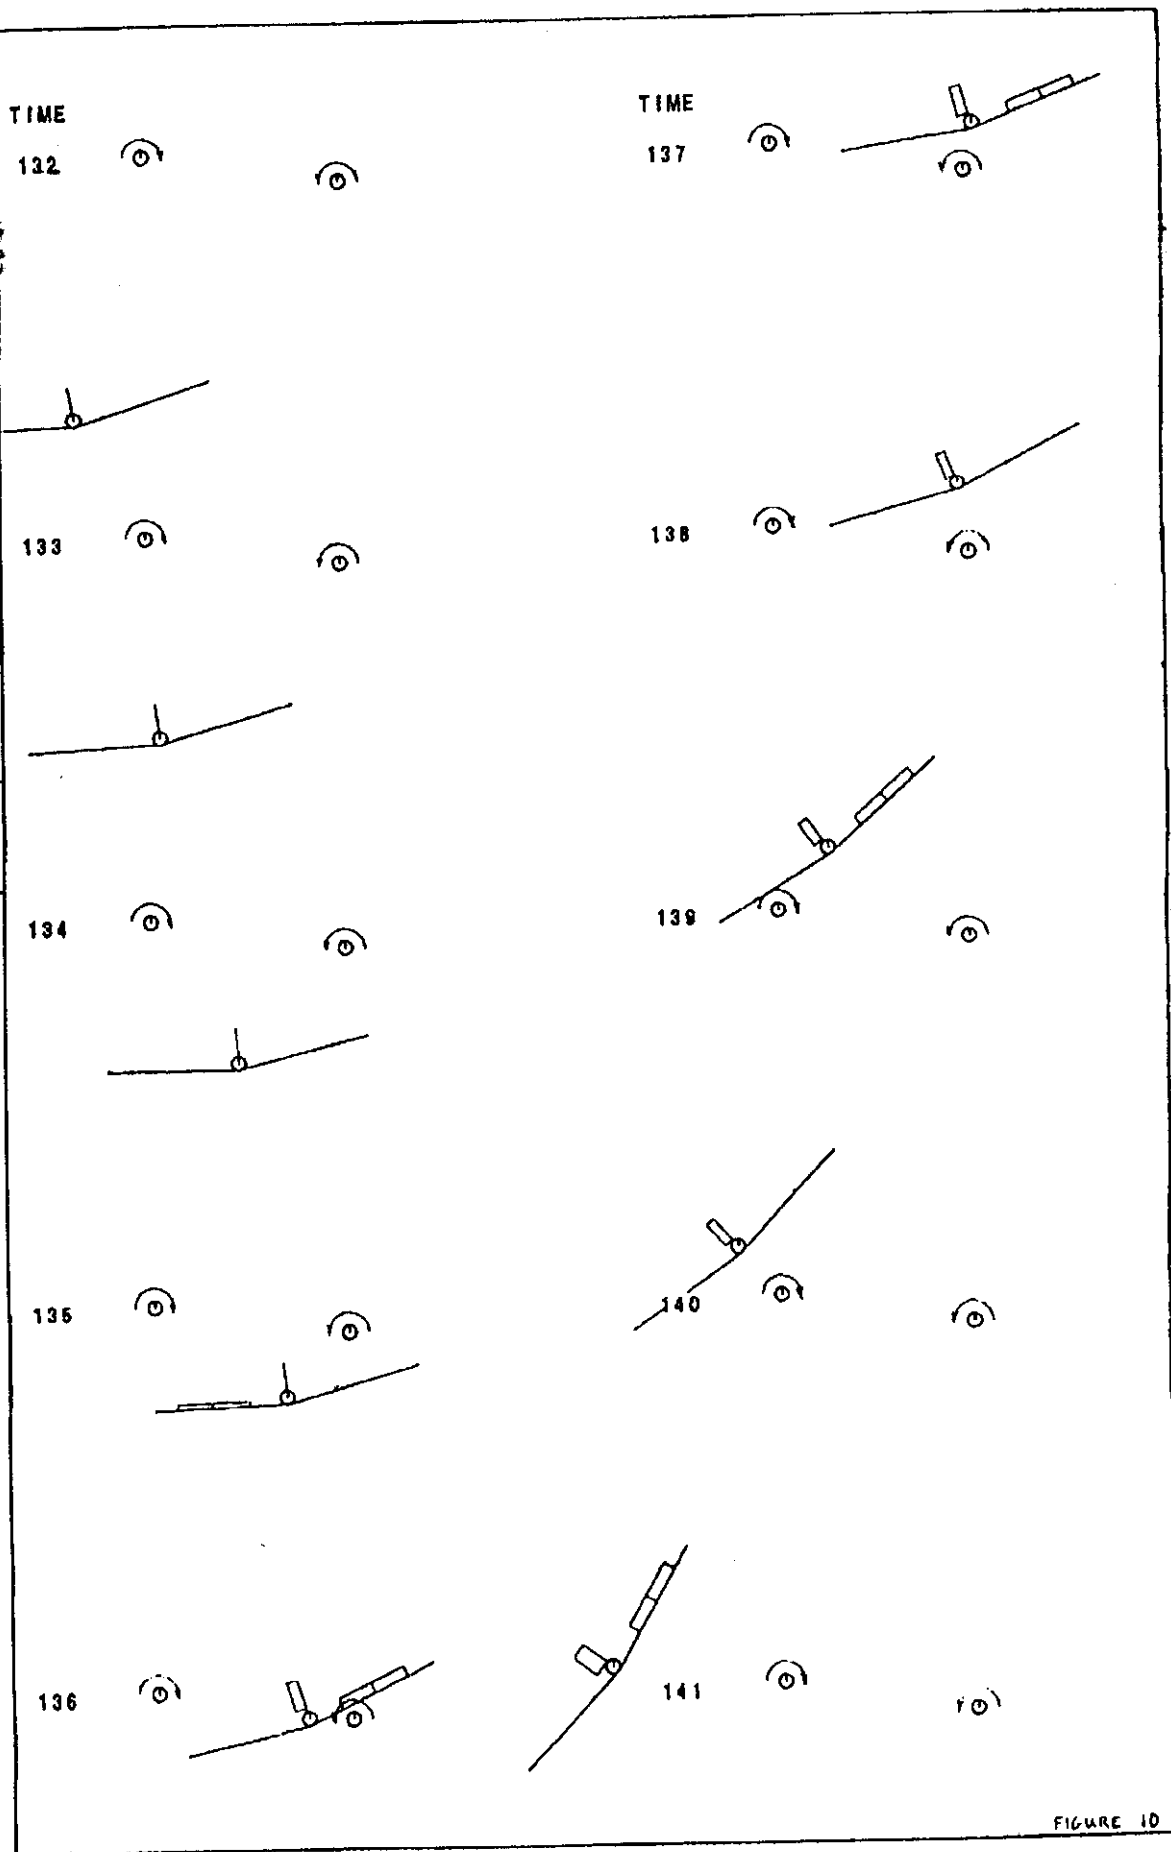
FIGURE 10

Figure 10 shows a frame by frame view (once per second), looking from the back, as the aircraft moves through the wake from underneath the left core at 133 seconds, out over the top of the right core at 137 seconds, then back to the left over the top of the left core at about 140 seconds. Spoilers are illustrated on the wings to indicate the probable pilot wheel input at each point in time. Rudder deflection is also indicated.

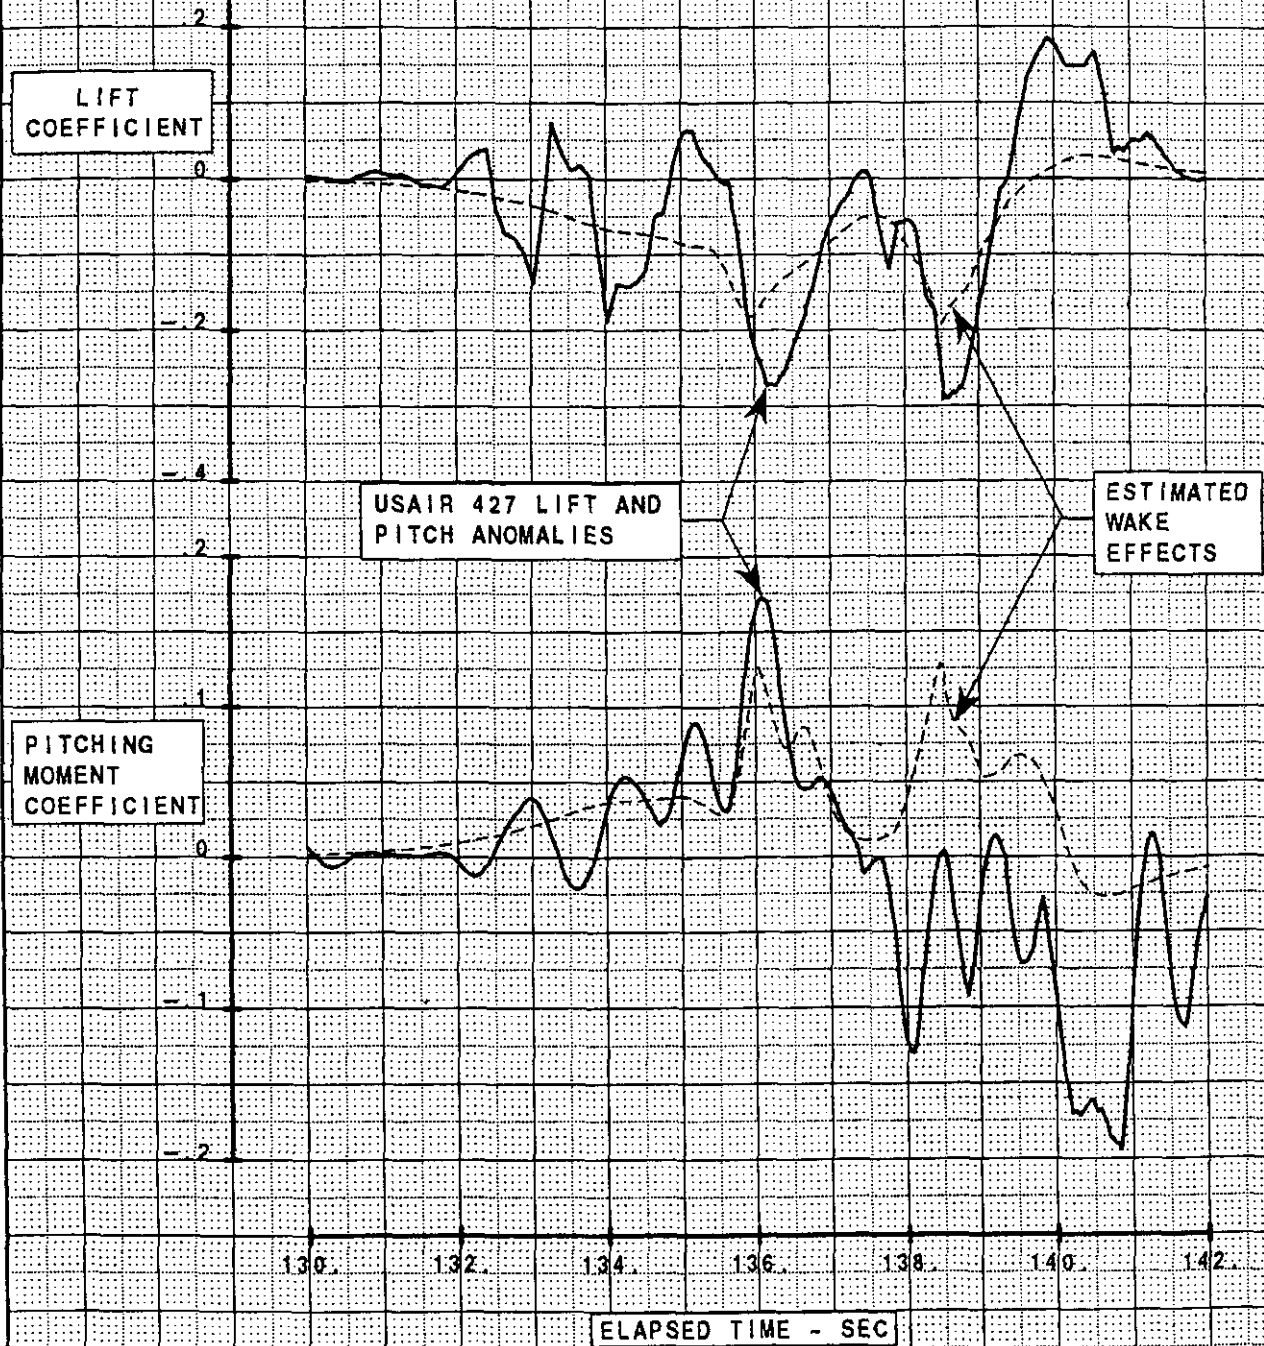
FIGURE 1.1

Figure 11 shows a preliminary comparison of the lift and pitching moment anomalies experienced by the aircraft during the wake encounter, vs the predictions from the analytical wake model for the scenario just described. Figure 12 shows the residual lift error when the theoretical wake induced lift is subtracted out. That which remains may be characterized simply as low level noise.

Comparison of USAir 427 Lift and Pitch
Anomalies During Wake Encounter
Vs. Estimated Wake Effects

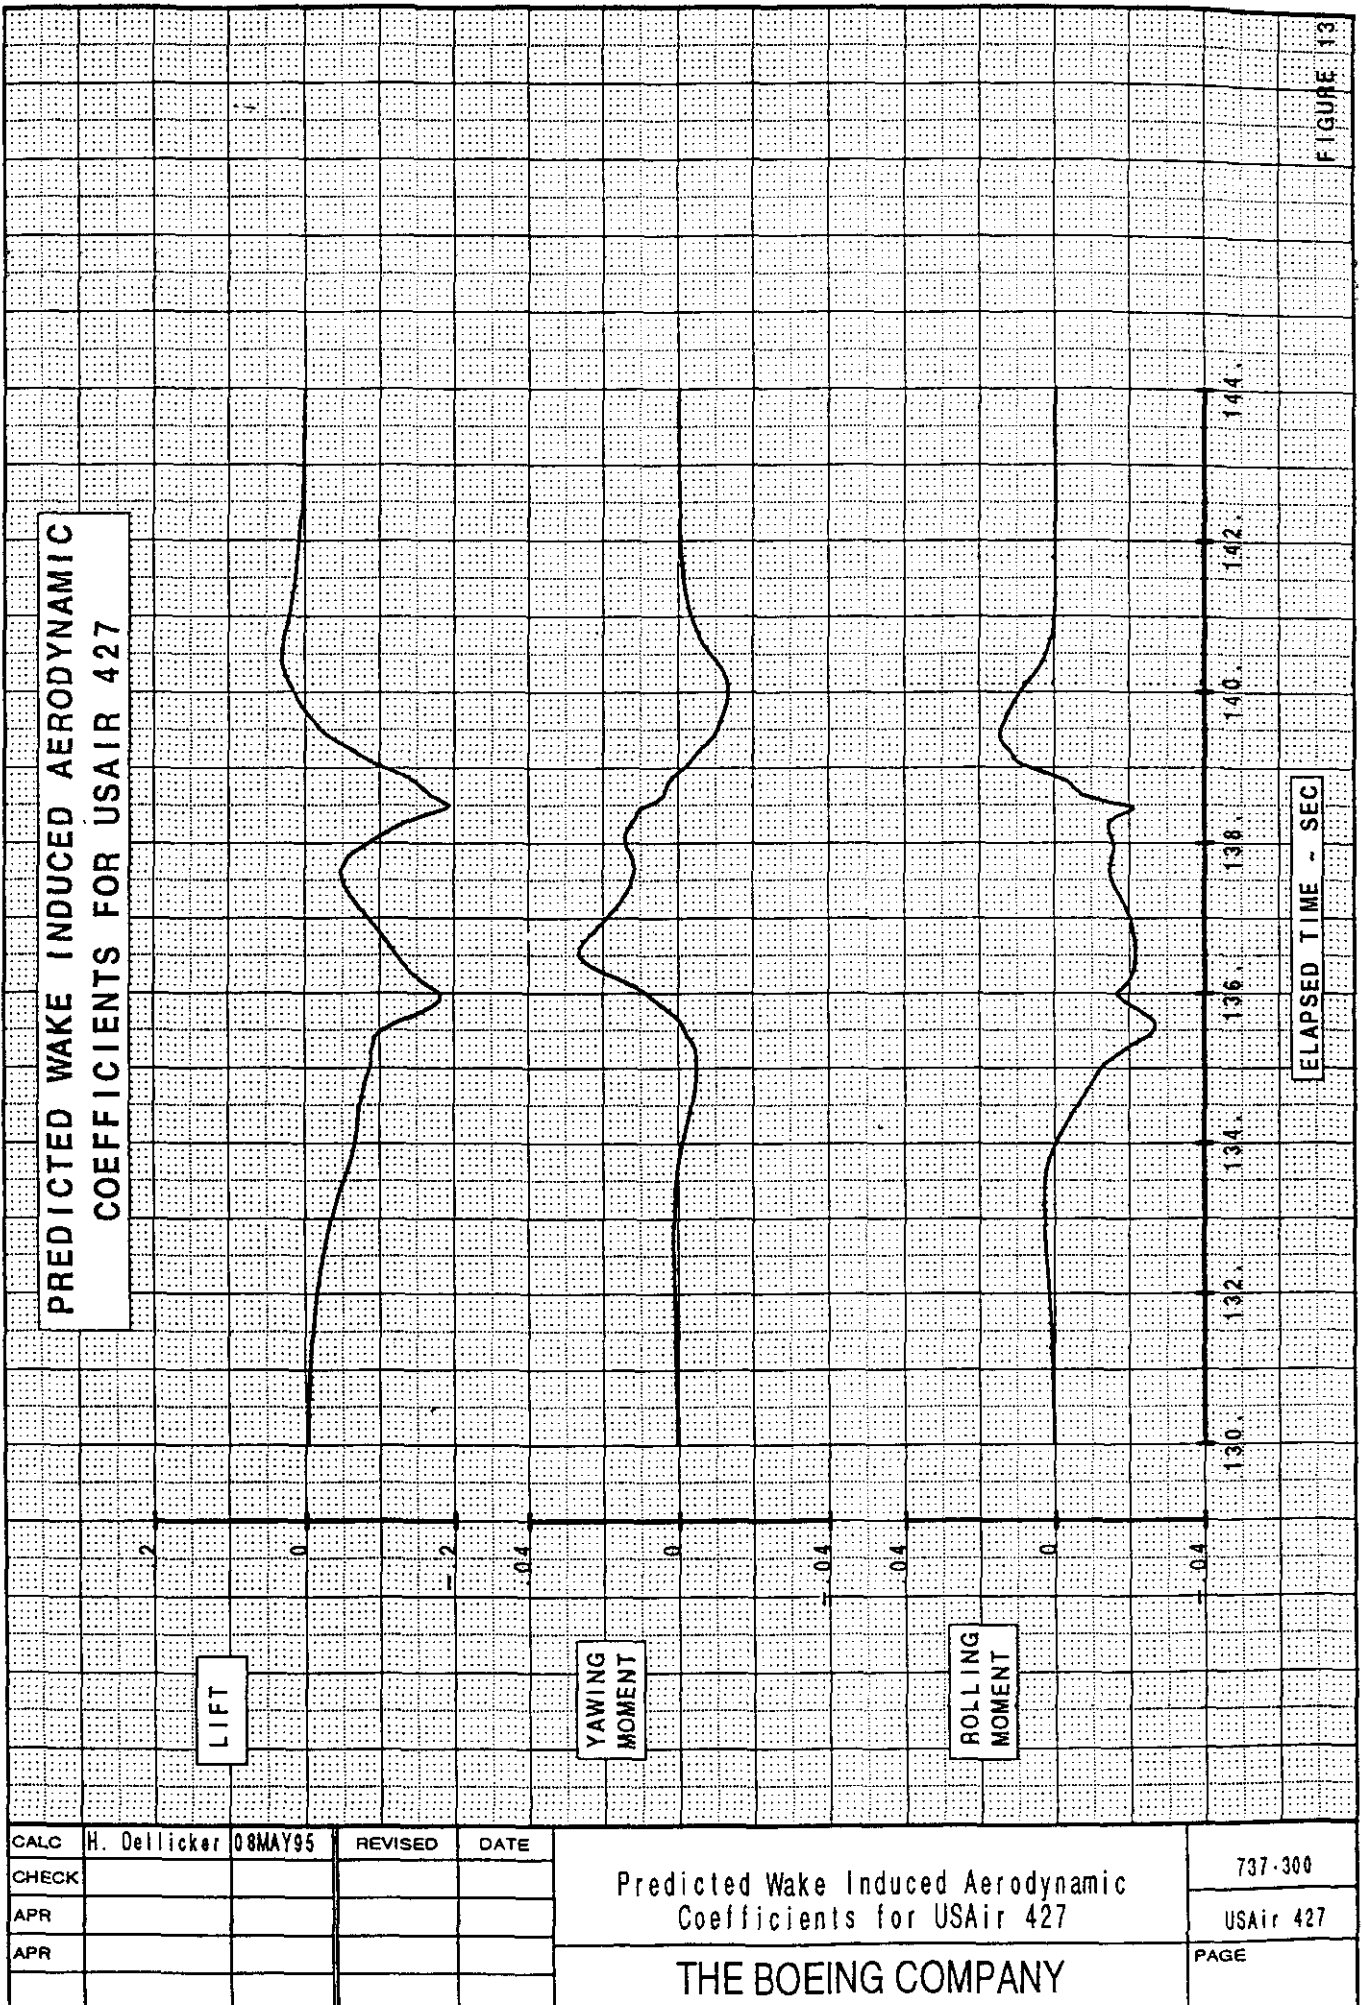
FIGURE 13

Figure 13 shows the yaw and roll effects associated with the derived wake, together with the lift coefficient discussed above. These data indicate a general trend of yaw to the right (opposing the derived rudder) and roll to the left through the central portion of the encounter.

Predicted Wake Induced Aerodynamic
Coefficients for USAir 427
