June 20, 1995
B-U01B-15291-ASI

Subject: Kinematic Analysis Update USAir 737-300 N513AU Accident
Near Pittsburgh - September 8, 1994

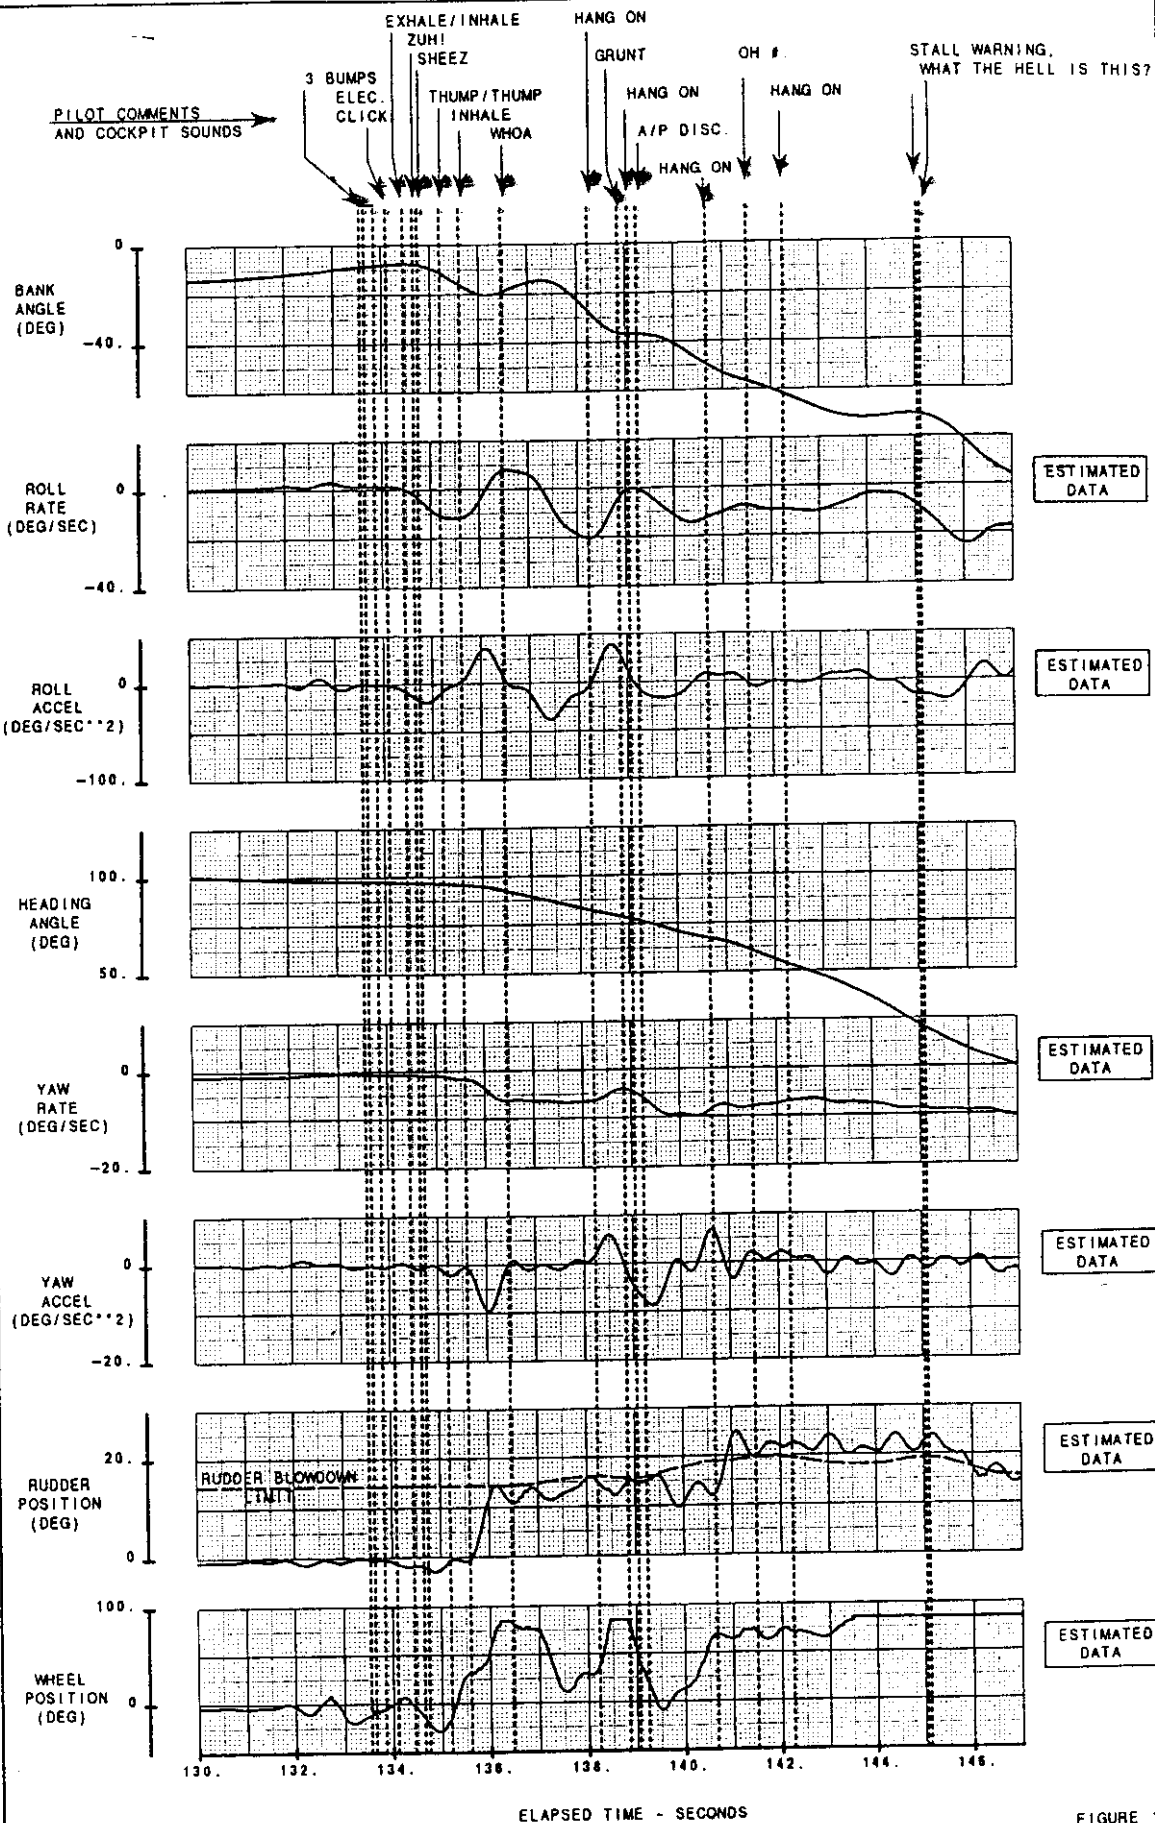
FIGURE 14

Figure 14 shows the rudder and wheel position data which result from subtracting out the predicted yaw and roll effects of the wake. As in Figure 5, these data are shown together with the relevant roll and yaw motion variables and CVR events.

CALC	DATE	TIME	REVIEWED	DATE
CHECK				
APR				
APR				
APR				
USAF 427 Lateral/Directional Motion and Estimated Controls Data Based on Currently Estimated Wake Effects				
THE BOEING COMPANY				
PAGE				737-300 USAF 427

Figure 15 shows the estimated rudder position data from Figure 14, along with the predicted yaw damper activity (assuming a normal, functioning yaw damper). It also shows an approximate, derived rudder pedal position, calculated by subtracting the yaw damper command from the rudder, then dividing by an approximate rudder-to-pedal gearing ratio. The yaw damper command used in this analysis is derived from the simulator match of the flight data (primarily yaw rate, which is derived directly from the FDR data), and assumes normal yaw damper operation. Note that the simulated yaw damper commands right rudder from 135.5 to 138.5 seconds, which is opposite to the rudder input which is required to match the airplane motion.

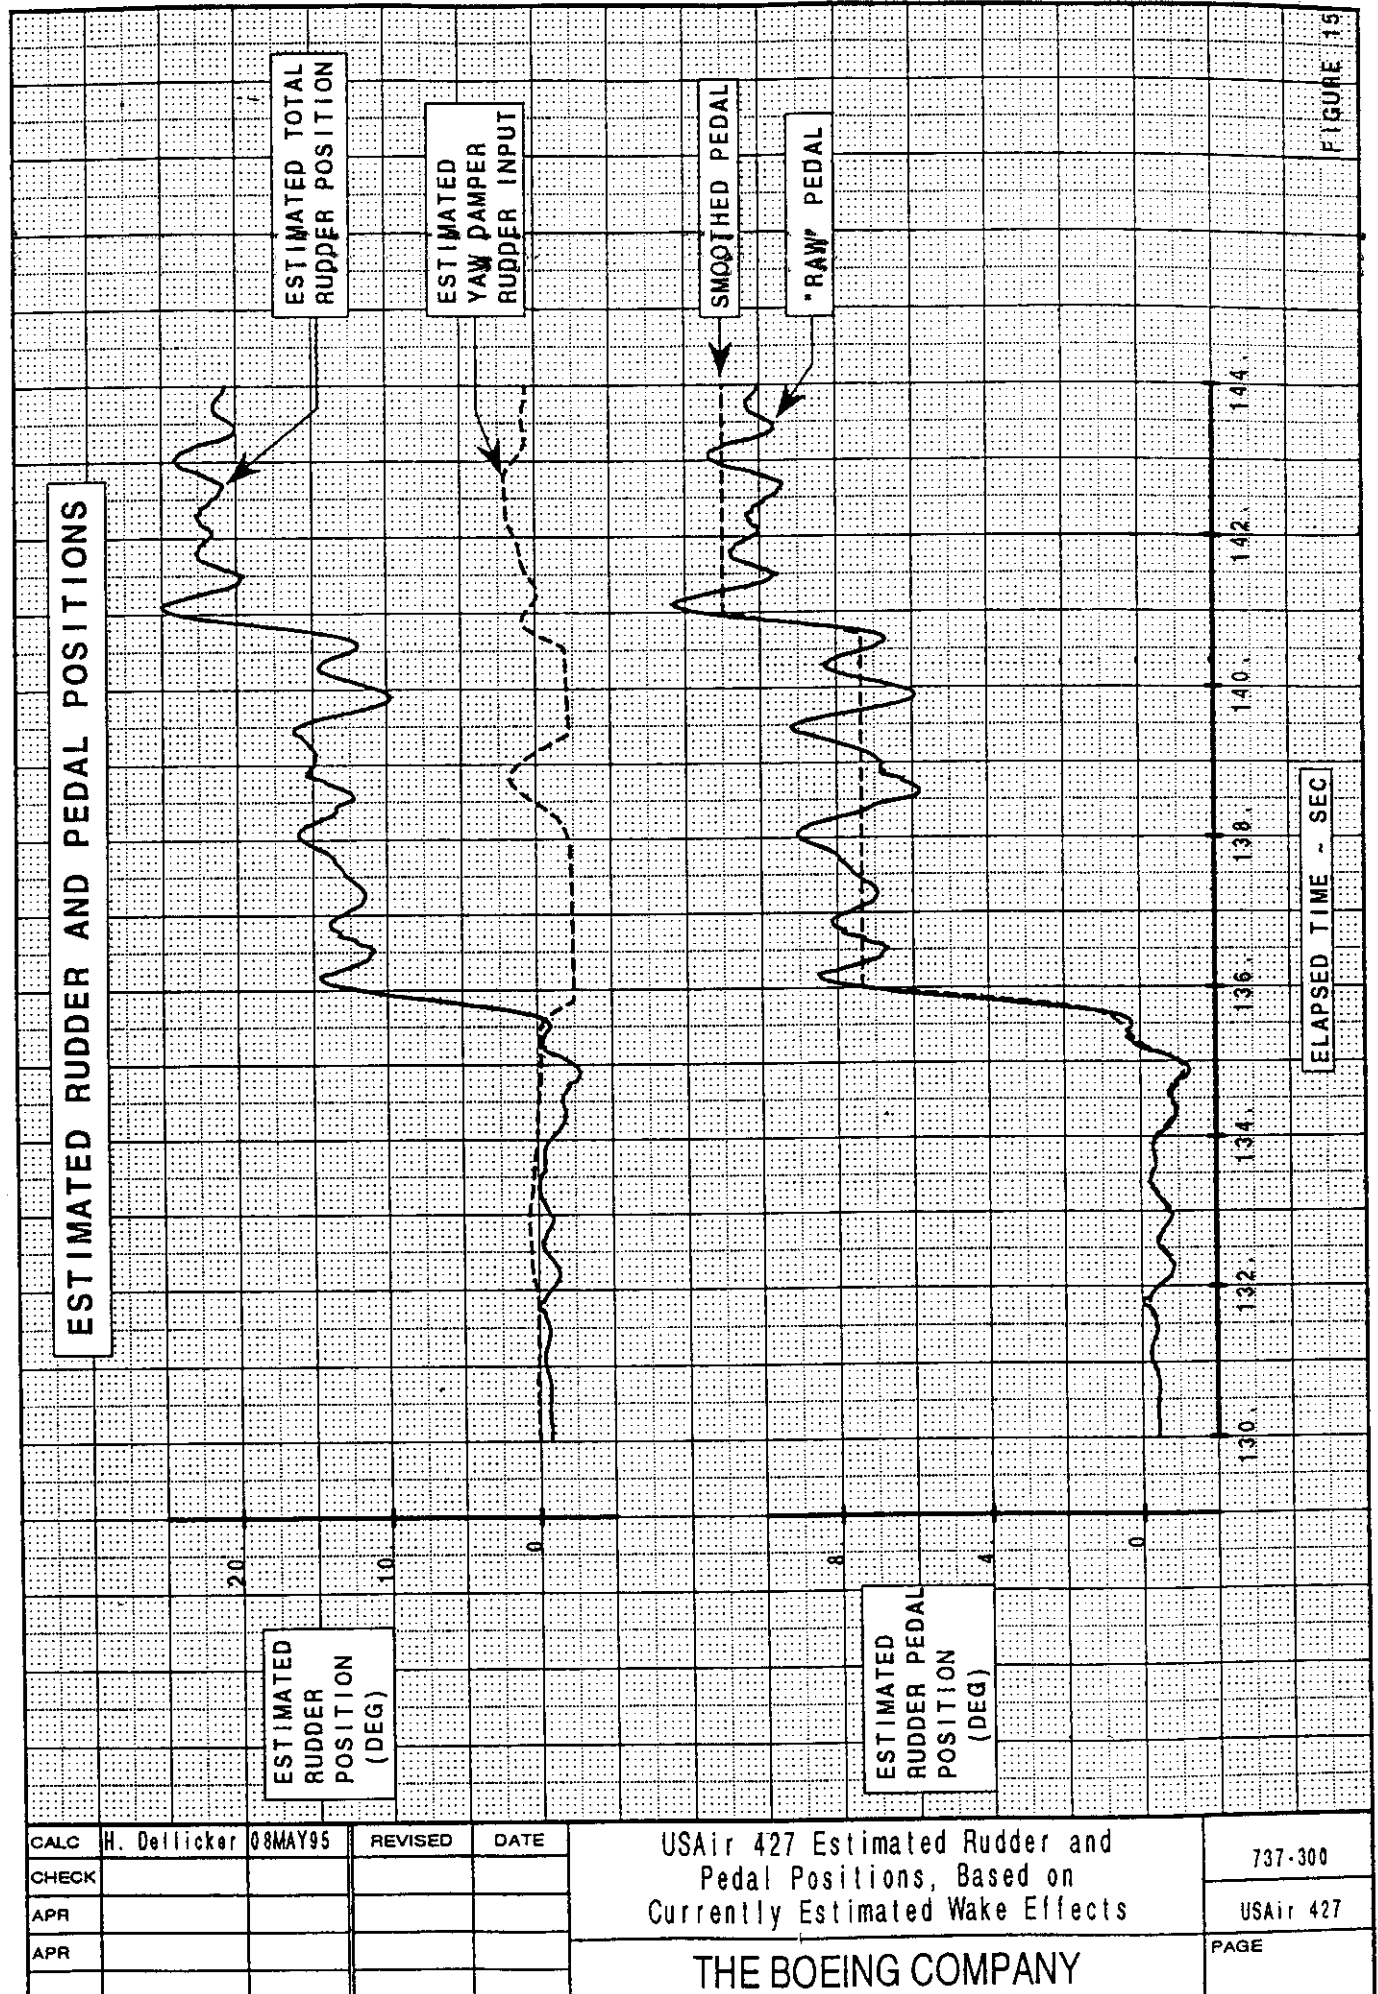
USAir 427 Estimated Rudder and Pedal Positions, Based on Currently Estimated Wake Effects

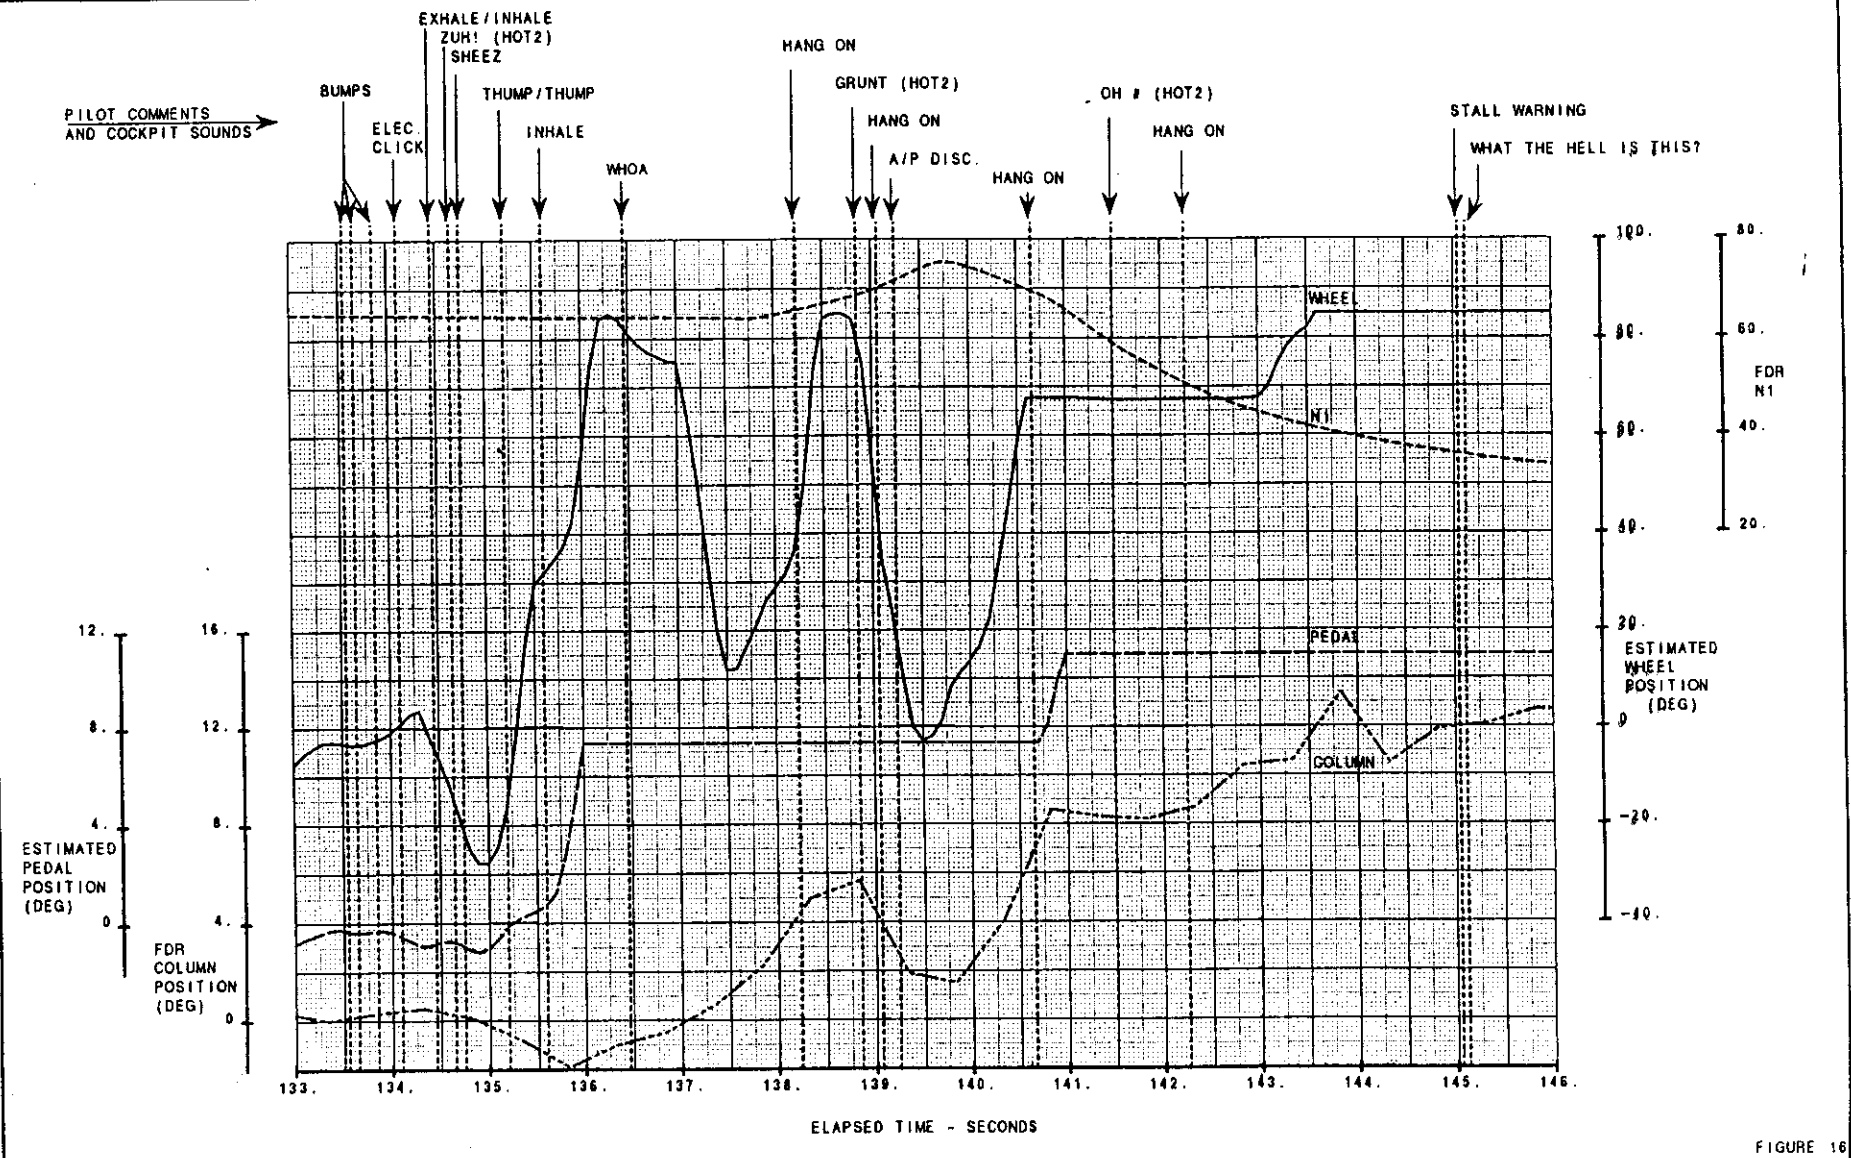
FIGURE 16

Figure 16 is a composite plot of the FDR column position and engine speed (N1), along with the estimated control wheel and rudder pedal (corrected for estimated wake effects). CVR cockpit sounds and pilot comments are annotated across the top of the plot.

CALC	H. Delichet	24MAY95	REVISED	DATE	USAir 427 FDR and Estimated Control Position Data, Based on Currently Estimated Wake Effects THE BOEING COMPANY	737-300
CHECK						USAir 427
APR						PAGE
APR

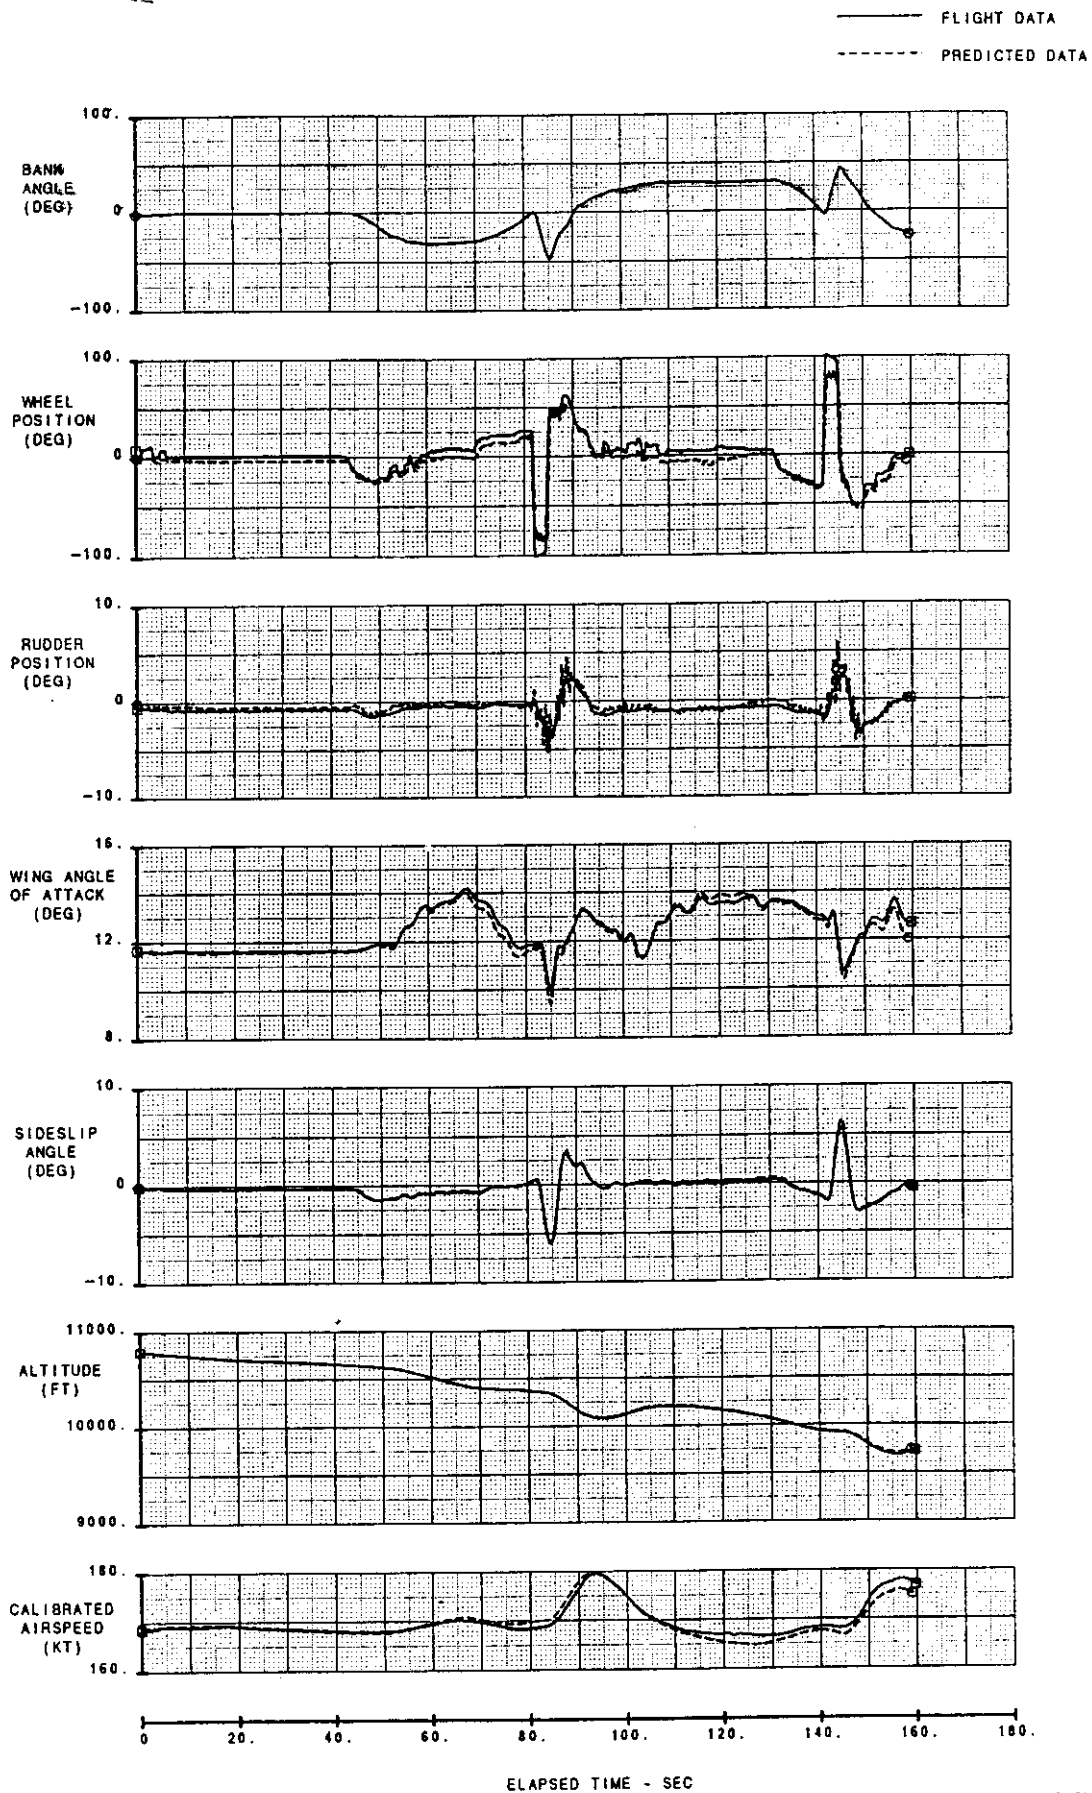
FIGURE A-1

Data for a "Roll Rate Reversal" maneuver with large wheel inputs was provided to the analyst by another member of the group, in a blind test of the procedure. The data included the equivalent seven motion parameters (pitch, roll, heading, vertical and longitudinal acceleration, airspeed and altitude) at the same sample rates as were available from the USAir 427 FDR. The data were analyzed and given back to the supplier for comparison with the flight test measured wheel and rudder position, sideslip angle, and angle of attack. The results, shown in Figure A-1, are generally quite good. (Note: The physical control wheel can exceed 100 degrees deflection but reaches its aerodynamic effectiveness limit at about 85 degrees, agreeing well with the predicted results.)

CALC	REVISED	DATE
CHECK		
APR		
APR		
Wheel and Rudder Prediction Test Case (Seq. No 4913)		
THE BOEING COMPANY		
PAGE		737-300

An unexplained apparent time lag of about 0.2 seconds in the predicted wheel deflection will require further analysis.
