## AIRCRAFT PERFORMANCE REPORT

# Express

BY BRIEN A. SEELEY, C.J. STEPHENS AND THE CAFE BOARD

EXPRESS N360EZ  
by

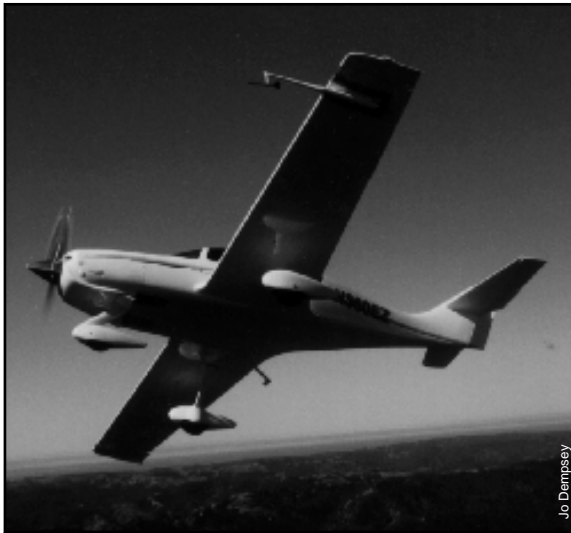
The Express has a cruciform horizontal tail with sweep-back.

The cruciform tail (mid-mounted horizontal stabilizer), wide tapering fuselage, and highly swept vertical stabilizer combine to produce low yaw stability. This was evident during dynamic testing, high angles of attack, and during excursions into high yaw situations at one g. An uncommanded right yaw with inadequate elevator control occurred after 1 g clean stalls and persisted until airspeed over 85 kts had been regained. This behavior should receive more investigation by a professional test pilot wearing a parachute.

The tail power seemed to be adequate for most regimes of flight, however, during post stall and high yaw maneuvering the horizontal/elevators seemed to have inadequate effect. This seemed to be caused by blanking of the horizontal tail and elevators by the vertical stabilizer at the highly yawed condition. More testing is definitely in order to study the flow field around the tail in this situation and to develop improved tail effectiveness.

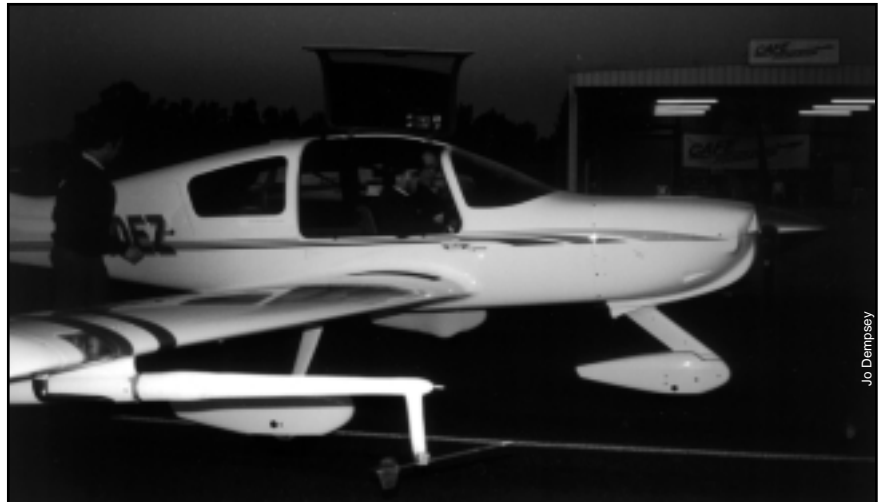
CAFE Barograph, pitot-static and boom mounted on rt. wing for first data flight at dawn on 9/20/97. Note large, gull-wing cabin door and rear baggage door.

Barograph #3 was used on a wing cuff mount and was compared to CAFE Barograph #1 mounted in the cabin and connected to the stock aircraft pitot static system using "T" fittings to allow the panel airspeed and altimeter to indicate their normal readings. These 3 airspeed system's data appear in the calibration table in this report. Compensation was made for the drag of the wing cuffs in determining the cruise speeds published here.

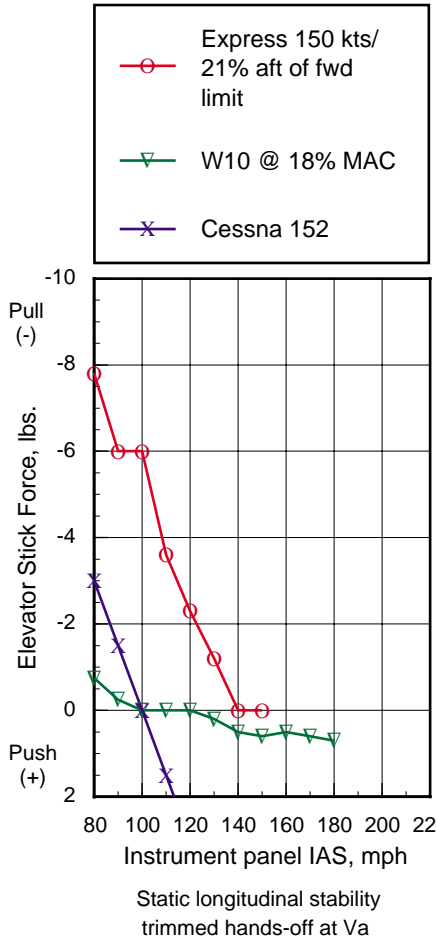
At 7,500 ft altitude the airplane was trimmed to "hands off" at 150 kts. Without retrimming, measurements were taken of the stick force required to hold level flight at each 10 kt increment of all attainable airspeeds. The

graph shows the results of these samples.

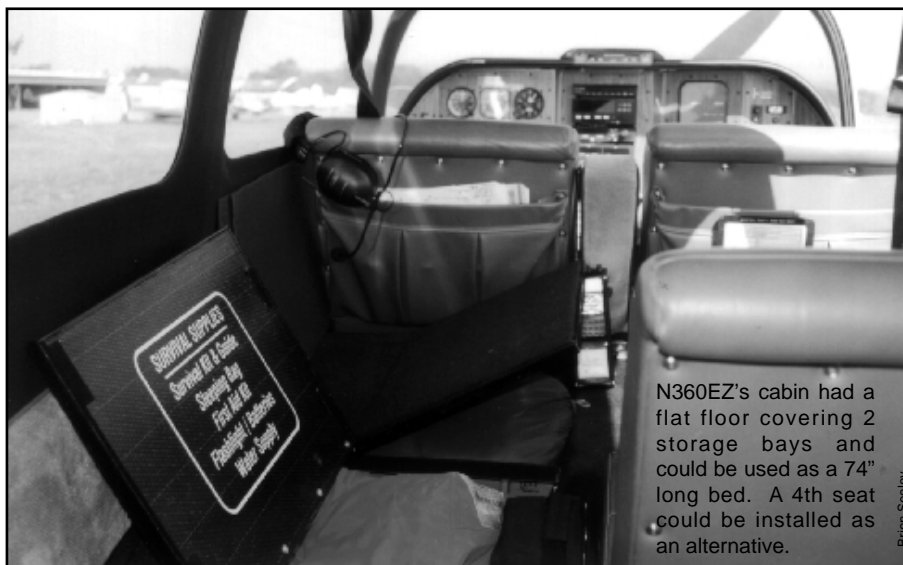
N360EZ's cabin had a flat floor covering 2 storage bays and could be used as a 74" long bed. A 4th seat could be installed as an alternative.

Jerry designed the seats for quick removal and created a nifty cabin layout allowing 3 seats and a 74" long litter/baggage floor area underneath which are 2 large storage bays. These bays were covered by carpeted graphite floor panels (see photo).

One very nice and unusual feature, of the aircraft design, was the tremendous amount of leg room in the back seats. It measured 74 inches from the back of the front seats to the baggage compartment bulkhead. The owner had even built a litter type of installation that could be used with a sleeping bag giving a full 6 ft. 2 in. place for

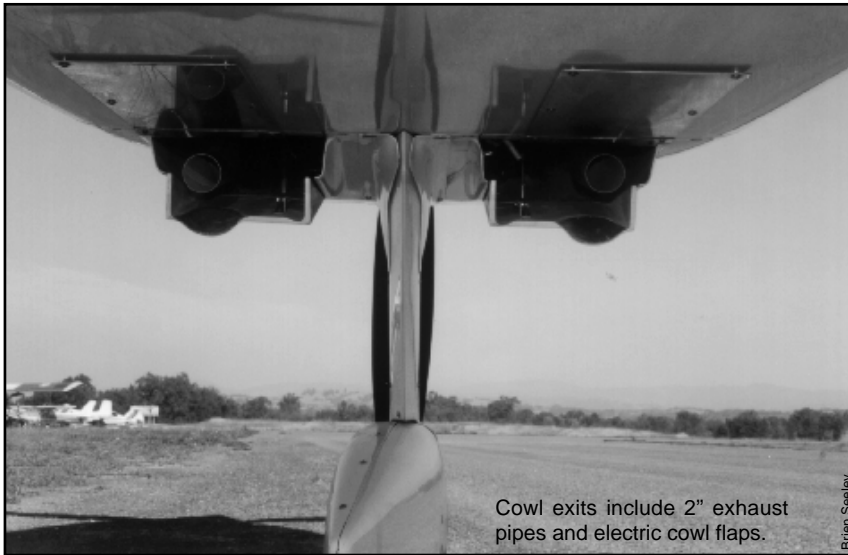
Cowl exits include 2" exhaust pipes and electric cowl flaps.

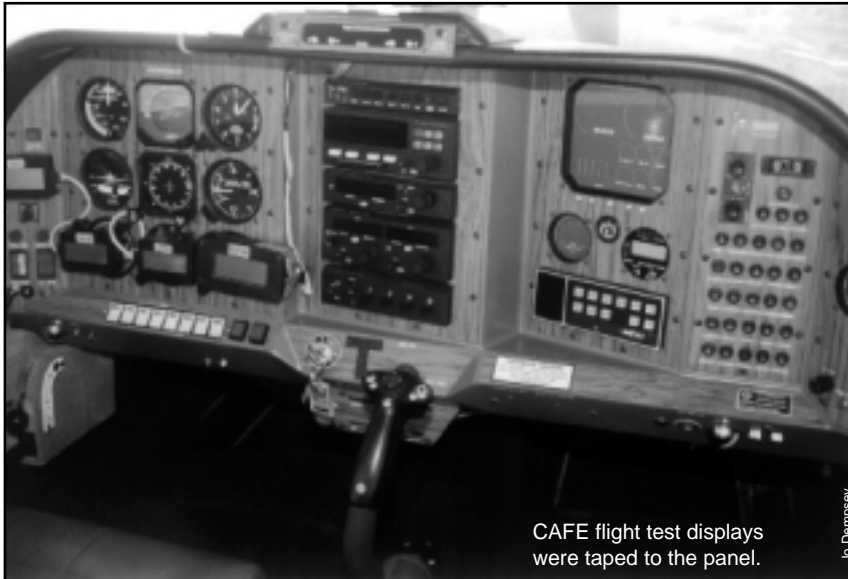
CAFE flight test displays were taped to the panel.
