NATIONAL TRANSPORTATION SAFETY BOARD
Vehicle Recorder Division
Washington, D.C. 20594

17 – Electronic Devices Factual Report

Location: Tupelo, Mississippi
Date: 08/17/2011
Aircraft: Cessna 310Q
Registration: N444YM
Operator: Private
NTSB Number: ERA11FA458

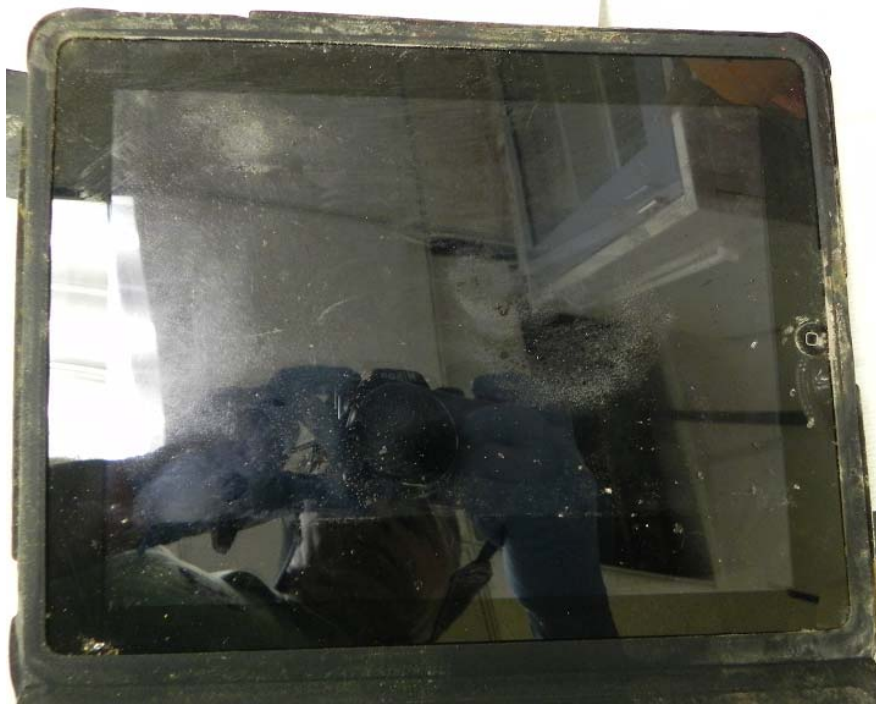
Figure 1. Apple iPad.

Upon arrival at the Vehicle Recorder Laboratory, an exterior examination revealed that the unit had sustained major damage from impact forces as shown in figure 1. An internal inspection was performed and fluid was found to have penetrated inside the unit and the Lithium-ion internal batteries were bent. Due to damage to the unit, repair was not practicable. The main logic boards were removed from the accident unit and placed into an NTSB surrogate Apple iPad. Power was applied and the unit started in an unusable state. Software tools were used to download and examine the files on the unit.

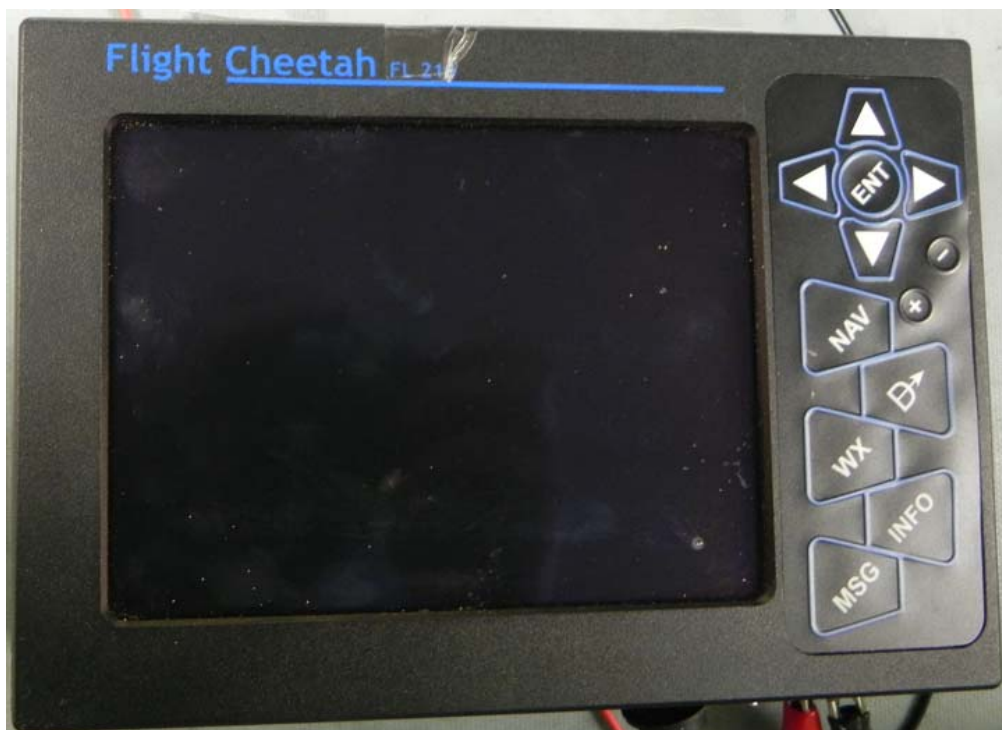
Figure 2. True Flight Flight Cheetah FL210.

Upon arrival at the Vehicle Recorder Laboratory, an exterior examination revealed that the unit had sustained minimal damage as shown in figure 2. An internal inspection was performed confirming no internal damage. Power was applied to the accident unit and it started normally.
