# NATIONAL TRANSPORTATION SAFETY BOARD

## Engine Data Monitor (EDM)

### Specialist's Factual Report By Sean Payne

Location: Bedminster, New Jersey  
Date: September 8, 2015  
Aircraft: Lake LA-4-250  
Registration: N1401P  
Operator: Private  
NTSB Number: ERA15FA348

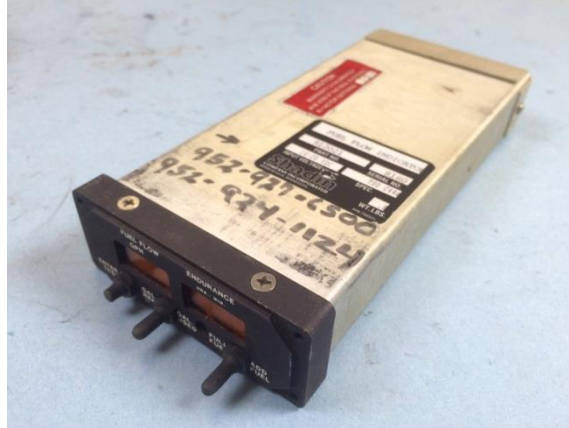
The recorder was in good condition and the unit was able to be powered normally using the appropriate power harness and voltage for the device. Figure 1 shows the condition of the device upon arrival to laboratory.

Figure 1. The Shadin fuel flow unit.

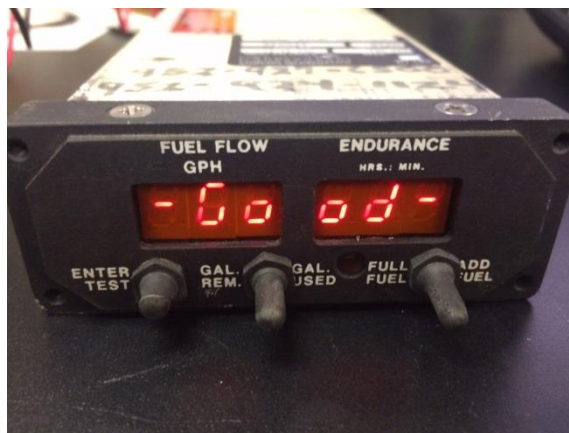
Upon power up, the fuel flow indicator performed a self-test and reported a status of “good” (figure 2). The unit was then prompted to show the logged number of gallons used after making an input to the interface. Figure 3 shows the fuel flow indicator reported a value of 44.7 gallons used. Figure 4 shows the fuel flow indicator reporting a value of 21.7 gallons remaining when commanded by the appropriate input. The device’s fuel value may not represent the total fuel amount relevant to the accident flight as it relies on proper user input to reflect accurate fuel load values upon engine start. No other data was available from the Shadin device.

Figure 2. The Shadin unit's self test upon power up.

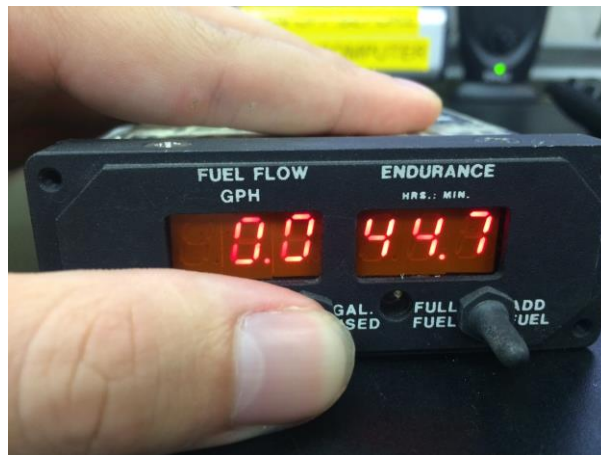
Figure 3. The indicated amount of gallons used.

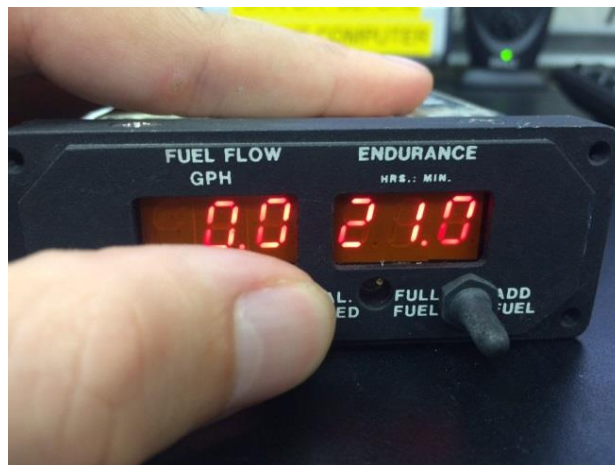
Figure 4. The indicated amount of gallons remaining.
