### Estimated Impact Attitude Profile, Slight Left Wing Low

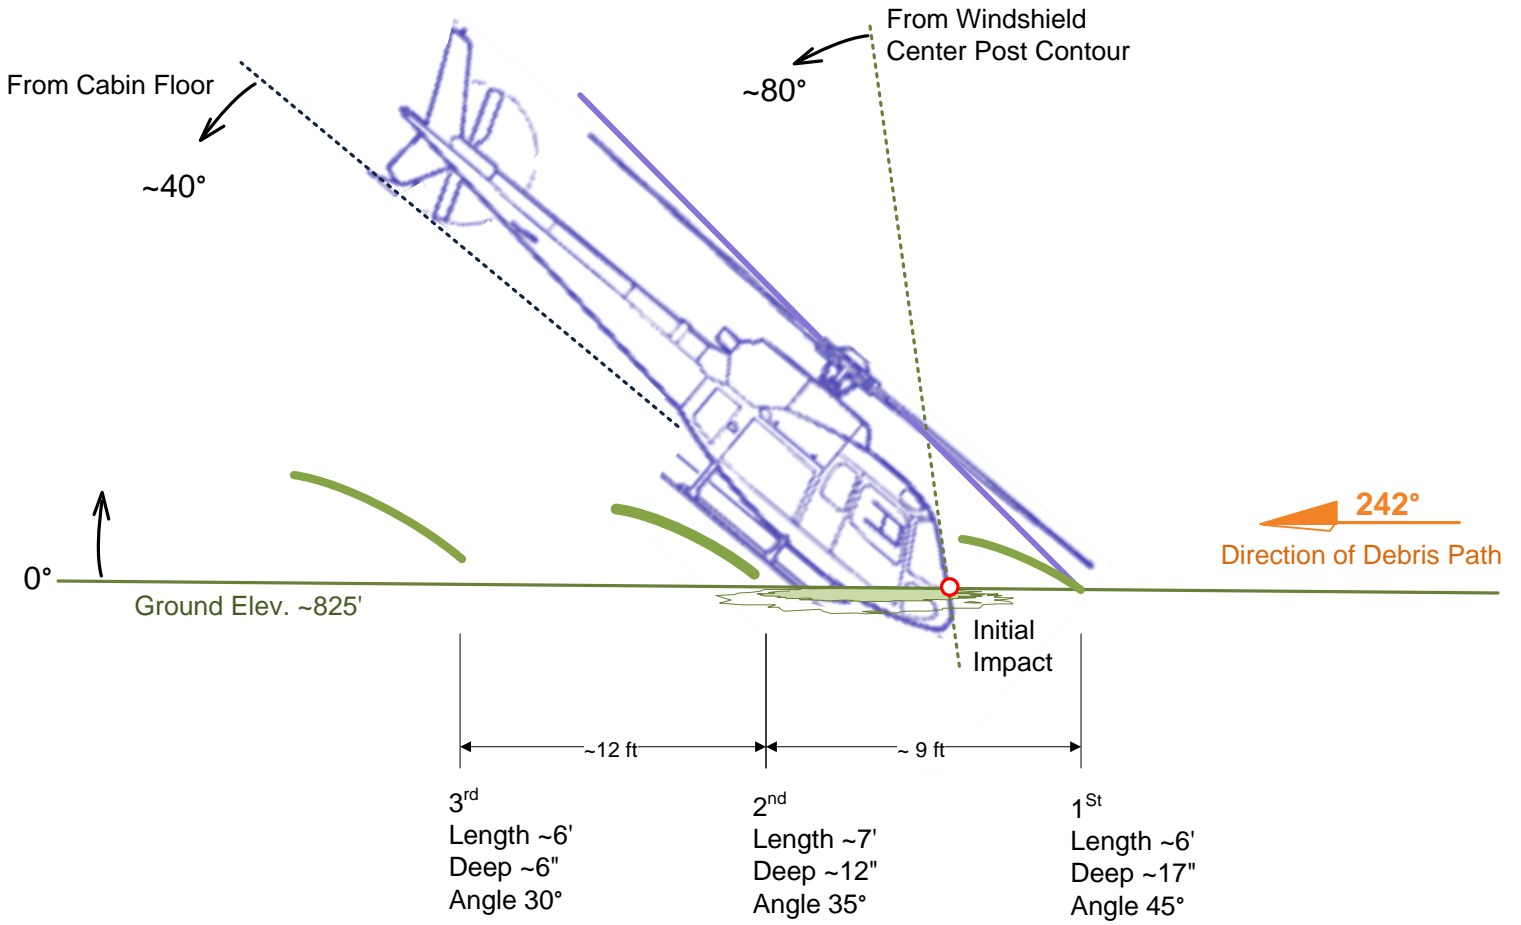
3 Independent Blade Strikes Approximately 15 ft to the Right of Wreckage Path (Left Side of aircraft)
