**NATIONAL TRANSPORTATION SAFETY BOARD**  
Vehicle Recorder Division  
Washington, D.C. 20594

## **17 - GPS Factual Report**

Location: Cle Elum, Washington  
Date: October 13, 2011  
Aircraft: Flugzeugbau DG-1000 S  
Registration: N7760A  
Operator: Northwest Eagle Soaring LLC  
NTSB Number: WPR12FA010

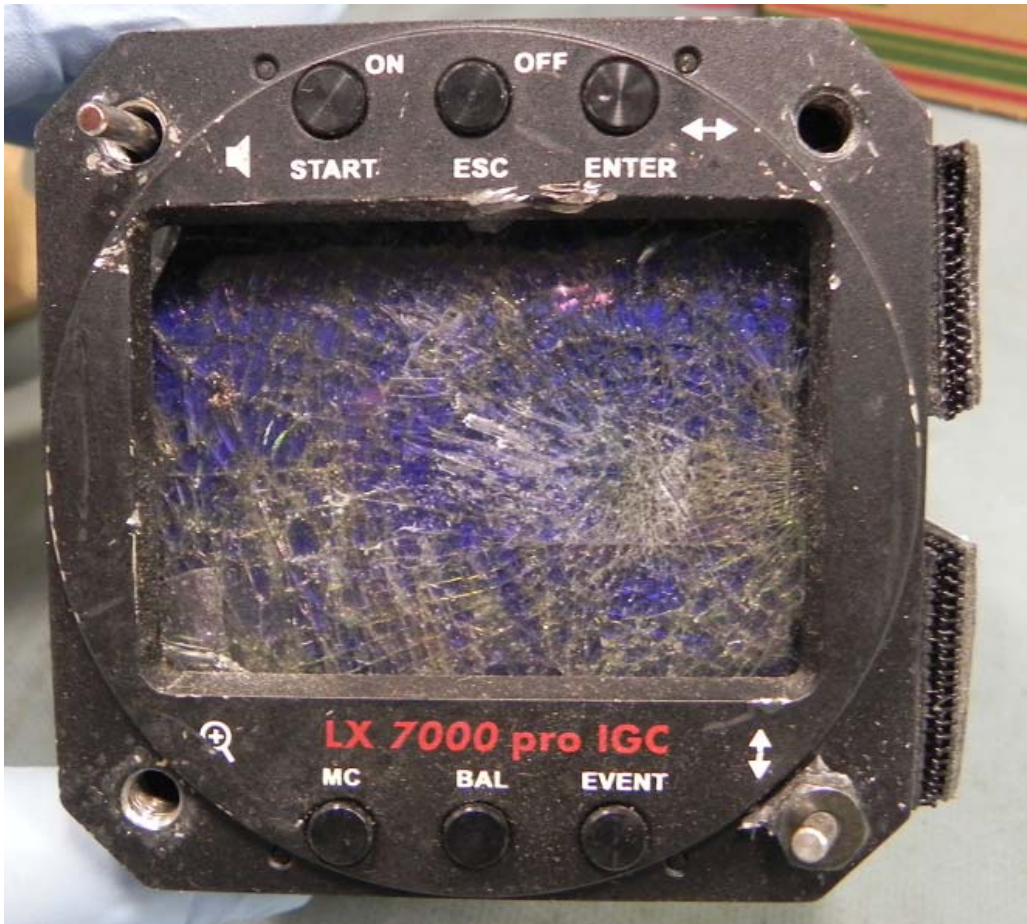
Figure 1. Front of unit.

Upon arrival at the Vehicle Recorder Laboratory, an exterior examination revealed that the unit had sustained major damage from impact forces (see figures 1 through 3). An internal inspection was performed. The internal backup battery was found to be dislodged from its holder, as shown in figure 3. It was concluded that accident damage had rendered any data once stored in the accident unit unrecoverable.

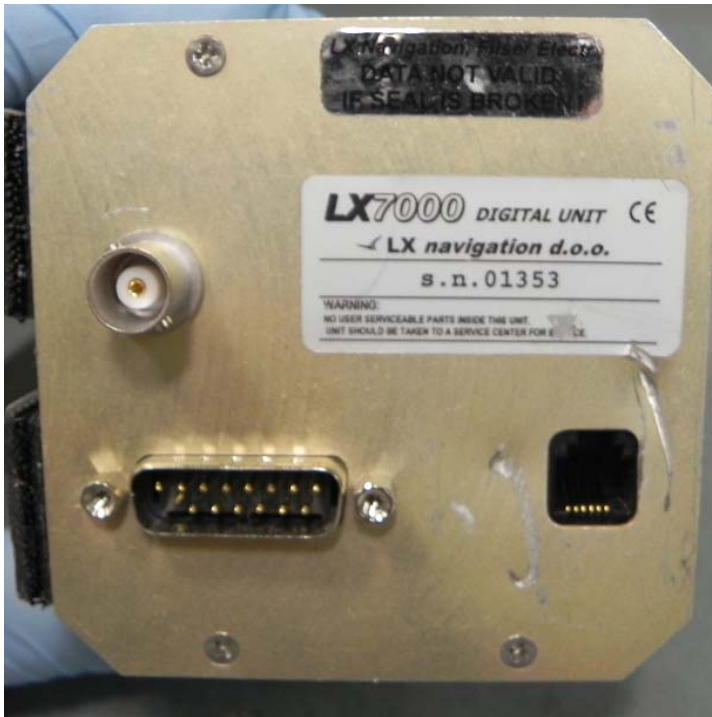
Figure 2. Back of unit.

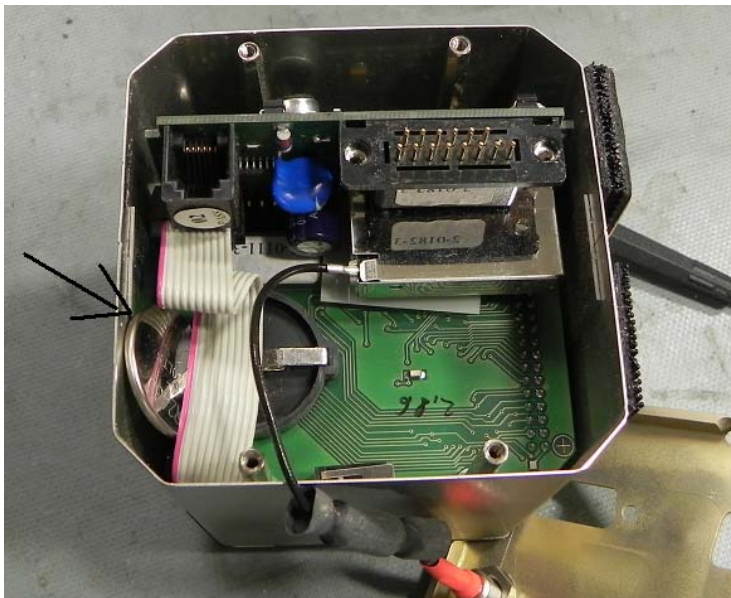
Figure 3. Interior of unit, dislodged battery.
