**NATIONAL TRANSPORTATION SAFETY BOARD**

## **17 - GPS Factual Report**

Location: Fredericksburg, Virginia  
Date: September 29, 2012  
Aircraft: Cessna 150M  
Registration: N66246  
Operator: Private  
NTSB Number: ERA12FA583

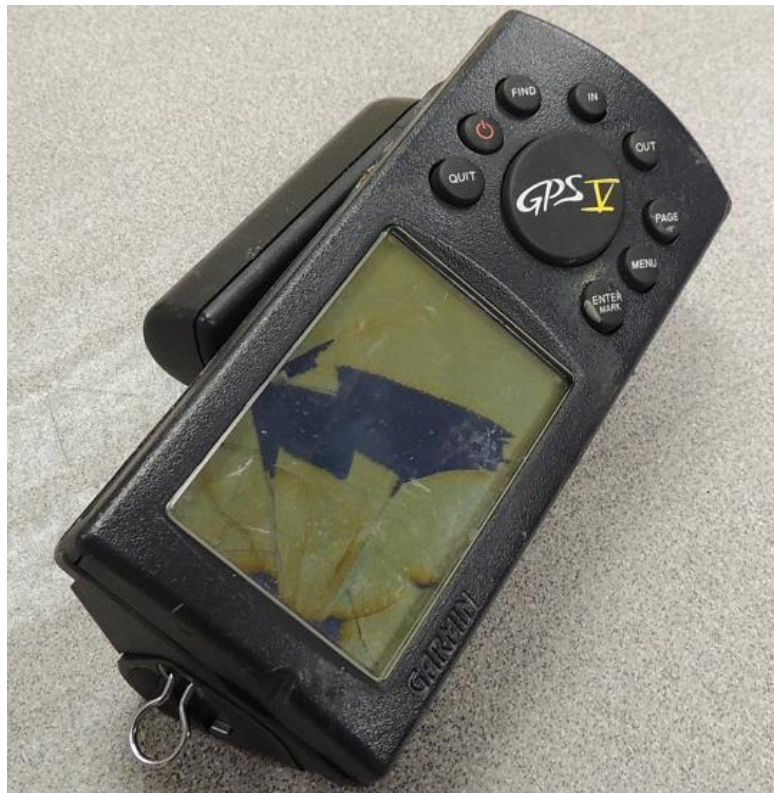
Figure 1. Photo of damaged device.

Upon arrival at the Vehicle Recorder Laboratory, an exterior examination revealed that the unit had sustained impact damage (see figure 1). An internal inspection was performed and no damage was discovered. Power was applied to the accident unit and recorded waypoint, route, and tracklog data was successfully downloaded from the unit via the proprietary interface connected to a PC serial port.
