# NATIONAL TRANSPORTATION SAFETY BOARD

## Global Positioning System Device

Specialist's Factual Report  
By Ben Xu

Location: Green Cove Springs, FL  
Date: December 26, 2011 / 0554 EST  
Aircraft: Bell 206B / N5016M  
Operator: SK Logistics, d.b.a. SK Jets  
NTSB Number: ERA12MA122

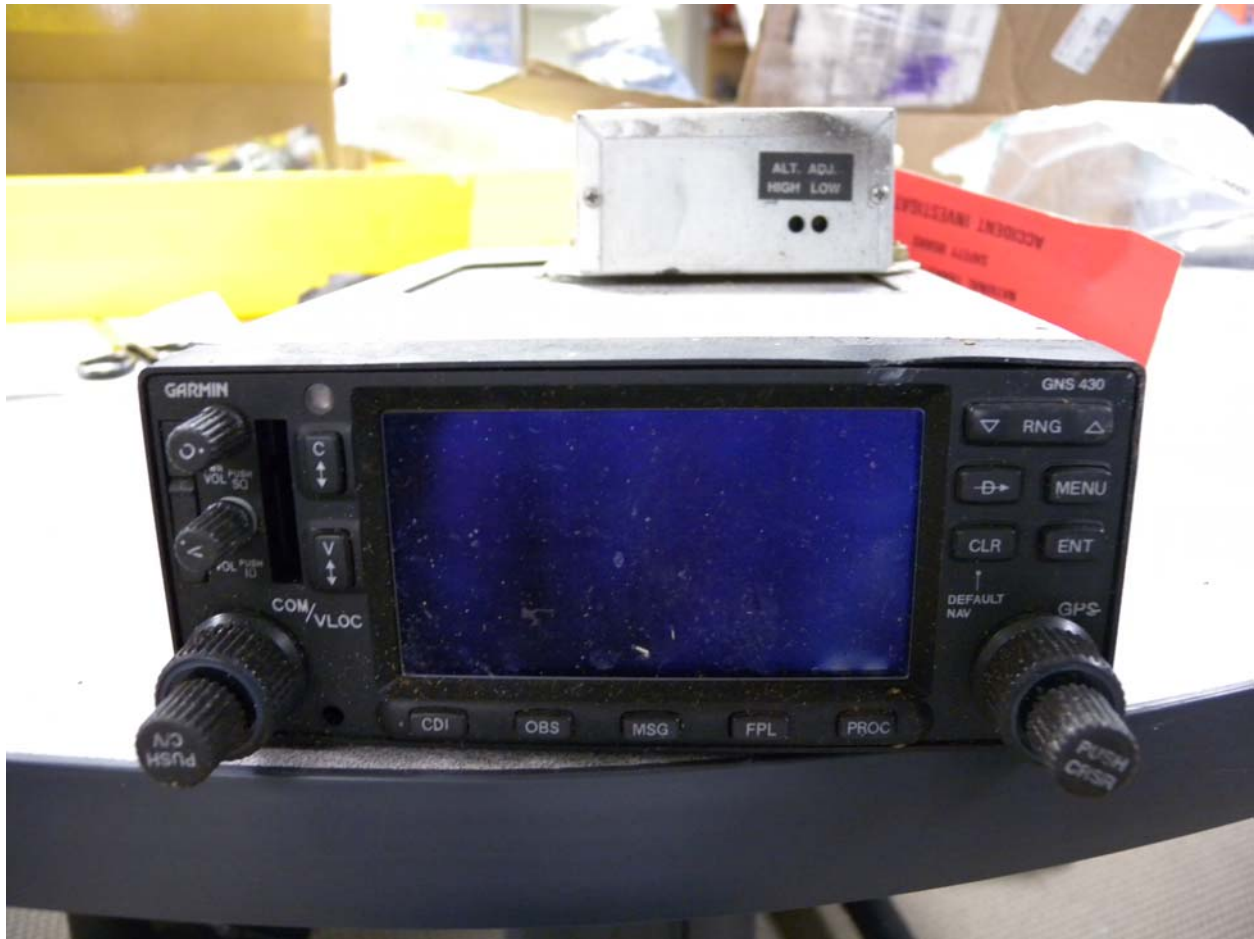
The Global Positioning System (GPS) device sustained minor damage from impact forces during the accident (Figure 1). Initial examination revealed that the unit's primary liquid crystal display (LCD) was not operational. The LCD was removed, cleaned, and placed in a drying oven. Power was applied using laboratory equipment and the device start-up was consistent with normal operation.

Figure 1: Garmin GNS 430 (S/N 97115322)

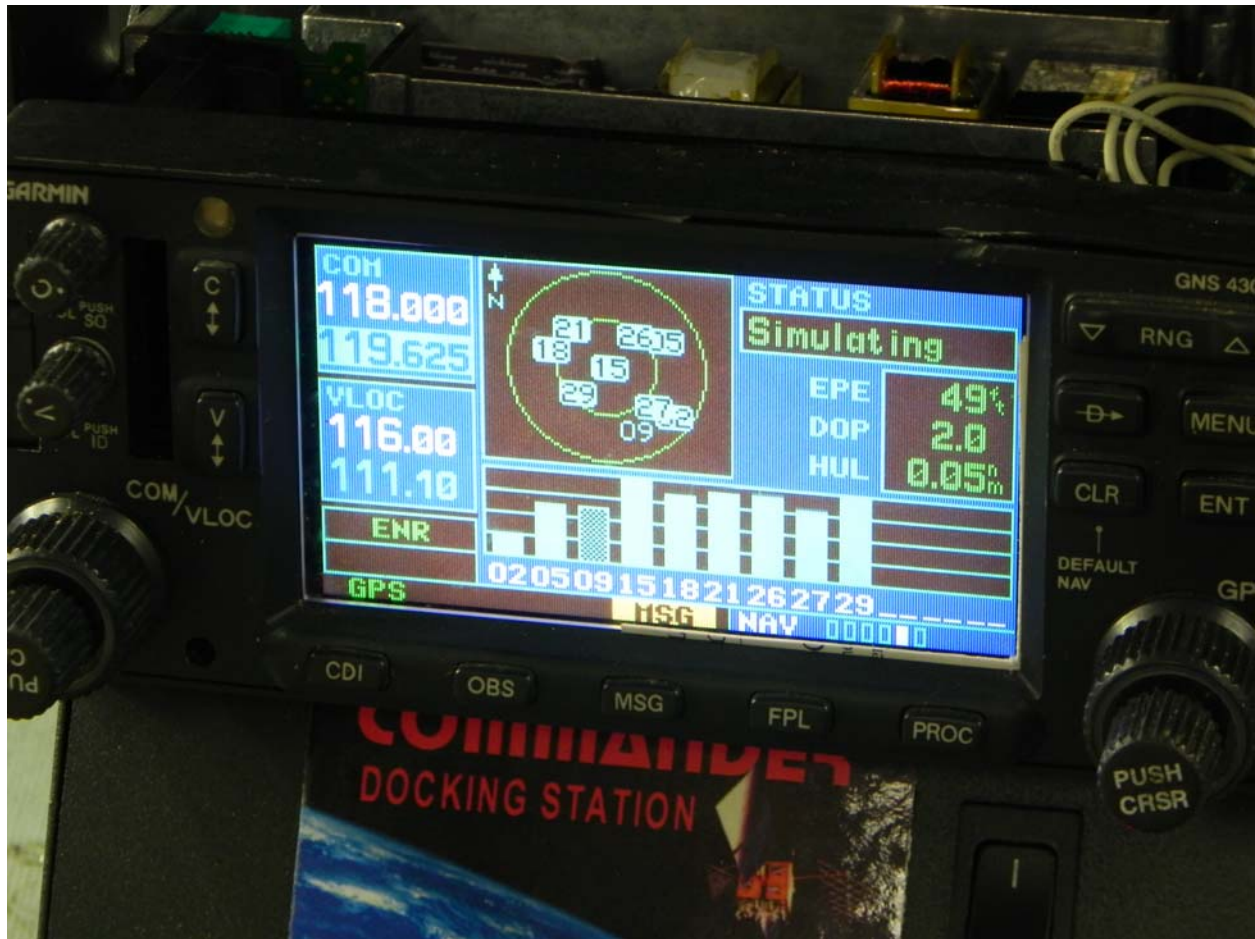
The device was manually inspected to determine the last-used frequencies (Figure 2). Table 1 summarizes these settings.

Figure 2: Garmin GNS 430 with power applied showing last COM and VLOC settings

Parameter	Frequency
COM (Primary)	118.000 MHz
COM (Secondary)	119.625 MHz
VLOC (Primary)	116.00 MHz
VLOC (Secondary)	111.10 MHz
