DCA16FR001
Norfolk Southern Corporation
February, 20, 2016
New Orleans, LA

Factual Report

Accident No.: DCA-16-FR-001
Location: New Orleans, Louisiana
Date: February 20, 2016
Time: 6:10 a.m. central standard time¹
Railroad: Norfolk Southern Corporation
Property Damage: None
Injuries: 0
Fatalities: 1
Type of Accident: Train strike resulting in employee fatality

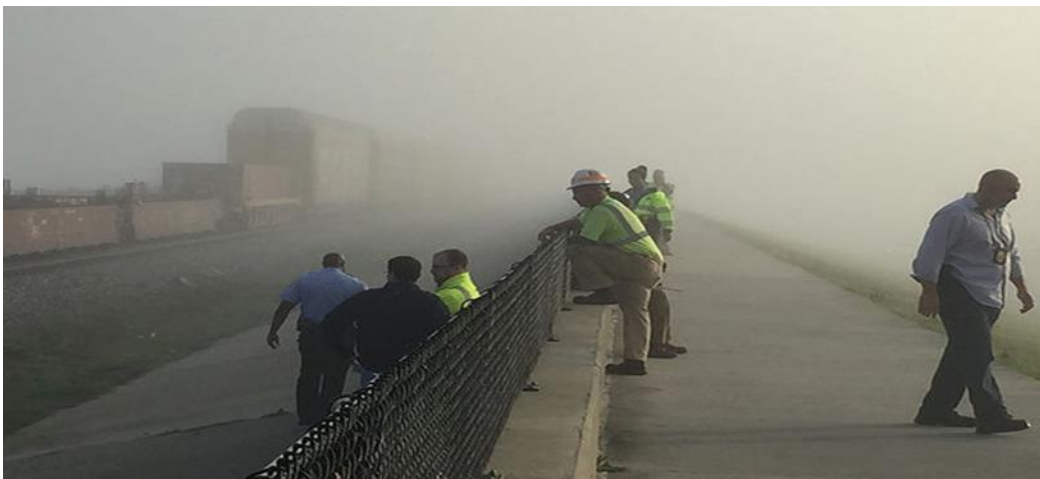
The weather at the time of the accident was foggy and mist with skies obscured. The station model for New Orleans indicated wind calm, and a temperature of 62° Fahrenheit (F). Visibility was reported at ¼ mile in dense fog. The National Weather Service (NWS) New Orleans/Baton Rouge Weather Forecast Office (WSO) issued a Dense Fog Advisory for the area after 4:00 a.m. and was valid until 9:00 a.m.

Photo of railroad employees at accident scene, heavy fog is present.
