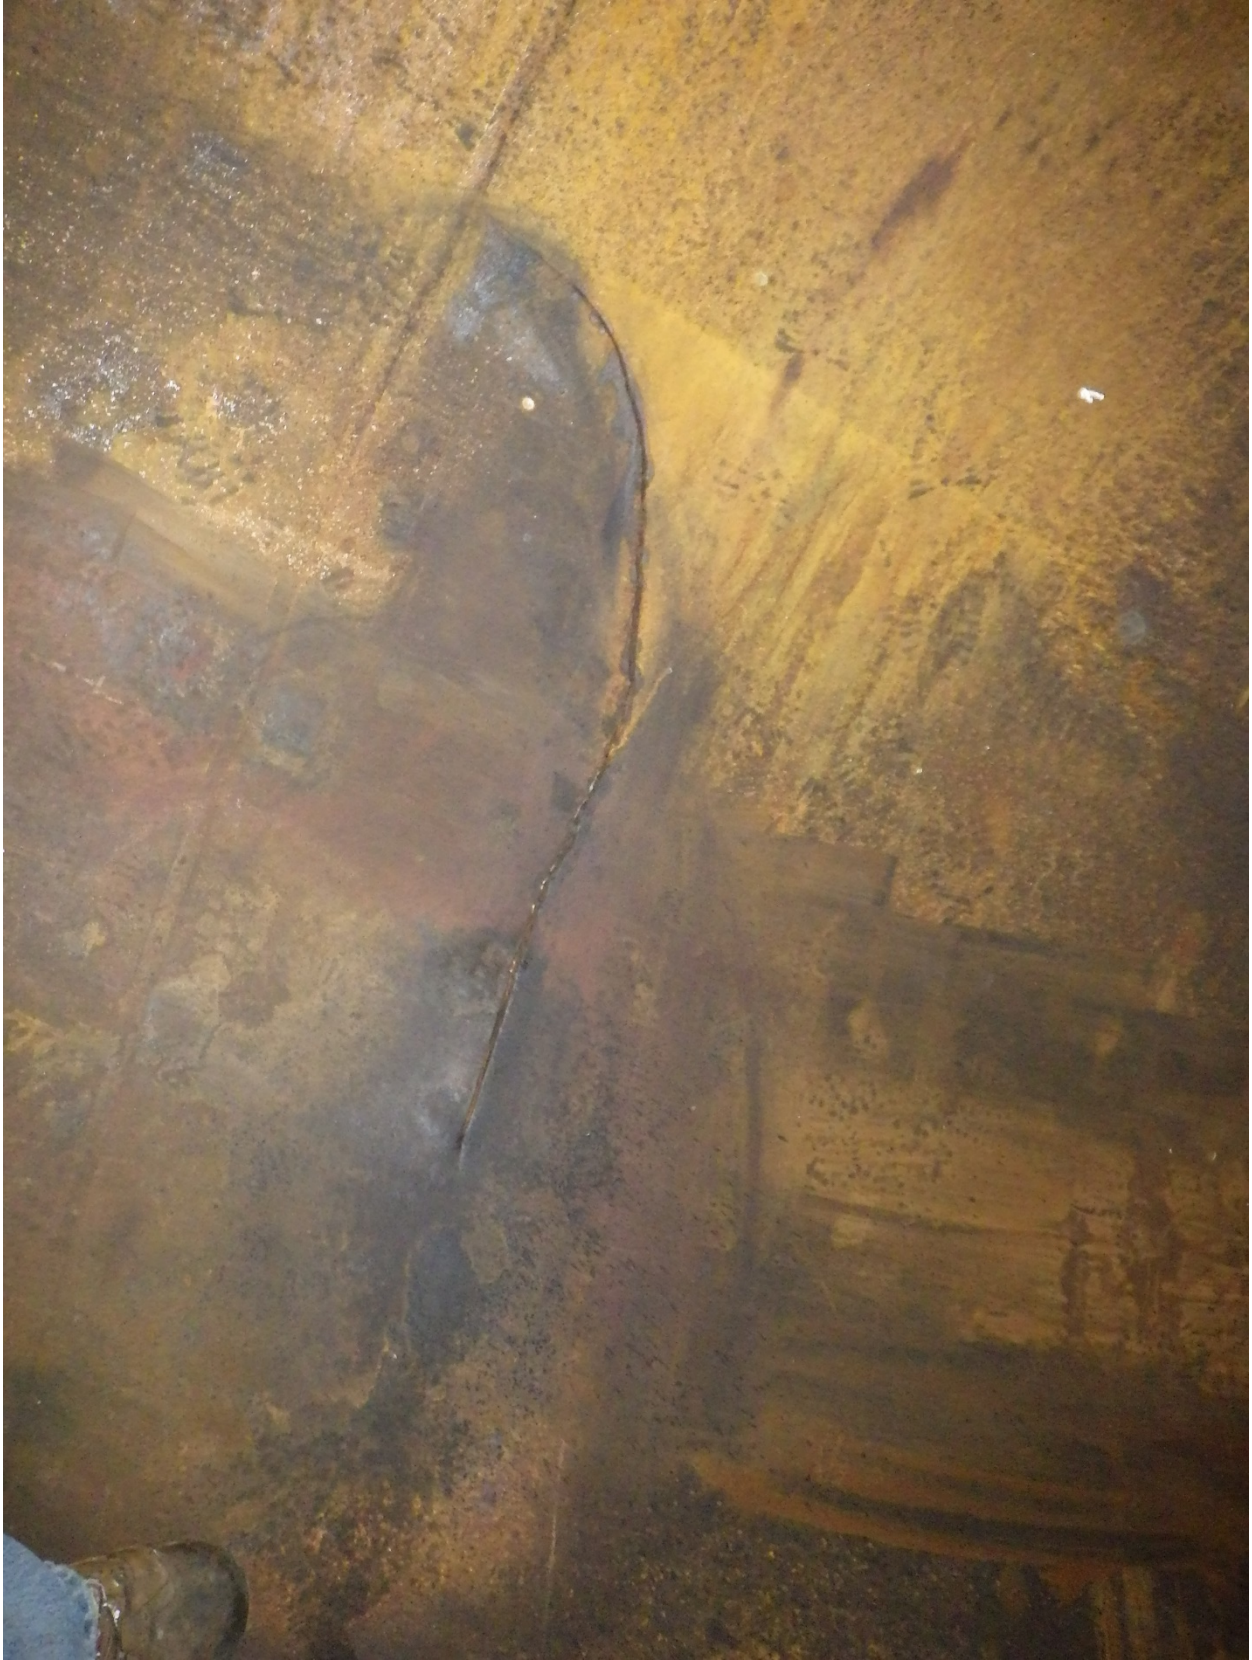
Interior tank shell view showing length of the crack in Ring 4, August 31, 2016
