Lancair Legacy Canopy Safety Issue

Valin Thorn

Legacy Project N114TF

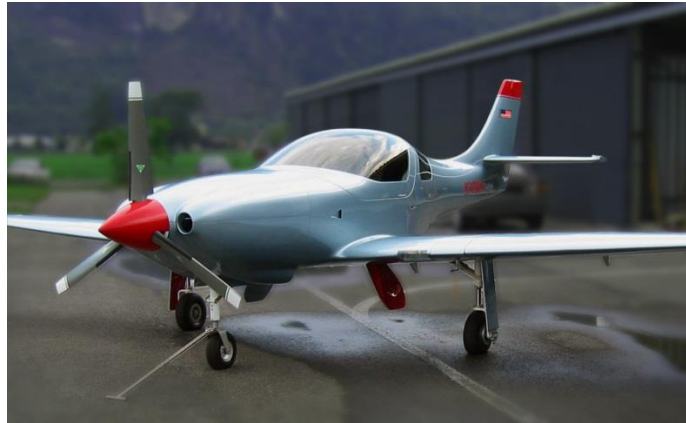
Mascheck's Legacy N345MW

After takeoff the canopy popped open, Wolfgang could not see forward, and the aircraft was very difficult to control. It's unknown if he tried to close the canopy. He reduced power and tried to land directly ahead in fields beyond the runway.

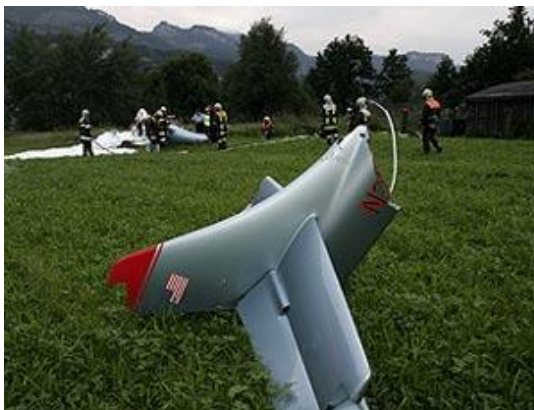
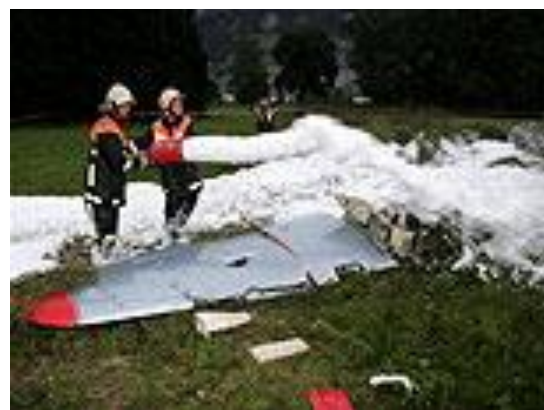
The plane lost the wings on the very hard touch down. The fuselage broke behind the seat and ejected Wolfgang out of the plane. It was a muddy soft grass field and the engine was buried in the mud.

N345MW Wreckage

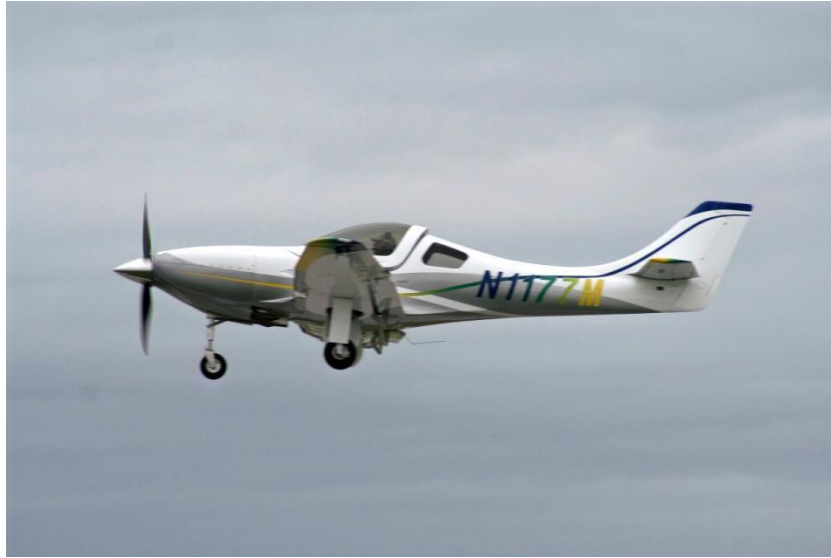
According to witnesses, the pilot was observed having difficulty closing the canopy on the airplane prior to takeoff. During the takeoff climb, a witness said he saw the cockpit canopy moving and believed the pilot was pushing it up and down about 6 to 12 inches. Another witness stated that shortly after takeoff, the engine lost power and the airplane continued straight and level. Another witness stated that she saw a plastic bag float down from the sky shortly after the airplane passed over her location. The bag contained several of the airplane's documents inside of it. The airplane then nosed down about 40 degrees and the left wing dropped as the airplane stalled and collided with the ground. A post-crash fire ensued which consumed part of the engine and the majority of the airframe, including the canopy latching system. Examination of the available wreckage did not reveal any evidence of pre-impact failures or malfunctions. The pilot Gerard Schkolnik, (Aeronautical Engineer, Private, ASEL) age 44, was fatally injured.

Photo of N1177M on takeoff before crash, note open canopy

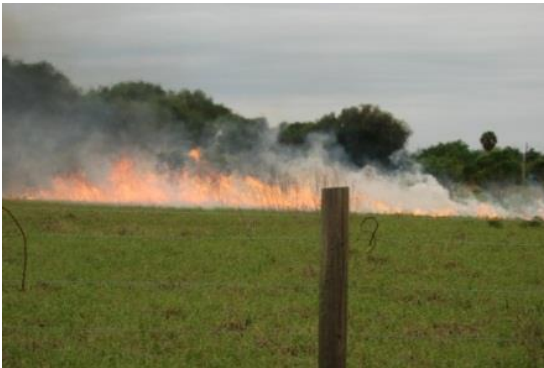
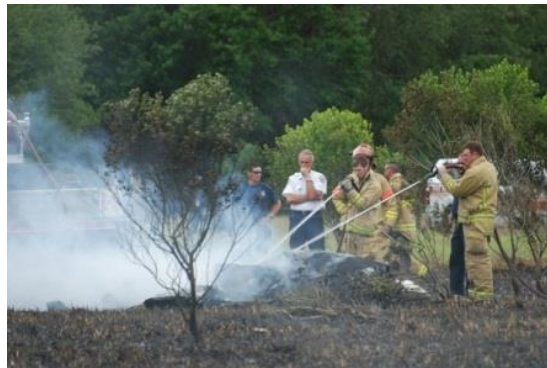
N1177M crash site, wreckage (Photos: The Ledger.com)

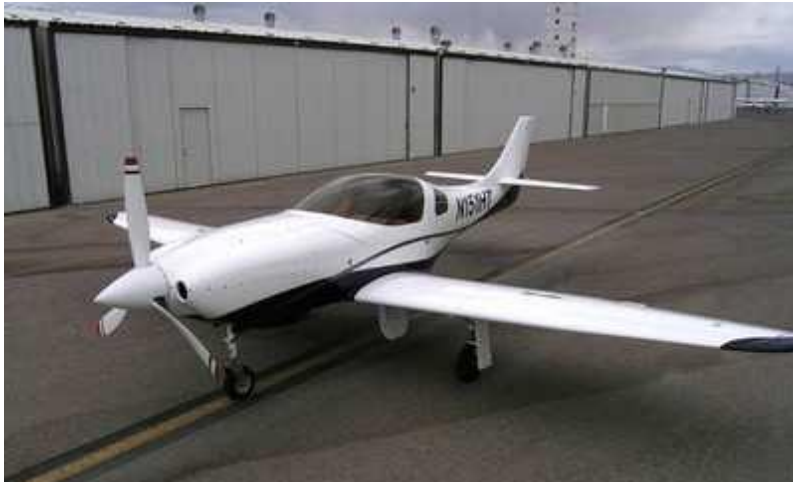
During departure, witnesses in the area reported that the airplane appeared unusually low and then entered a left turn. As the airplane entered the turn, items from the cockpit fell from the airplane. The airplane continued in the left turn until it impacted the ground. Examination of the wreckage revealed no evidence of pre-impact mechanical malfunction. The airplane, by design, does not have a cockpit indication for the security of the canopy. Structural documentation of the canopy latching mechanism did not reveal any damage to the latching mechanism, which is indicative of it not being latched when the airplane impacted the ground. Based on post-mortem toxicology results, the pilot had likely recently used two different prescription painkillers that commonly result in impairment, and that may increase risk of seizure, particularly when used together. Based on his height and weight, poorly controlled blood pressure in spite of the use of at least two different medications to lower it, and the presence on autopsy of right-sided heart enlargement, he likely had obstructive sleep apnea, a condition

N151HT Photo

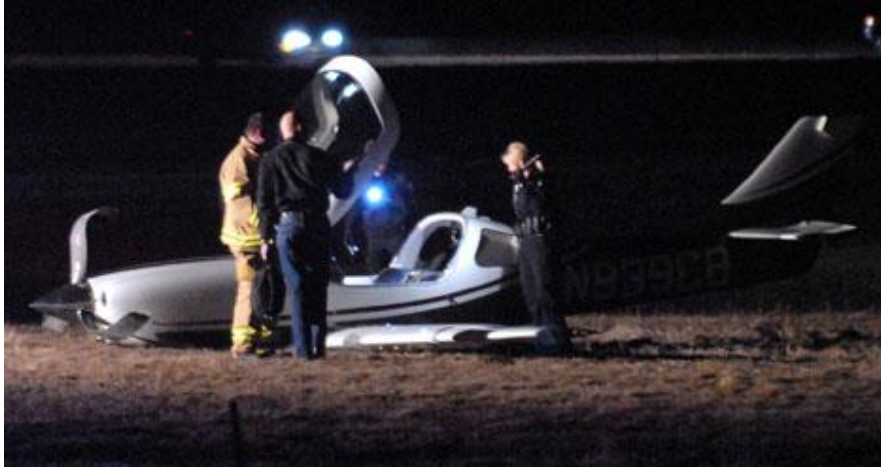
David said on final approach, the canopy opened so far that the runway could not be seen straight ahead. When looking to the side for reference, the wind blast was so high that it blew his eye glasses off his face. On landing, his Legacy's landing gear sheared off, skidded through fence posts, with significant damage.

N939CB After Open Canopy Crash Landing

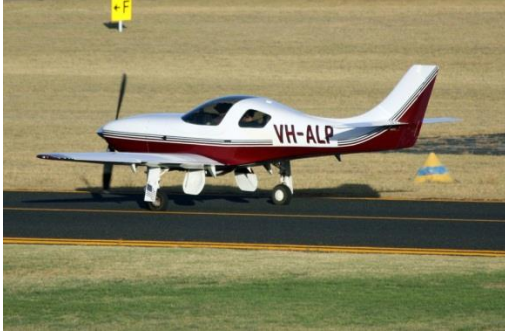
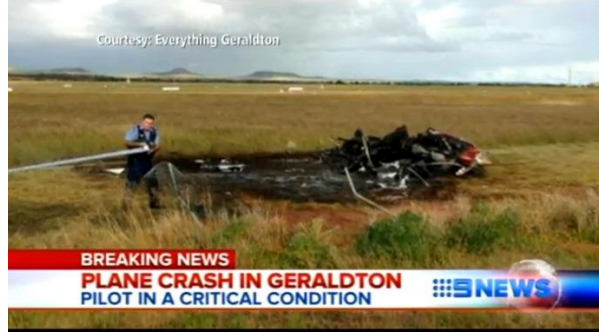
The pilot appeared to be maneuvering for a landing on runway 08 but the aircraft wheels hit a road curb short of the airport perimeter. The aircraft then collided with the perimeter fence and became entangled as it overturned. Shortly after, an intense fire engulfed the aircraft.

VH-ALP Photo and Crash Site

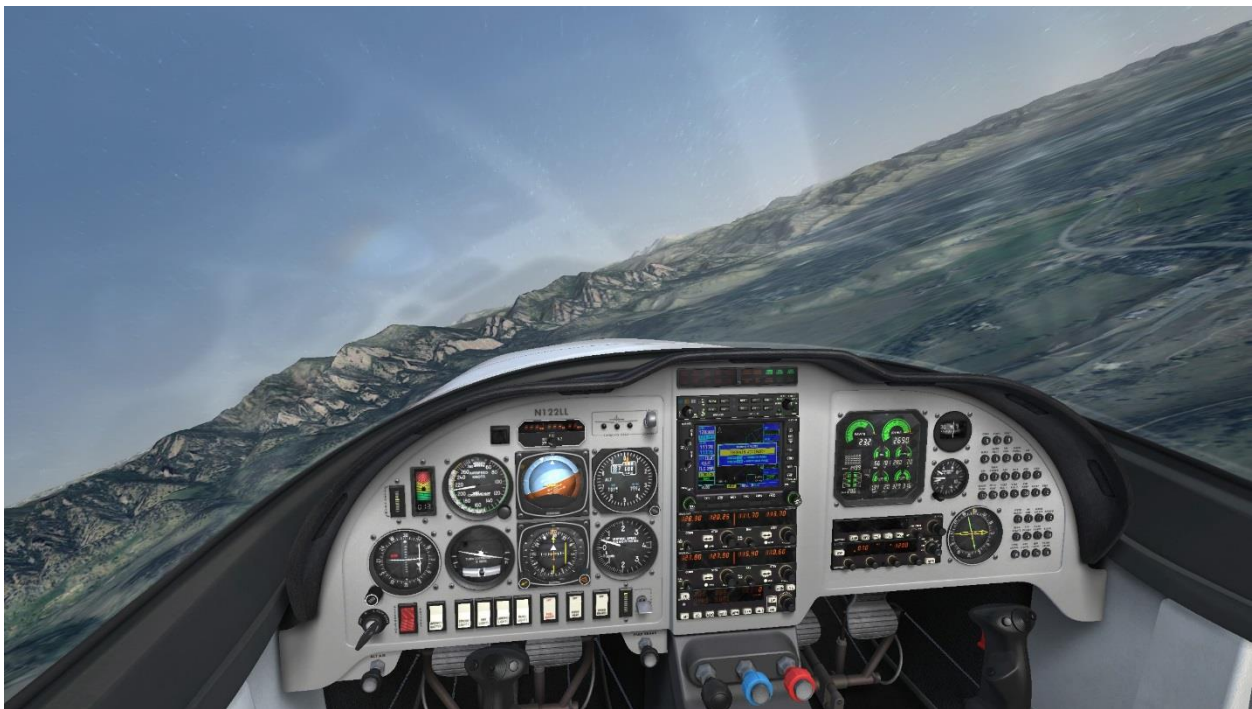
The illustration below shows an example sight picture of the visual attitude reference for the Legacy.

Legacy cockpit sight picture, visual pitch attitude reference

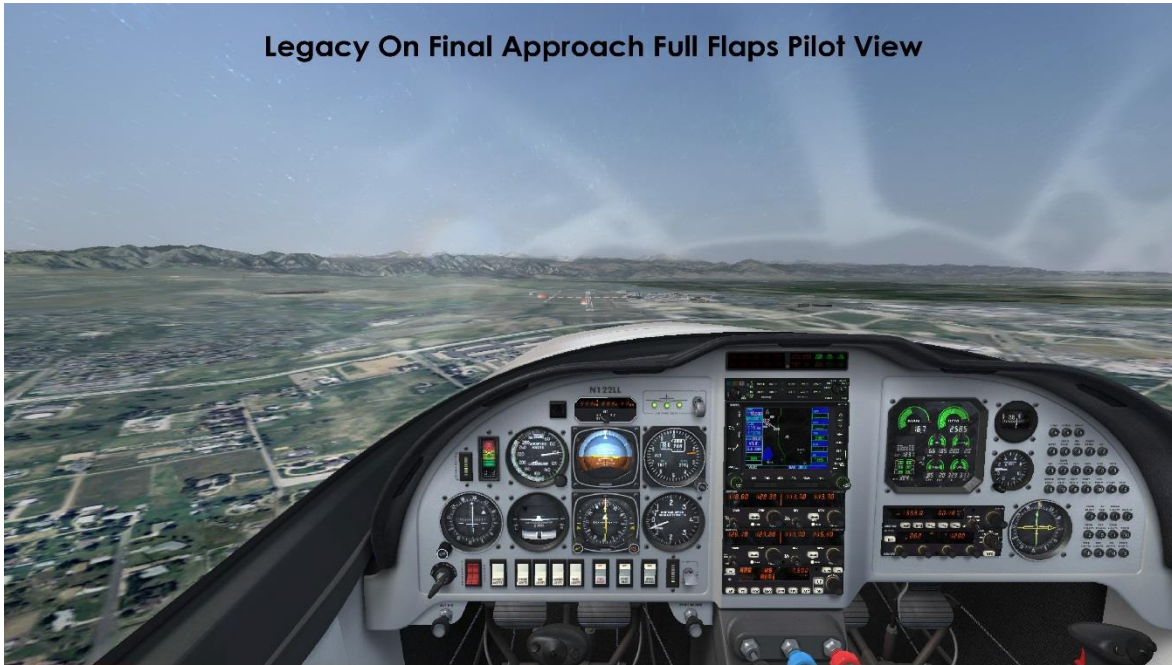
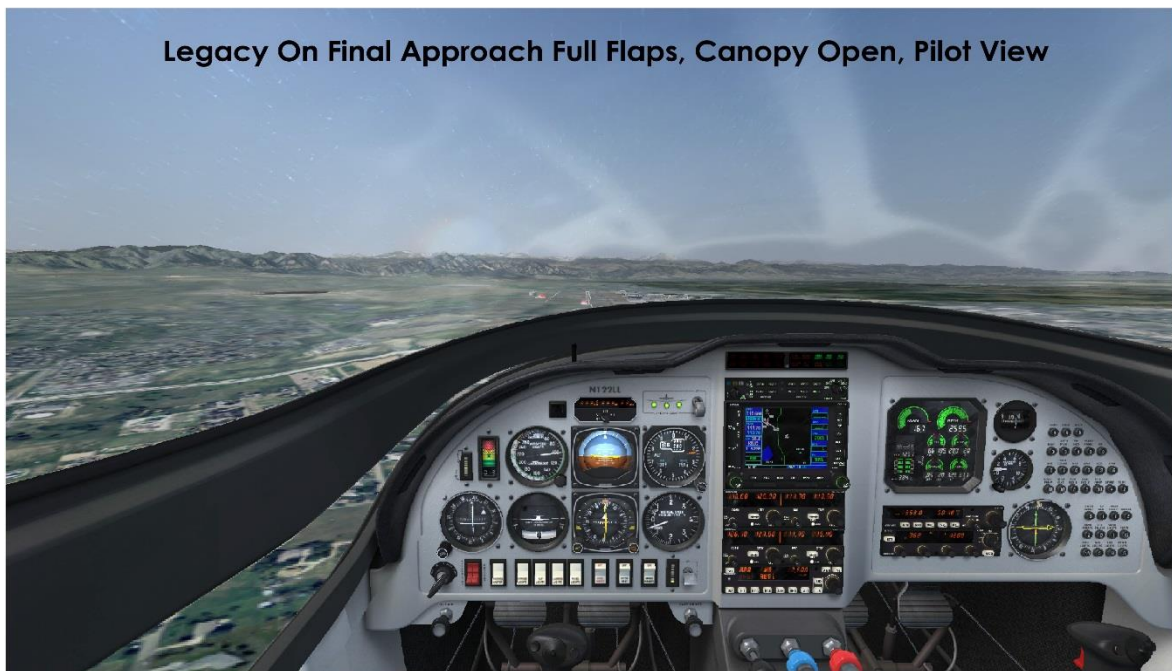
To understand this dynamic, it's helpful to examine either of the images in the last two rows where the second row from the bottom is the Legacy on final approach with the canopy closed and the bottom images are the exact same airplane location and flight attitude but the canopy is open several inches. The images with the flaps extended are shown in larger scale below. The left photo column is with no flaps and the right is with full flaps. As the canopy moves up, the view of the nose is lost, the instrument panel glare shield reference is obscured, and the canopy frame location can make it seem as if the airplane has been pitched nose down significantly.

Legacy view on final approach with canopy closed and partially open

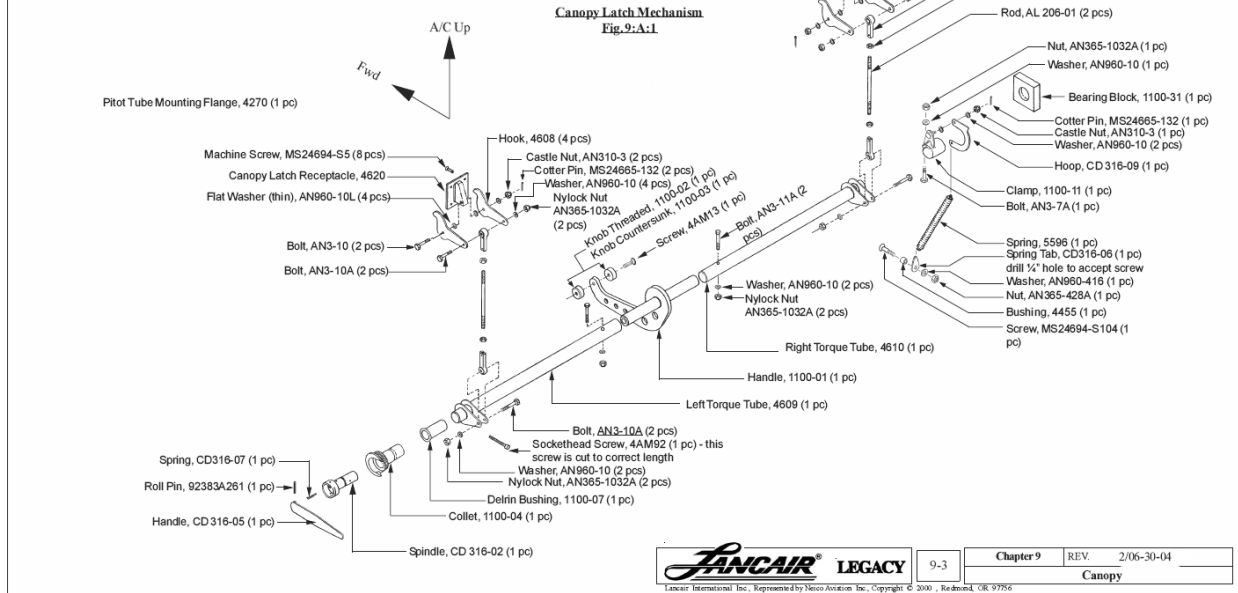
The canopy latch mechanism installs along the upper edge of the seat back. It is an over-center type mechanism that draws the canopy down and locked. The canopy is actually the first step in the fuselage construction. Installing the canopy before mounting the center wing section allows easy access to the inside of the fuselage.

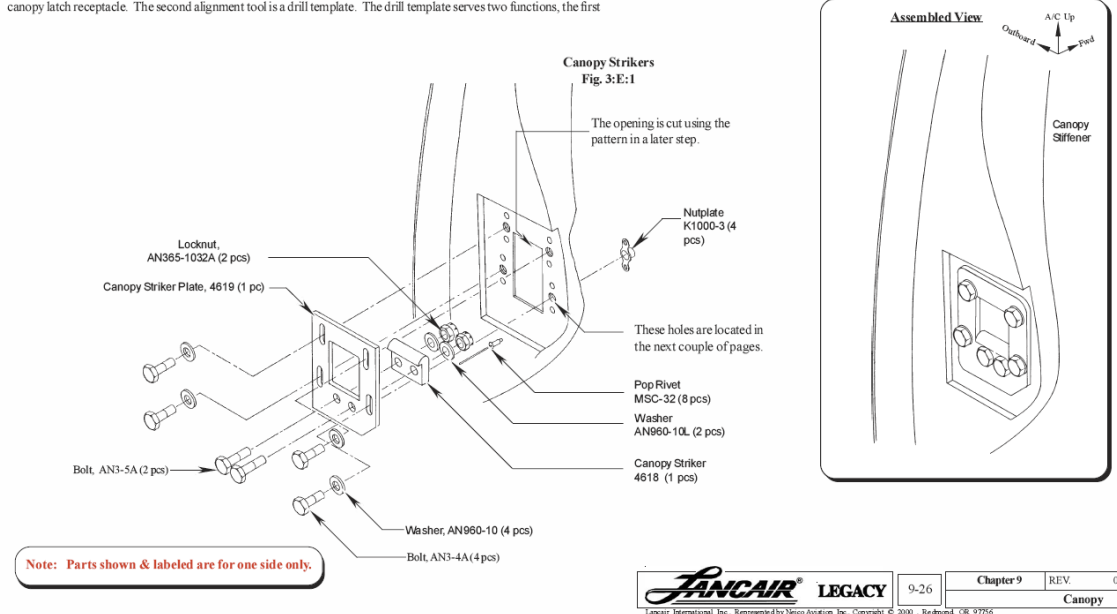
In section A you installed the canopy latch mechanism in the fuselage. When closed the canopy hooks move out of their slots and "grab" a catch in the canopy stiffener. The alignment of this catch is obviously critical to properly locking the canopy down. We will refer to this "catch" as the canopy striker mechanism.

We supply two parts used to properly align the canopy striker mechanism. The first is a screw that has a #40 hole drilled through the center. This is used to transfer a reference hole in the canopy stiffener by back drilling through the canopy latch receptacle. The second alignment tool is a drill template. The drill template serves two functions, the first

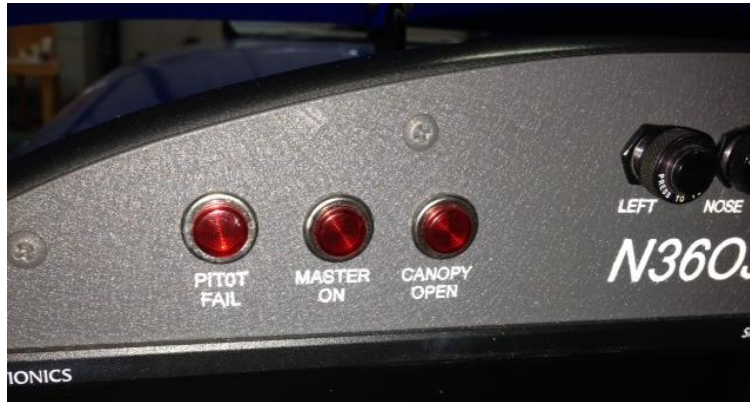
Example Canopy Unsafe Warning Light in Jack Addison's Lancair 360

The risk of takeoff without the canopy latched can be reduced with a prominent annunciator on the instrument panel warning the canopy is in an unsafe configuration – not down and latched and/or with the condition wired to an Electronic Flight Instrumentation System (EFIS) for alerting.

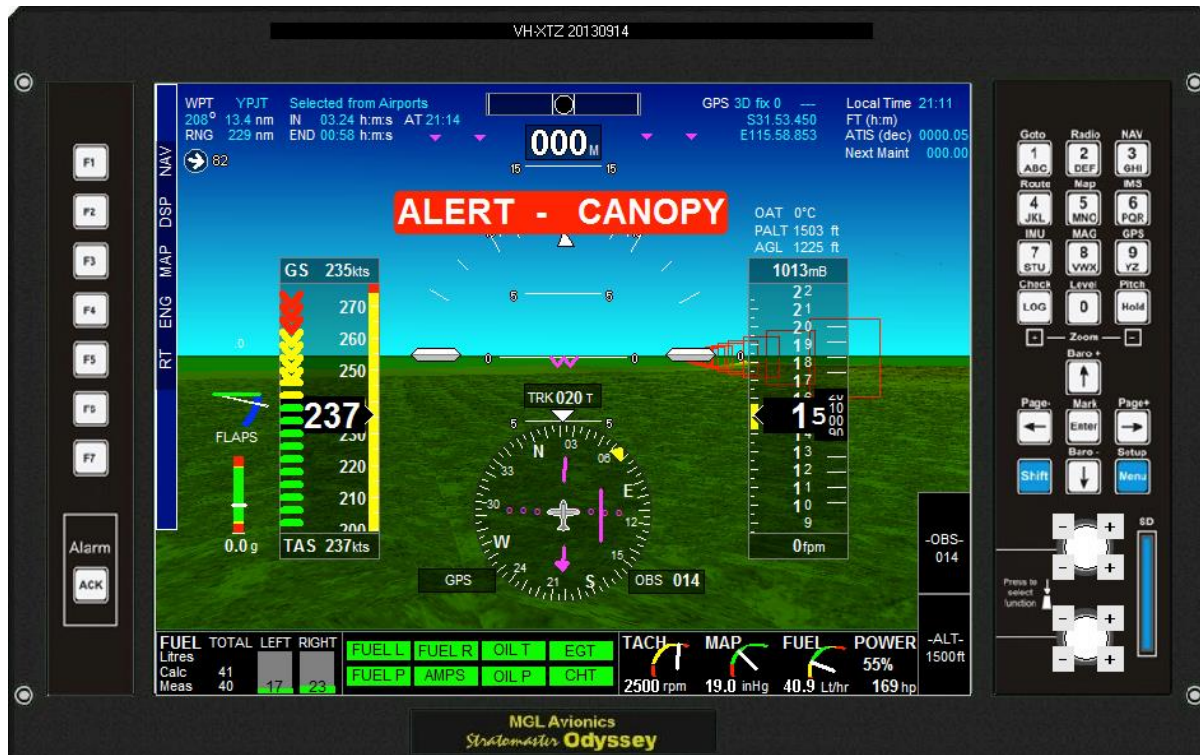
Example EFIS Warning in John Smith's and Gary Weeks' Lancair Legacys (VH-XTZ and VH-ZYA)

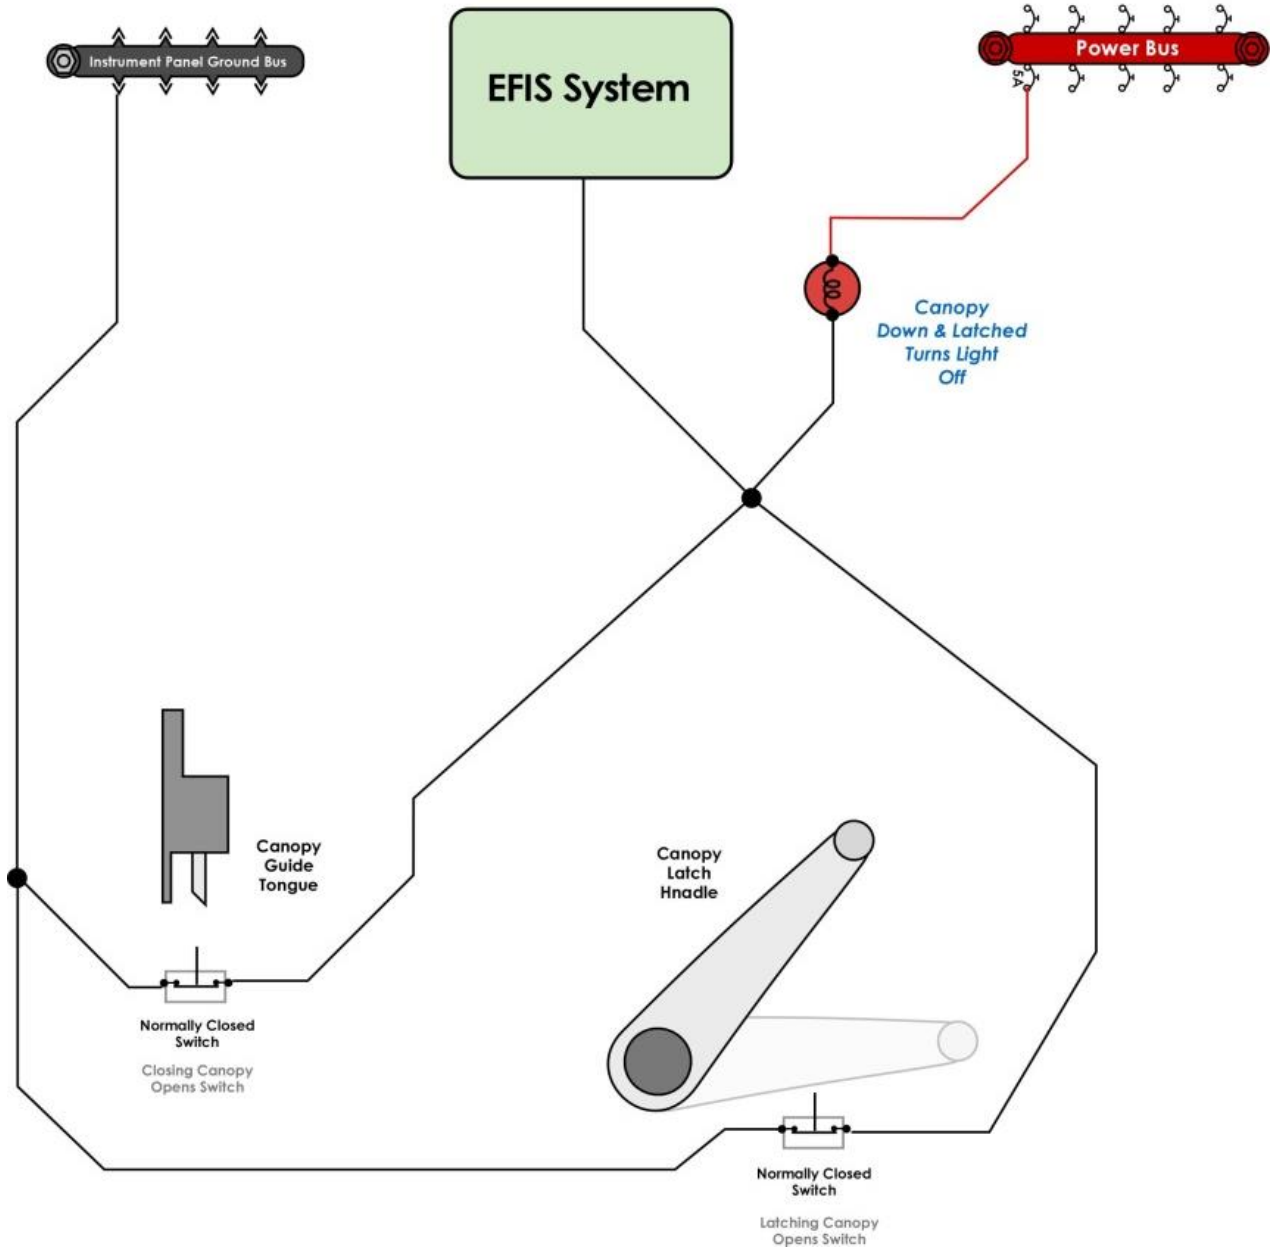
Whilst the following “warning light” circuit example is not a FAIL SAFE solution, it does nevertheless present perhaps the simplest means of setting up a warning light circuit.

Canopy Safety Warning Wiring Drawing Example

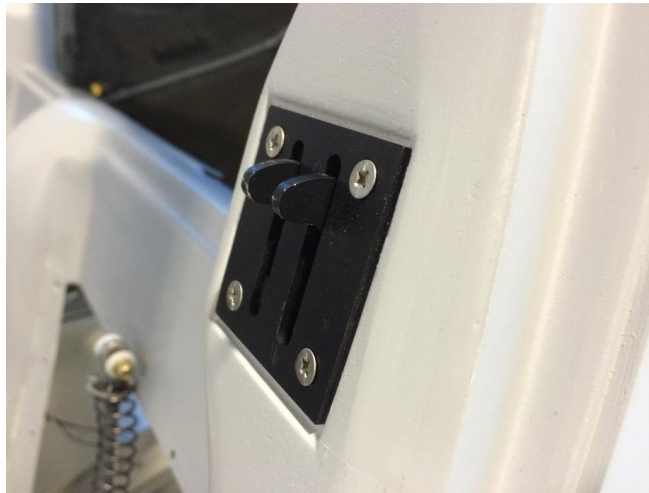
The Canopy Latch Mechanism Modification requires the upper lever stop be moved lower so the canopy latching claws remain extended $7/16$ " when the canopy lever is in the fully unlatched position.

Photo of Canopy Latch Claws Modified to Remain Partially Extended When In Full Canopy Release Position

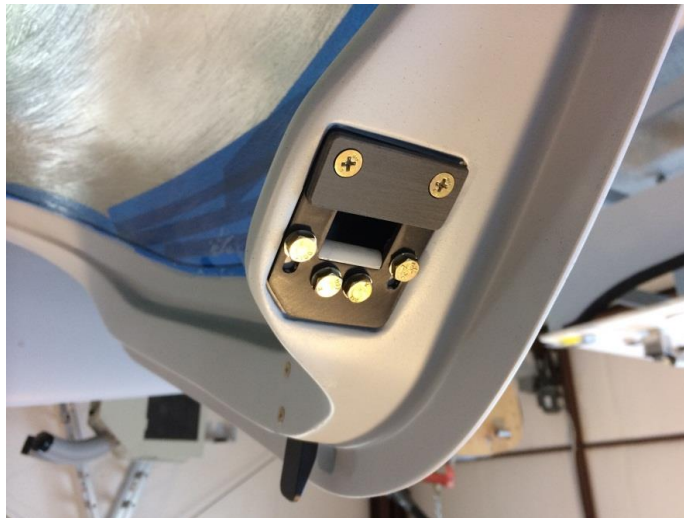
The canopy latching striker plates require installation of 1" x 2" pieces of 1/8" thick Nylon or ABS. The top AN3 hex head bolts are replaced with MS24694 – S54, (10-32) countersunk screws to secure the new "canopy lift plates".

Photo of Canopy Striker Modified with Lift Plate Installed

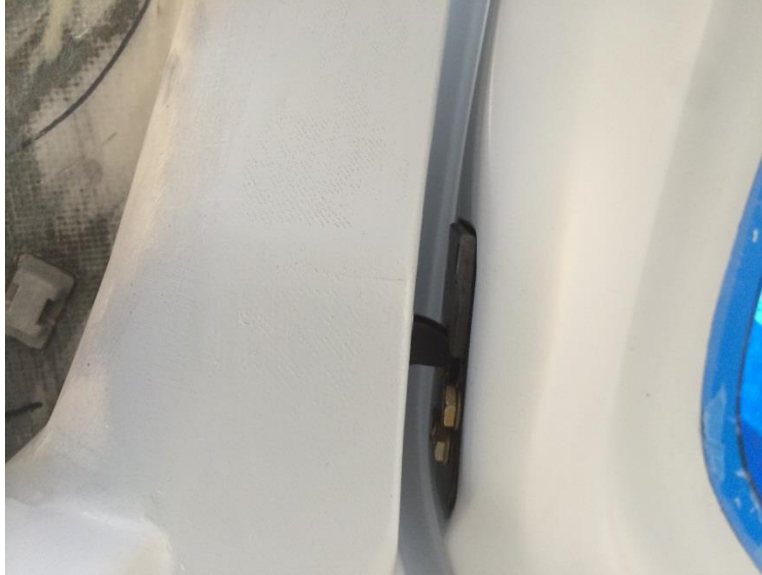
Photo Showing Claws and Striker Plate with Canopy Propped Open by Latch Mod
