**From:** Epperson Joe  
**Sent:** Friday, November 17, 2017 2:36 PM  
**To:** Gretz Robert  
**Cc:** Budinski Michael; Fox Matthew  
**Subject:** Front Royal, VA ERA18FA006  
**Attachments:** 1711Image57402.JPG; 1711Image57407.JPG

Front Royal, VA  
10/7/2017  
Piper PA-25-235, N90866  
ERA18FA006  
Bob Gretz, ASI ERA

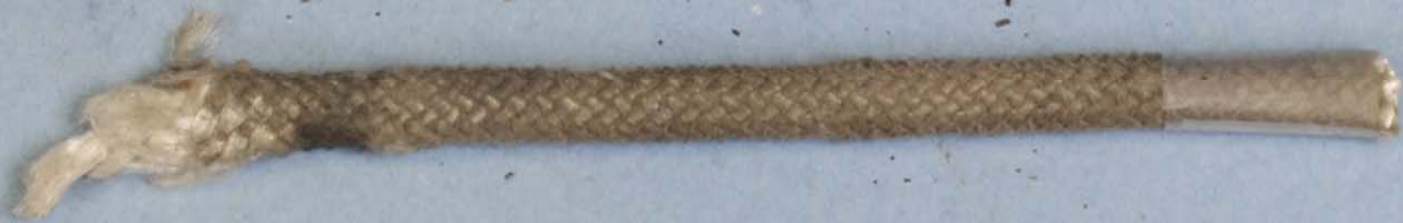
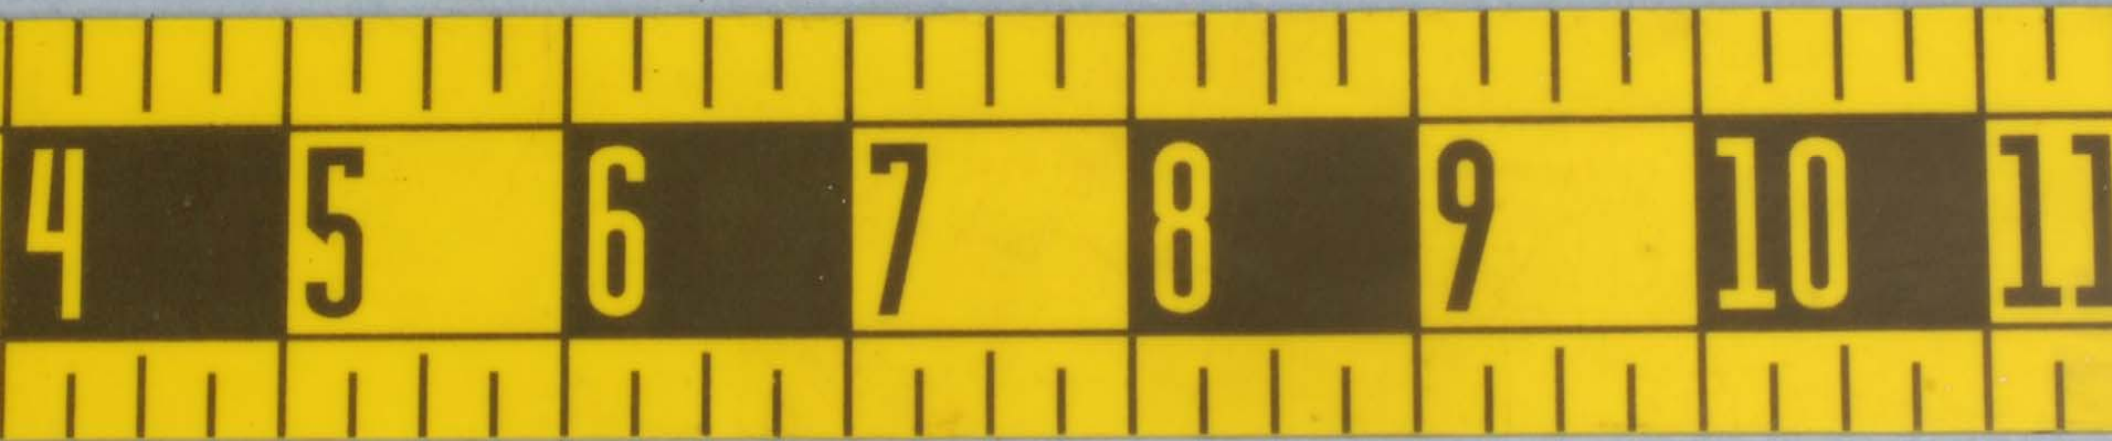
The received section of tow rope was visually and microscopically examined in the NTSB Materials Laboratory. The as-received rope was separated at one end and intentionally cut at the other as show in attached image 1711Image57402. The ¼ inch diameter rope had a braided outer layer covering approximately 13 twisted inner strands.

Magnified inspection of the separation found mushroomed fiber ends and partially fused strands indicative of adiabatic heating resulting from high strain rate overstress separations of synthetic fiber ropes. The longest strands were twisted as if they were part of a knot at the time of separation.

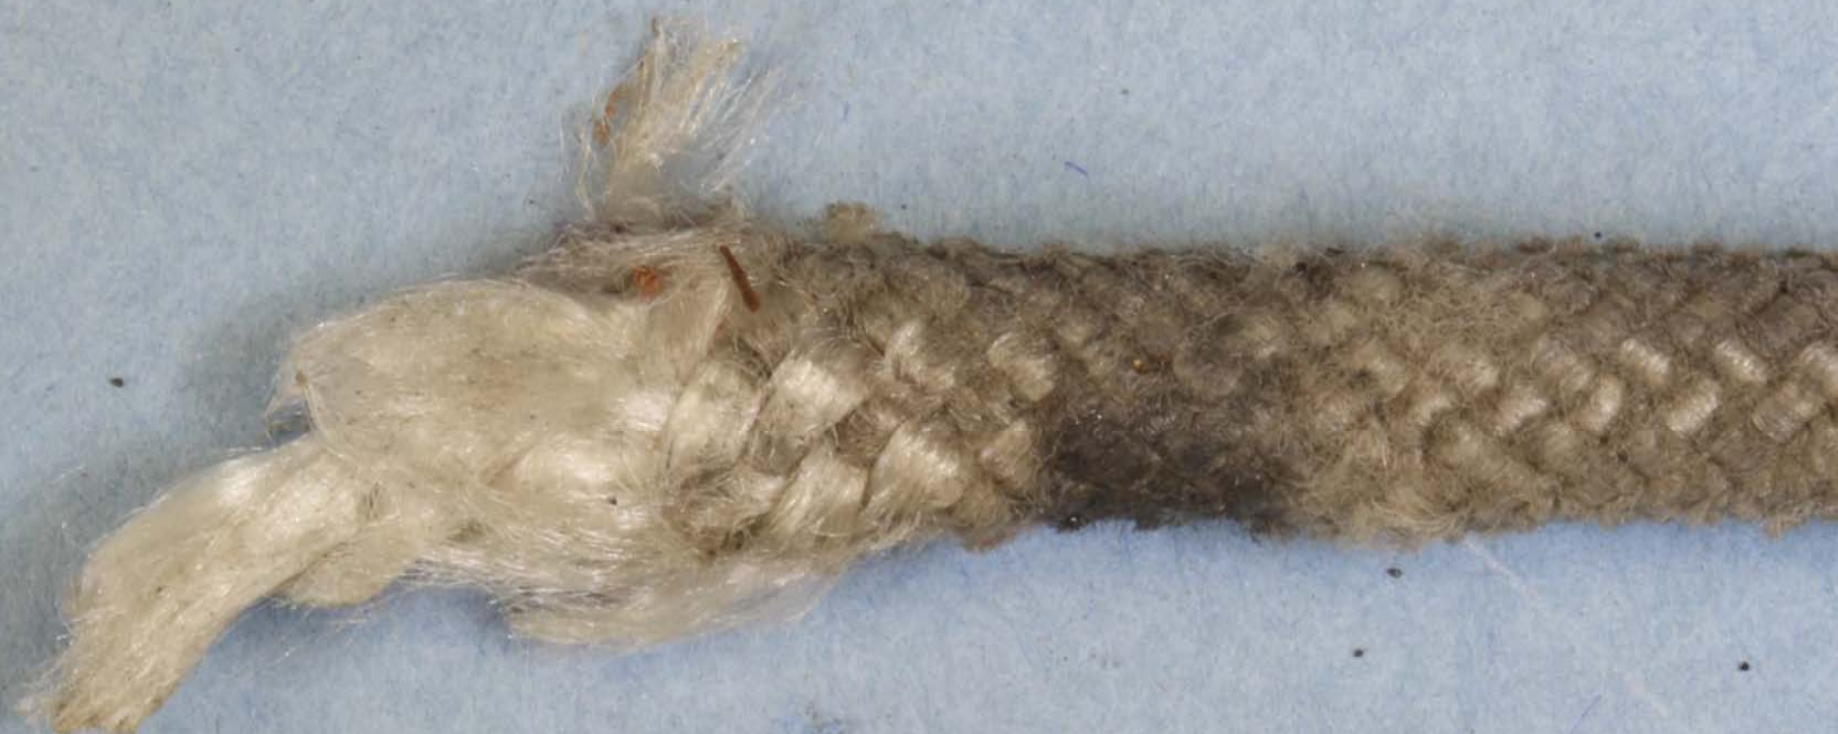
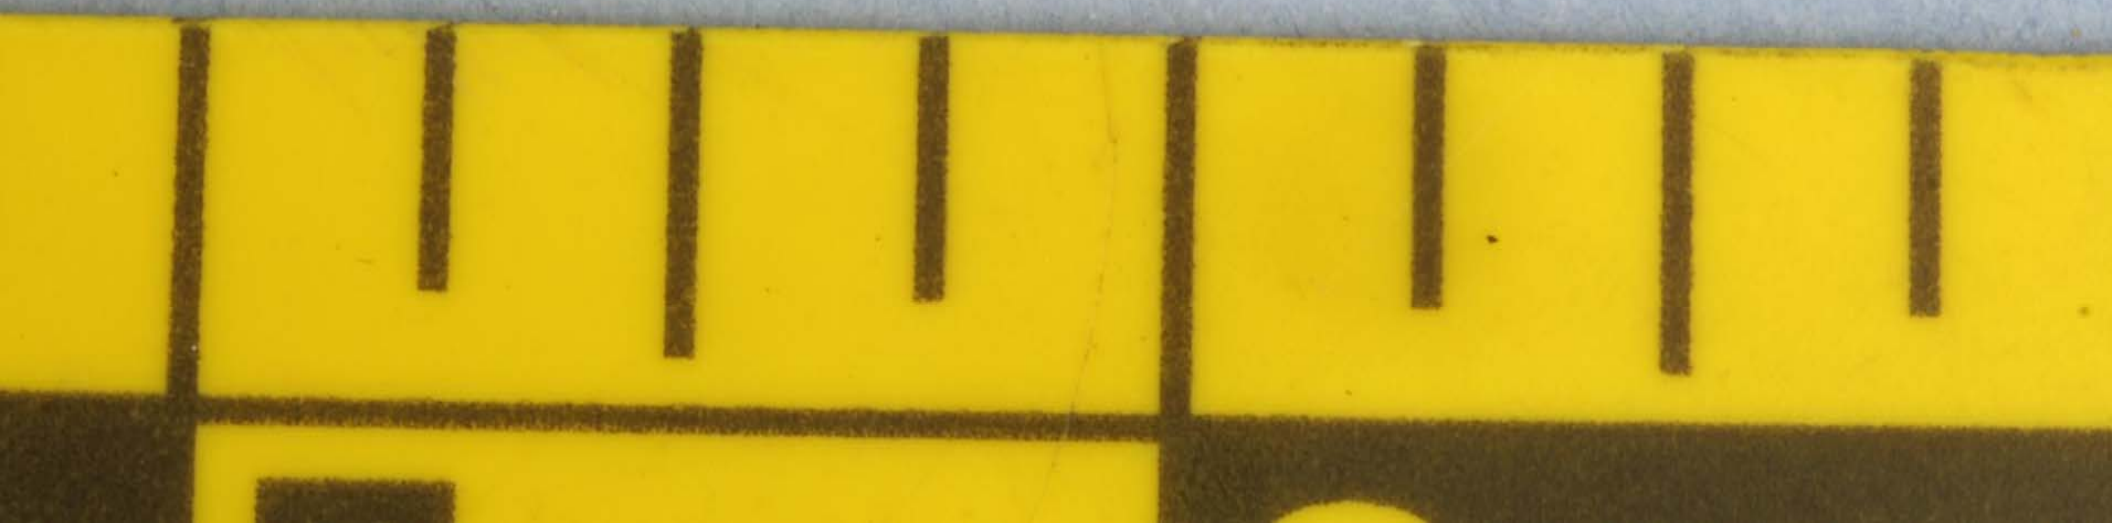
A dark band with a metallic sheen was visible on the braided cover adjacent to the separation, see attached image 1711Image57407. A hand held x-ray alloy analyzer revealed significant amounts of aluminum in the darkest part of the band.
