MEMORANDUM FOR RECORD

Accident Number: ERA18FA120
Subject: ADS-B N106ER Route¹ of Flight Views. Courtesy of ERAU

ADS-B N106ER Route/Track of Accident Flight provided by ERAU Director of Safety upon request.²

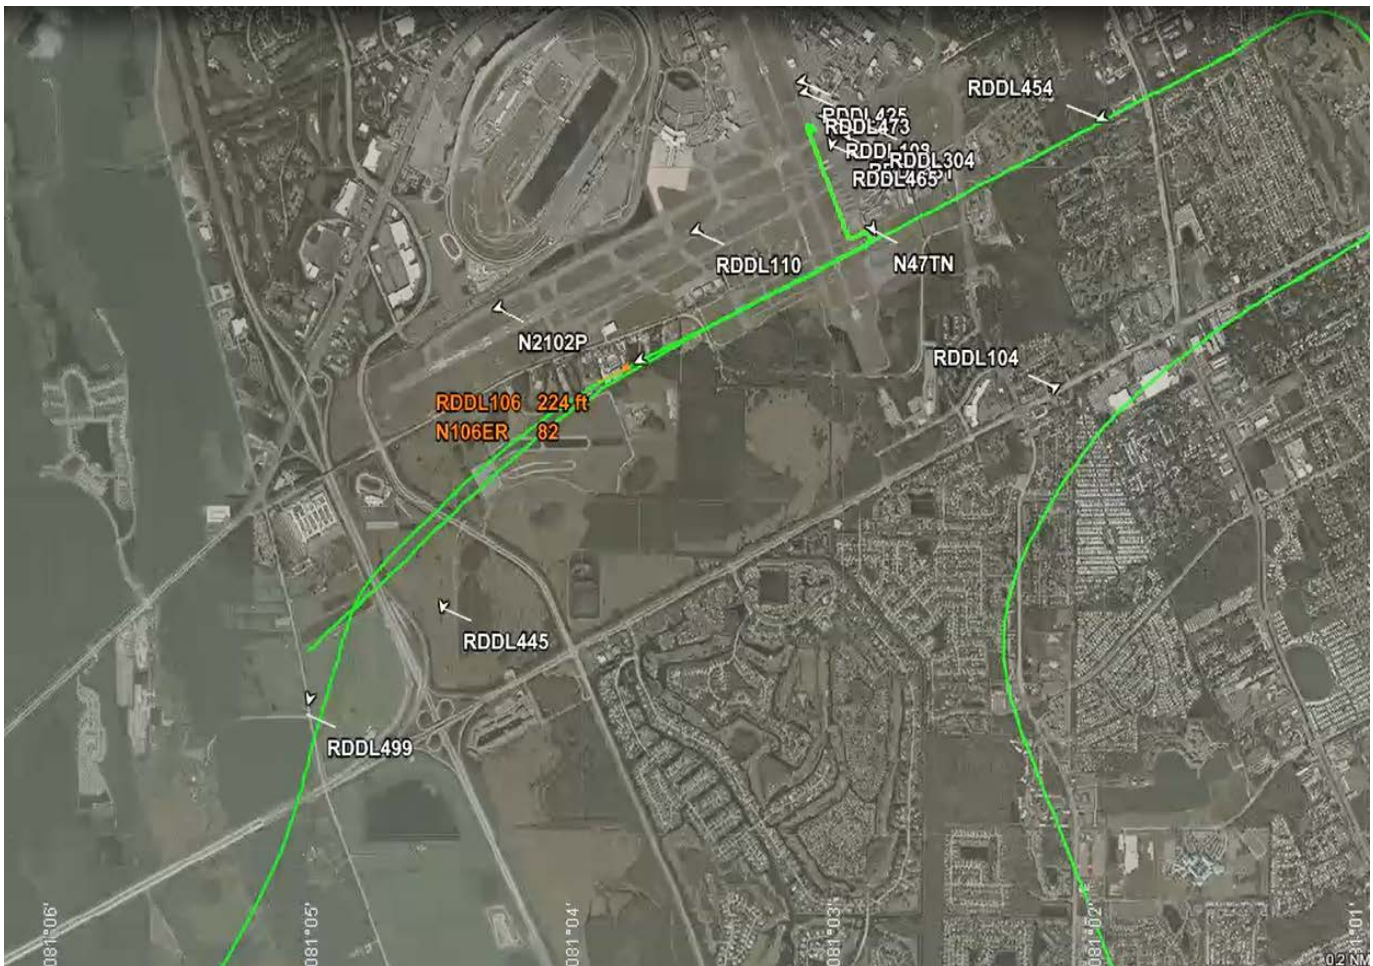
Figure 1- N106ER on initial climb after departing DAB runway 25L.

¹ N106ER (RDDL106) is colored amber and the route is indicated by the green line.

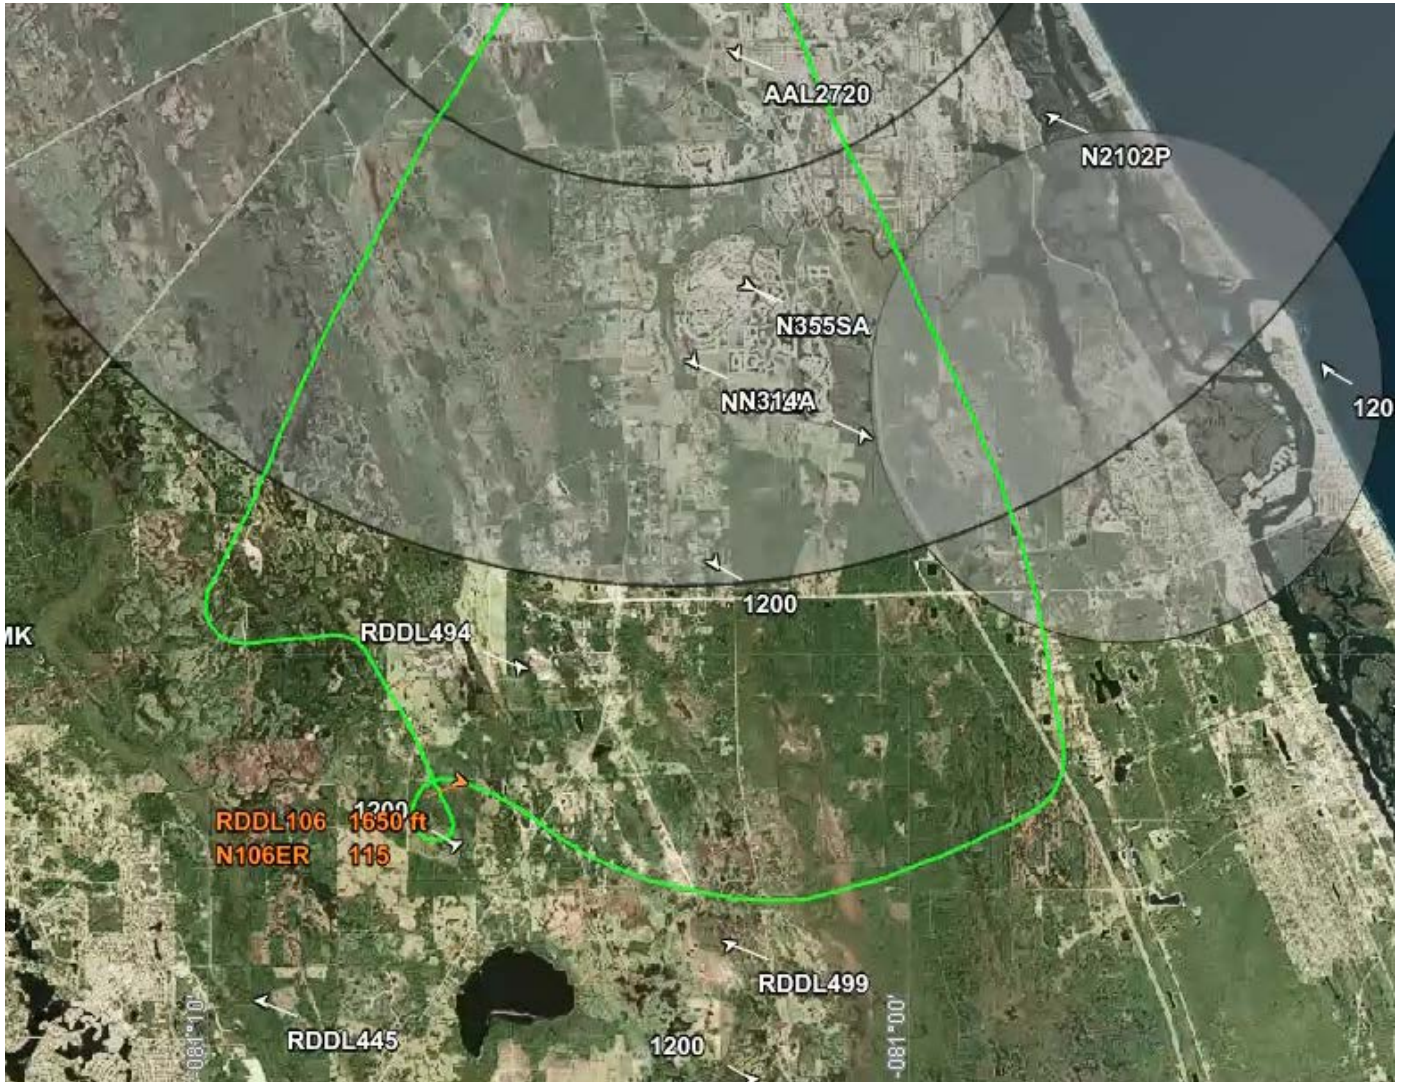
Figure 2- RDDL106 South of DAB at 1,650 ft flying on an easterly heading after performing a descending right turn.

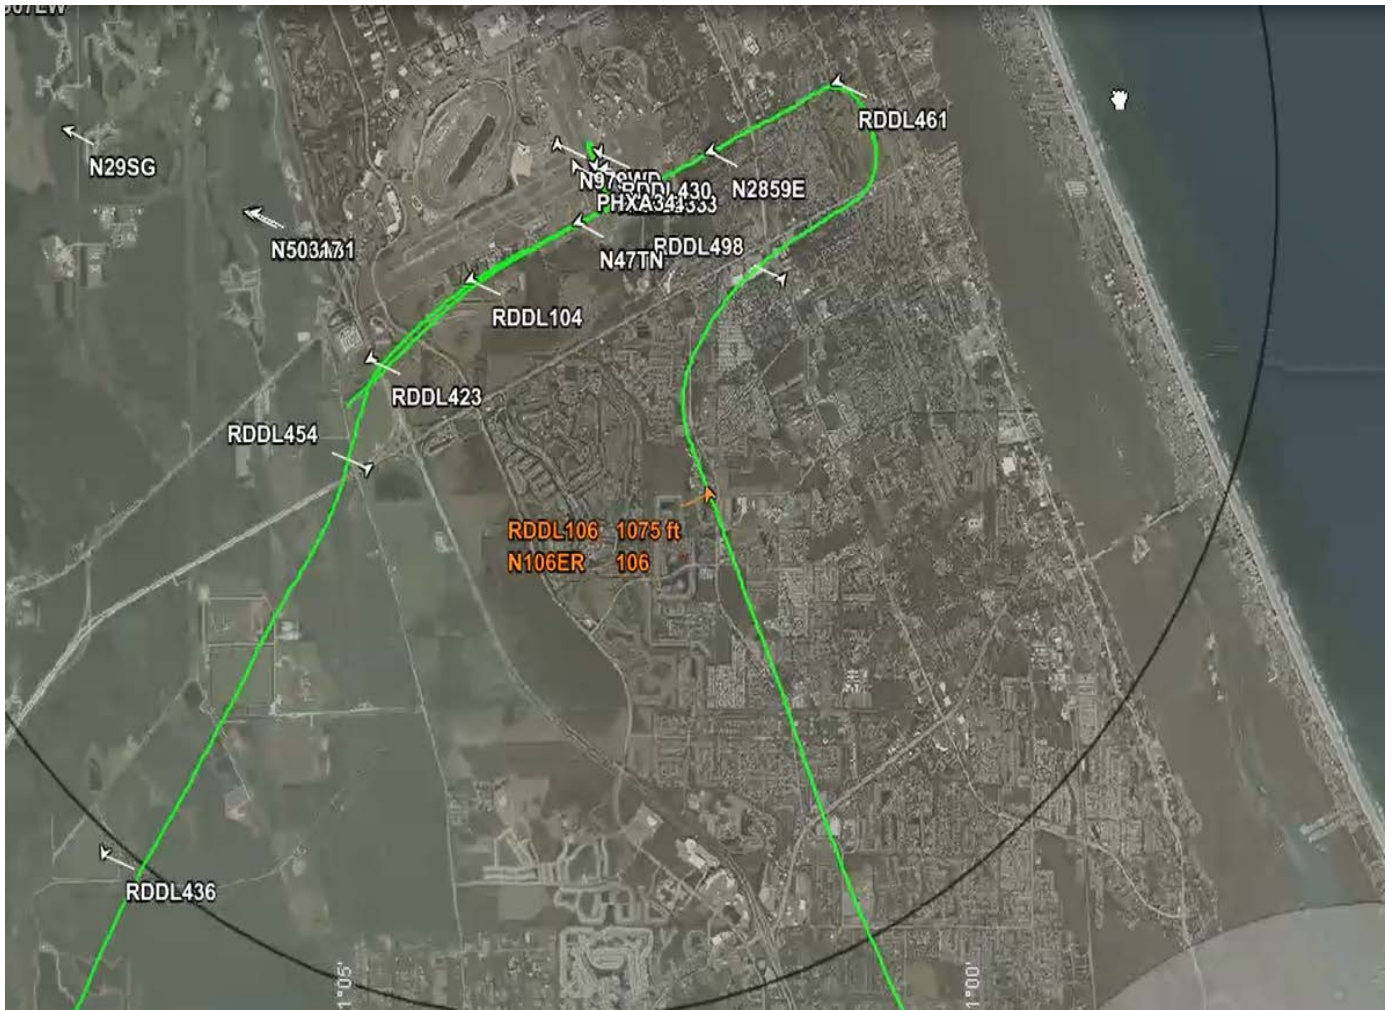
Figure 3- RDDL106 Preparing to enter the DAB downwind airport traffic pattern at 1,075 ft.

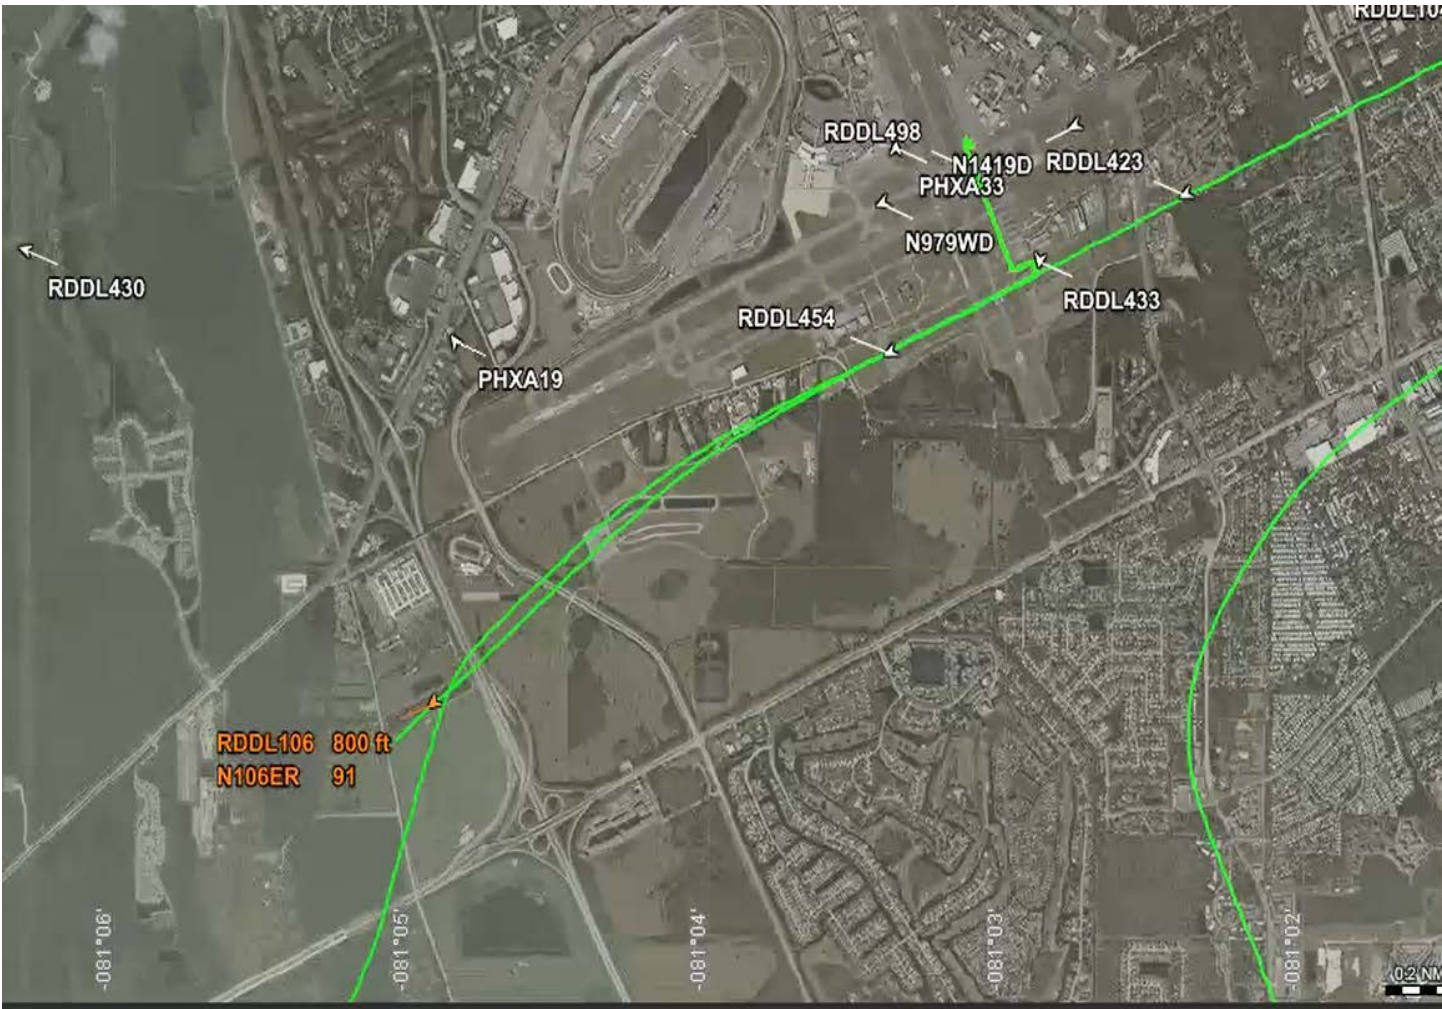
Figure 4-RDDL106 After touch and go during upwind climb immediately preceding accident.
