Survival Factors - Technical Working Group Chairperson's
Factual Report of the Investigation – Emergency Preparedness / Emergency Response¹

Addendum # 2 – Supplemental and Updated / Corrected Information of the Investigation –
Exhibits

*Heavy Smoke Release and Multiple Train Evacuations that occurred in the WMATA Metrorail
Transit System, in and near the L'Enfant Plaza Metrorail Station,
in Washington, DC, on January 12, 2015*

Exhibit 4. Workroom Site Inspection Notations of DC Fire Marshal's staff

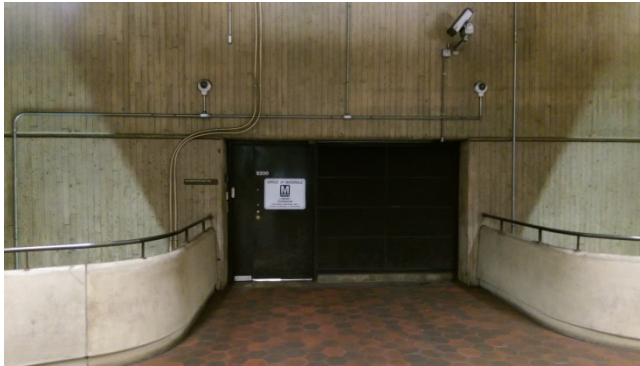
The space has been identified as a limited access area

Inside the area, deficiencies noted included:

1. Exits (Signage and Illumination)
2. Emergency Lighting
3. Fire Door Assembly
4. Occupant Notification Audio Visual notification
5. Combustible Storage
6. Evacuation Plan
7. Employee Training
