NATIONAL TRANSPORTATION SAFETY BOARD

Personal Electronic Device (PED)

Specialist's Factual Report
by Bill Tuccio, Ph.D.

Location: Coeur d'Alene, Idaho
Date: June 25, 2016
Aircraft: Cessna A185F
Registration: N4585F
Operator: Private
NTSB Number: WPR16FA131

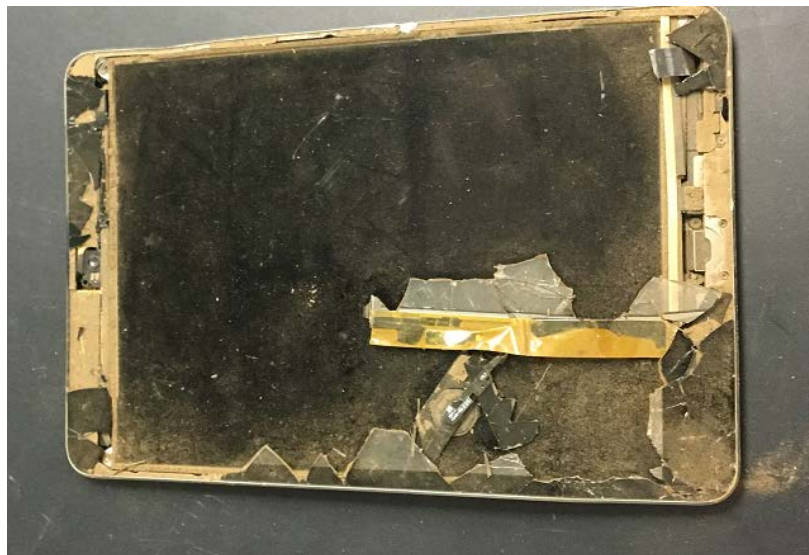
Figure 1. Apple iPad Mini 1, as received.

Upon arrival at the Vehicle Recorder Division, an exterior examination revealed the unit had sustained significant impact damage, as shown in figure 1. Initially the screen and digitizer were replaced and the unit started; however, it was protected by a password. The Investigator-in-Charge obtained the proper password and the unit unlocked. During subsequent restarts of the unit with only the replacement screen and digitizer, all functionality stopped working after a short period of time and the screen froze (that is, “locked up”). The unit was disassembled and the main printed circuit board, shown in figure 2, was installed in a surrogate unit.

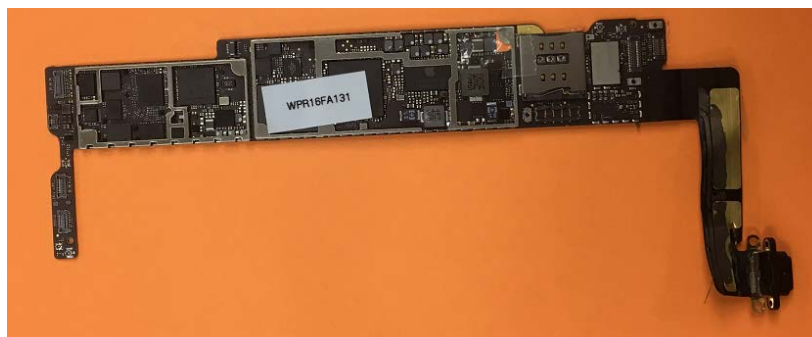
Figure 2. Internal printed circuit board removed from accident unit.

When installed in the surrogate, the lightning connector interface would not connect to a host computer, which would have enabled a full forensic download. The unit was examined from the user interface and photo-documented.

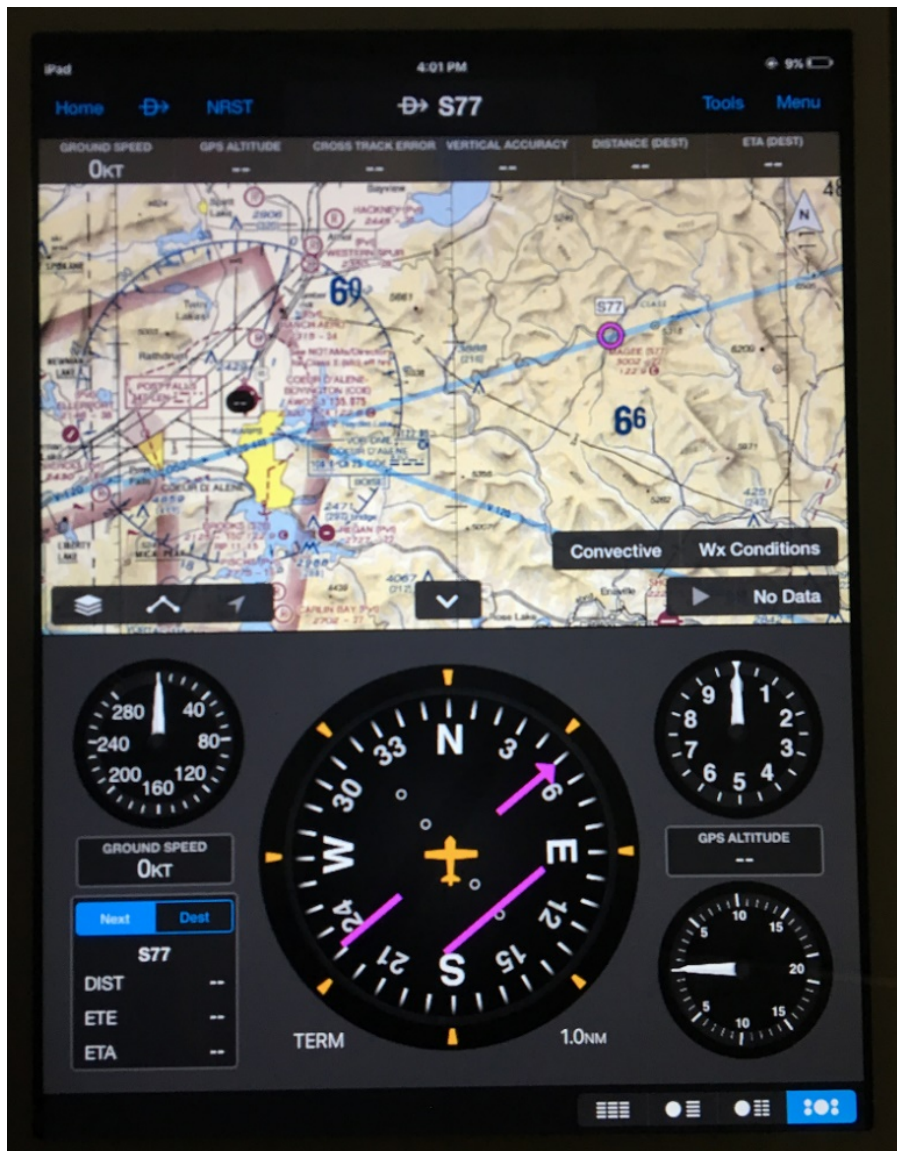
Figure 3. Map screen from Garmin Pilot.

The device contained one aviation-specific application, Garmin Pilot, which is an electronic flight bag application capable of flight planning and inflight navigation by displaying course-to-be-flown and aircraft position overlaid on a moving map. Upon starting the Garmin Pilot application and going to the map screen, figure 3 shows the image presented. A “direct to” navigation was enabled to the S77 airport, which corresponds to the Magee turf airstrip. Other screens within the Garmin Pilot application were examined (such as, the scratch pad, settings, flight plans) and contained no data pertinent to the investigation.
