NATIONAL TRANSPORTATION SAFETY BOARD

Personal Electronic Devices

Specialist's Factual Report
By Bill Tuccio, Ph.D.

Location: Saratoga, Wyoming
Date: September 20, 2014
Aircraft: Piper PA-28
Registration: N4618J
Operator: Private
NTSB Number: WPR14FA382

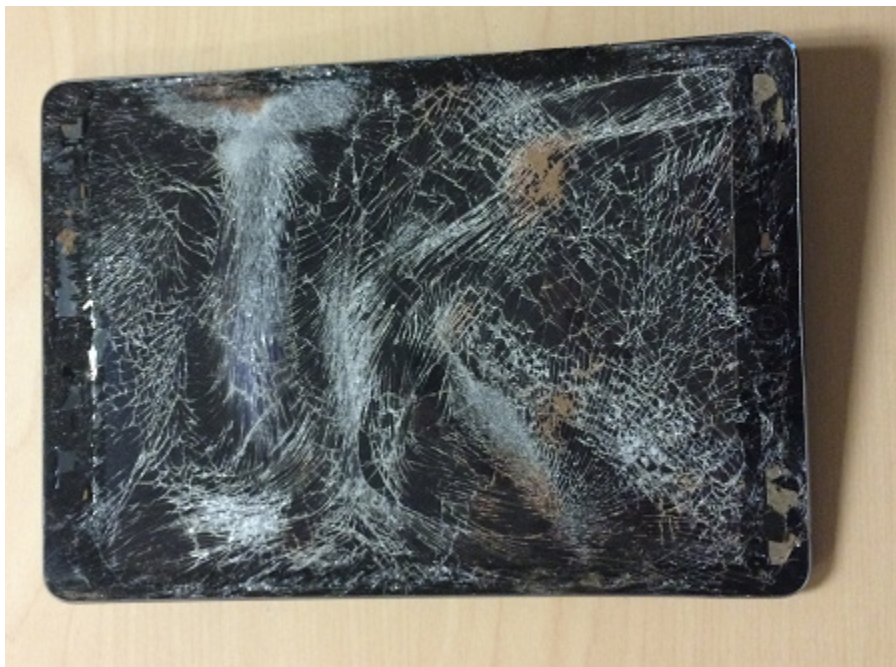
Upon arrival at the Vehicle Recorder Laboratory, an examination revealed both units had sustained significant impact damage. The extent of the damage is shown in figures 1 and 2.

Figure 1. Photo of damaged unit, serial number DLXMK0WYFKYC

The first iPad (serial number DLXMK0WYFKYC) sustained damage that precluded normal recovery procedures and additional attempts were unsuccessful in yielding usable data. Therefore, no data pertinent to the event were recovered.

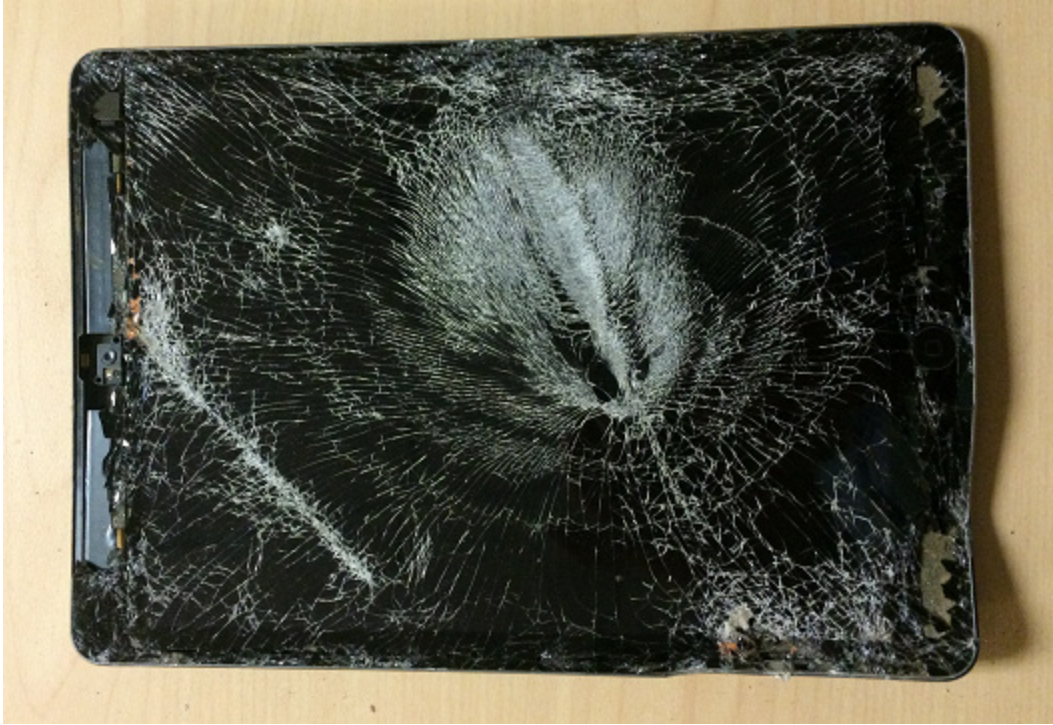
Figure 2. Photo of damaged unit, serial number DMPLTS8DFKYC

The second iPad (serial number DMPLTS8DFKYC) was repaired; however, it was protected by an optional security feature that requires a user-password to unlock the device and access functions and stored data. According to the investigator-in-charge, the password was not obtainable so the device's functions and any stored data were not accessible. With consent from the surviving family and via a subpoena, the device was sent to the manufacturer to attempt to bypass the password. The manufacturer was not able to bypass the password. Therefore, no data were recovered.
