NATIONAL TRANSPORTATION SAFETY BOARD

Personal Electronic Devices

Specialist's Factual Report
By Bill Tuccio, Ph.D.

Location: North Little Rock, Arkansas
Date: May 5, 2016
Aircraft: Cessna 310F
Registration: N6770X
Operator: Lashbrook Inc.
NTSB Number: CEN16FA172

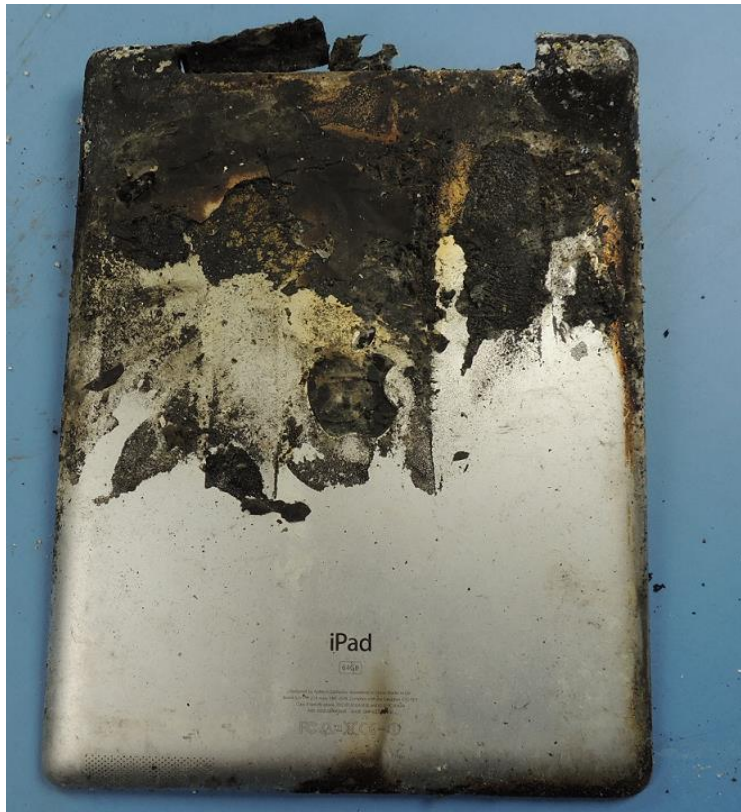
Figure 1. Photo of iPad #1.

Upon arrival at the Vehicle Recorder Laboratory, an examination revealed both units had sustained impact and heat damage. Figure 1 shows iPad #1 and figure 2 shows iPad #2. It was determined the damage to iPad #1 was too severe for any recovery. The internal component board of iPad #2 was intact, removed from the unit, installed in a surrogate unit, started, the password determined, and content downloaded using forensic software.
