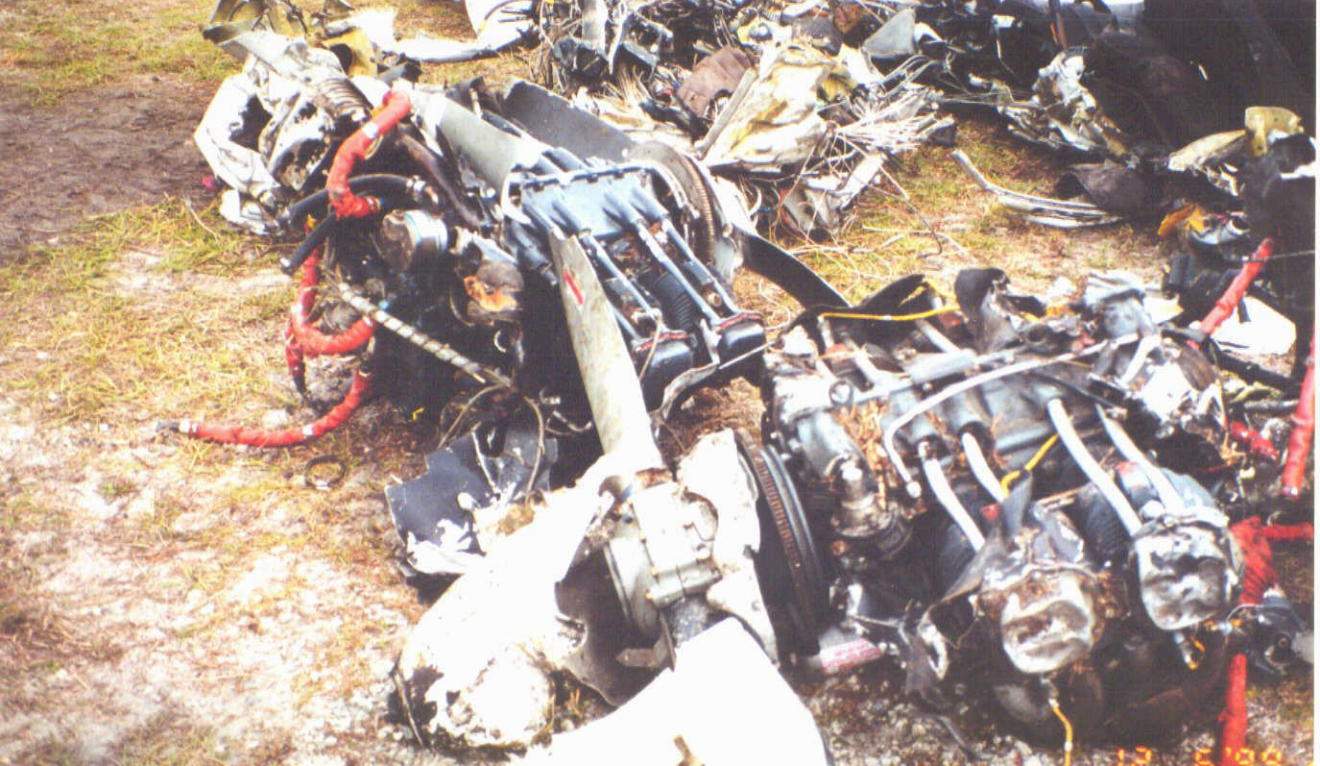
Photo 11: View of the left engine and fractured propeller blade of the Seminole matching impact signatures on the top of the engine of the Cadet
