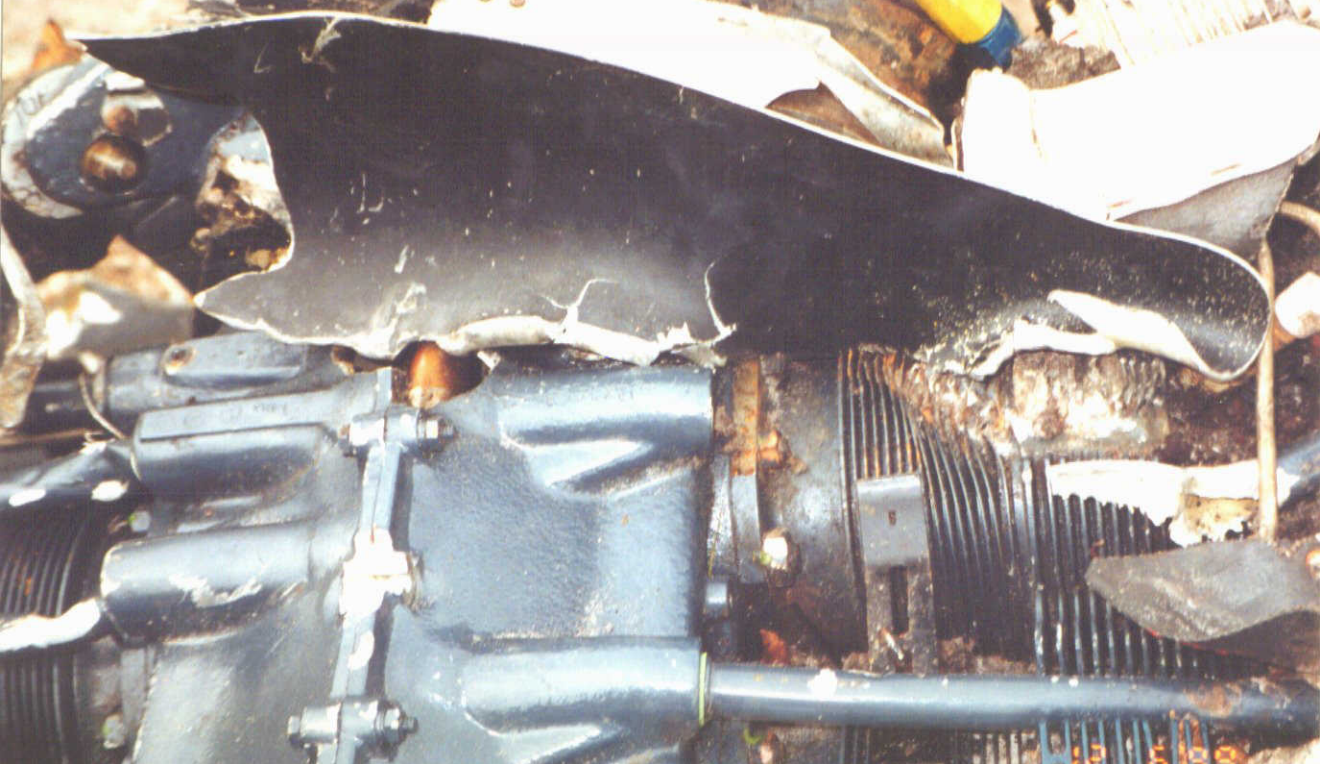
Photo 12: Closer view matching the impact signatures of the leading edge of the fractured propeller blade from the left propeller of the Seminole to the top of the engine from the Cadet
