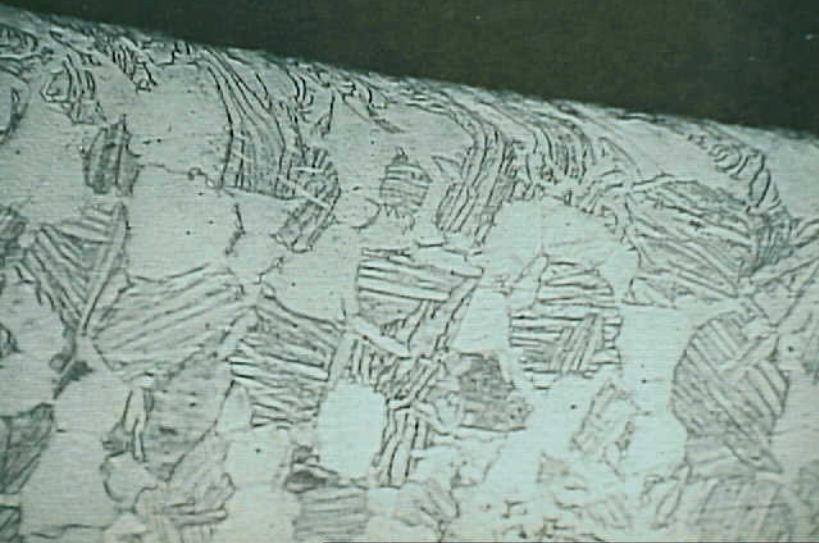
Photo 12. Cross section of hole #26 showing deformed material to a depth of up to 12 μm (0.47 mills). Mag 500X.
