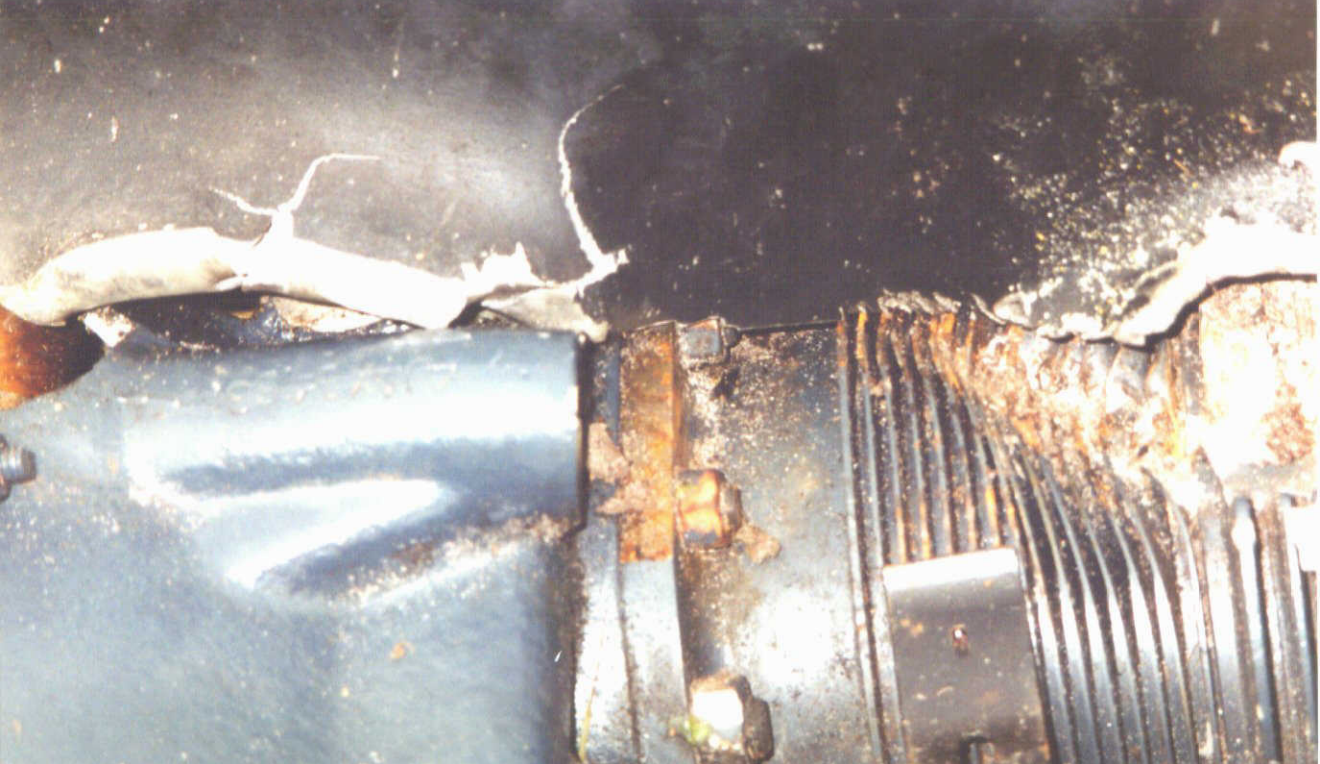
Photo 13: Closer view matching the impact signatures of the leading edge of the propeller blade from the left propeller of the Seminole to the top of the engine from the Cadet
