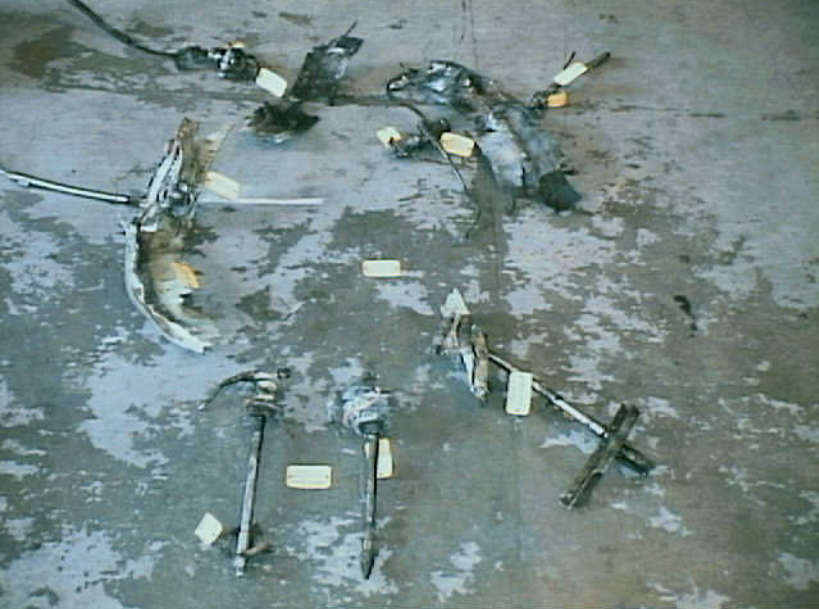
Photo 13. No. 1 engines reverser hydraulic actuators and TB/FW fragments
