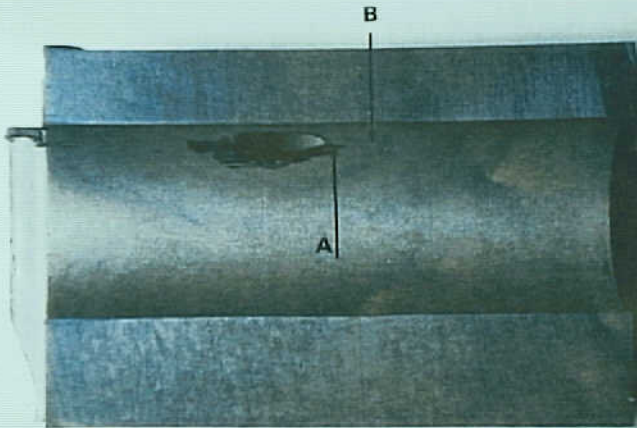
Photo 16. Hole #1A after opening up and BEA. An elliptical cavity can be seen on the ID. The surrounding area of the cavity indicated alternately in grey and blue.
