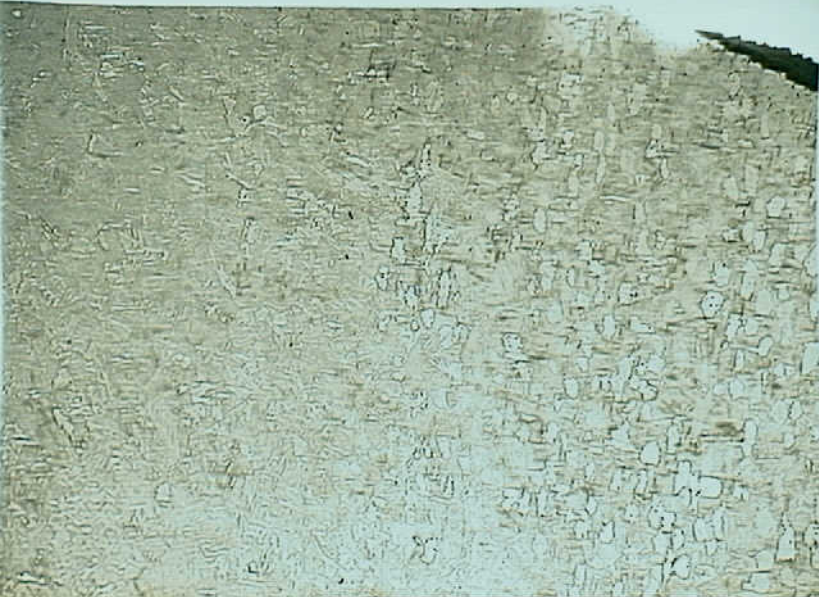
Photo 18. Hole #1A. Longitudinal section of showing overheated material (above B-transus) with transformed B and partially transformed B. The section is located at arrow B in photo 16. Mag 200X
