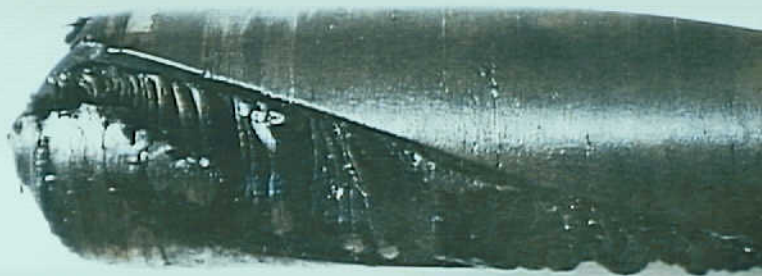
Photo 30. Example of a delta drill used without coolant. A heavy accumulation of chips accrued during the testing.
