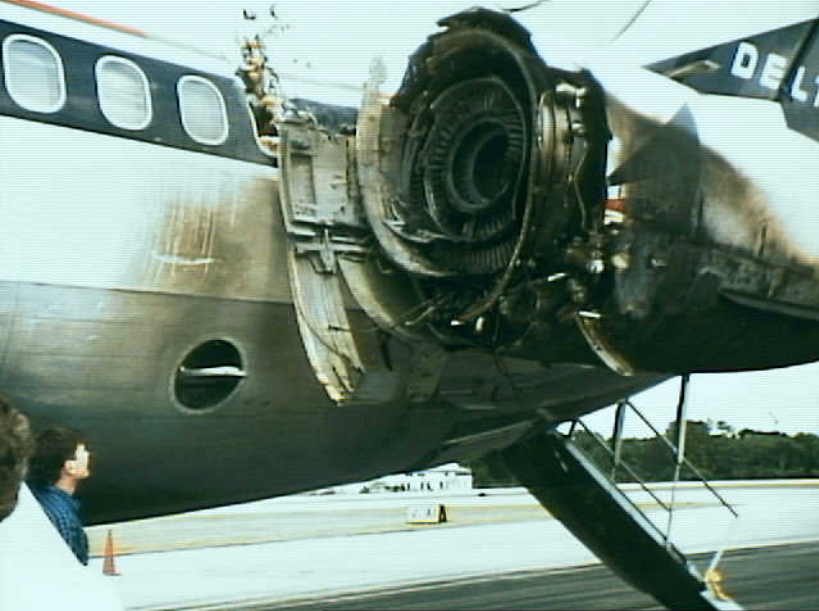
Photo 4. Left fuselage and engine damage, including fire damage to nacelle.
