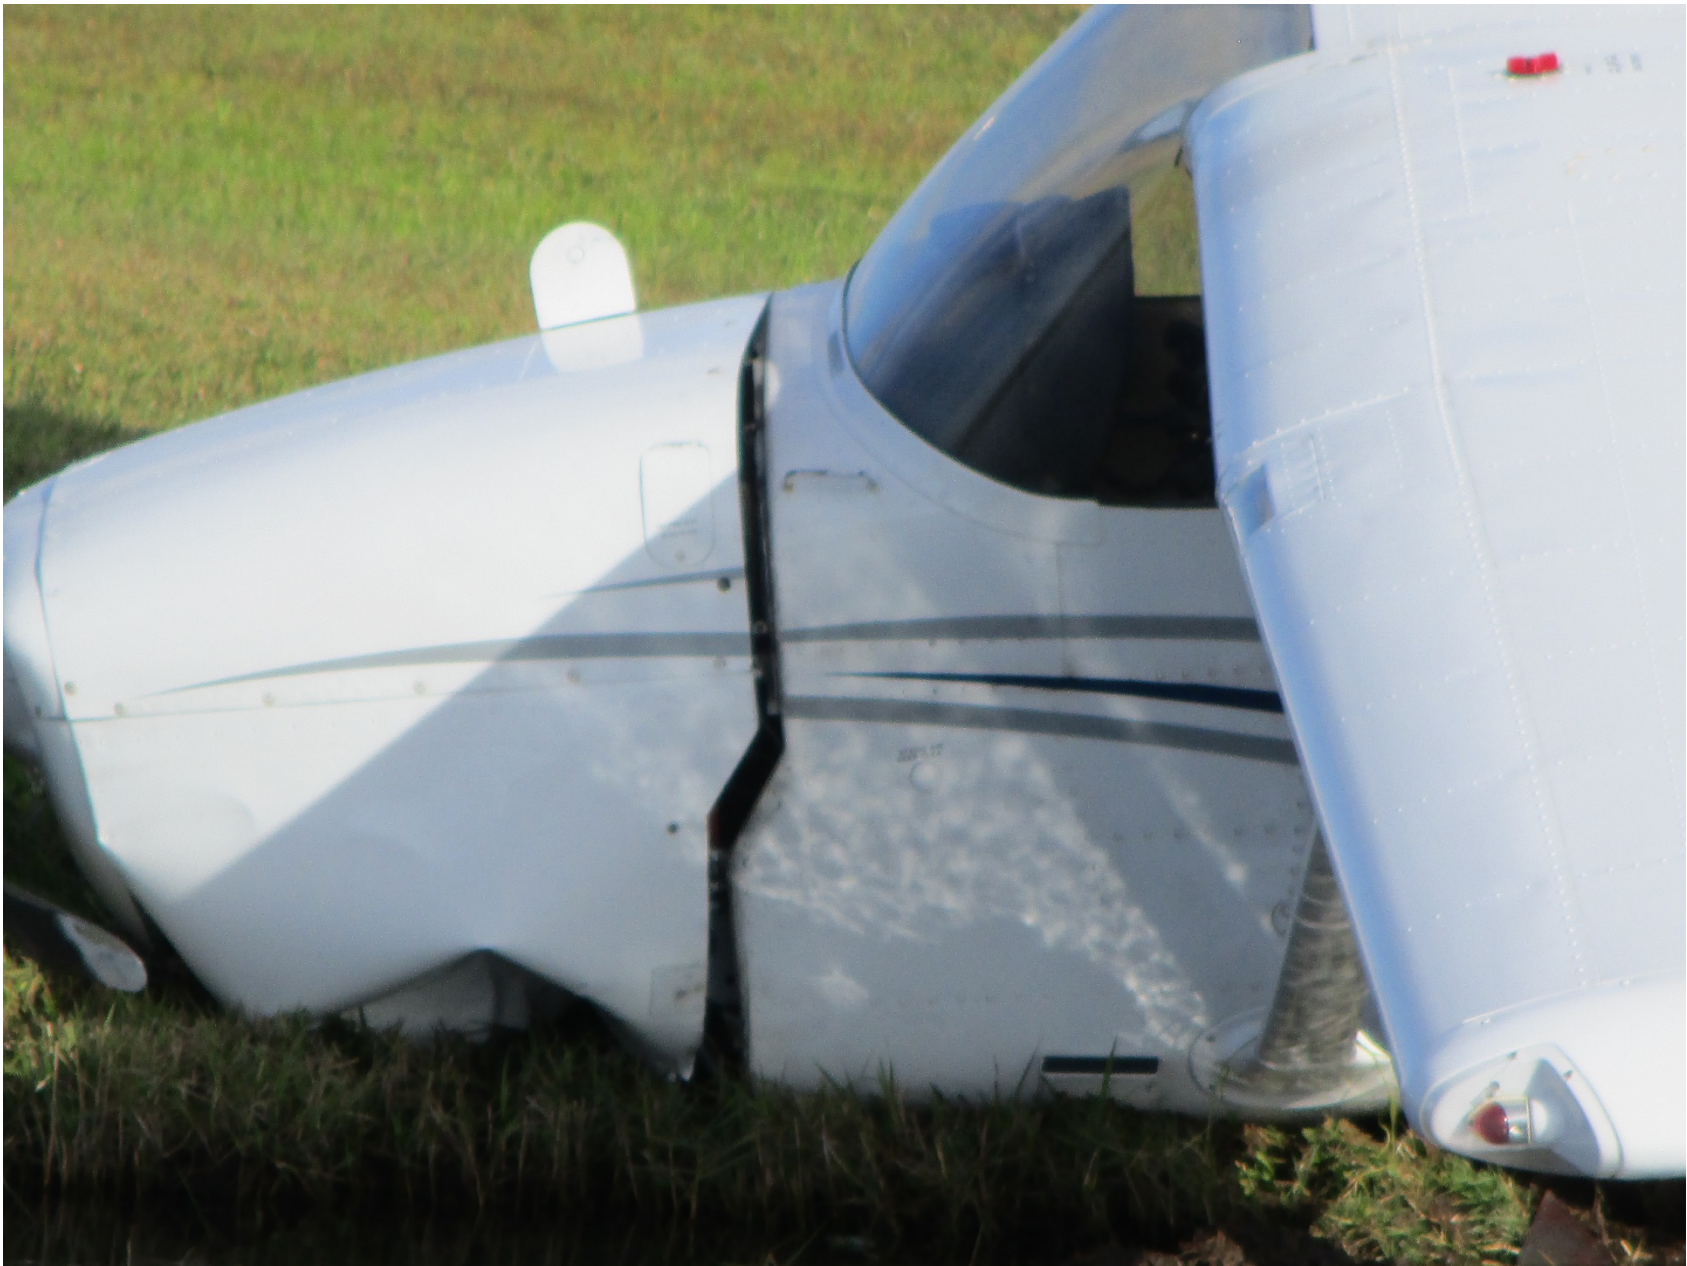
**Photo 1 – View of nose of airplane on right side showing buckling of fuselage**

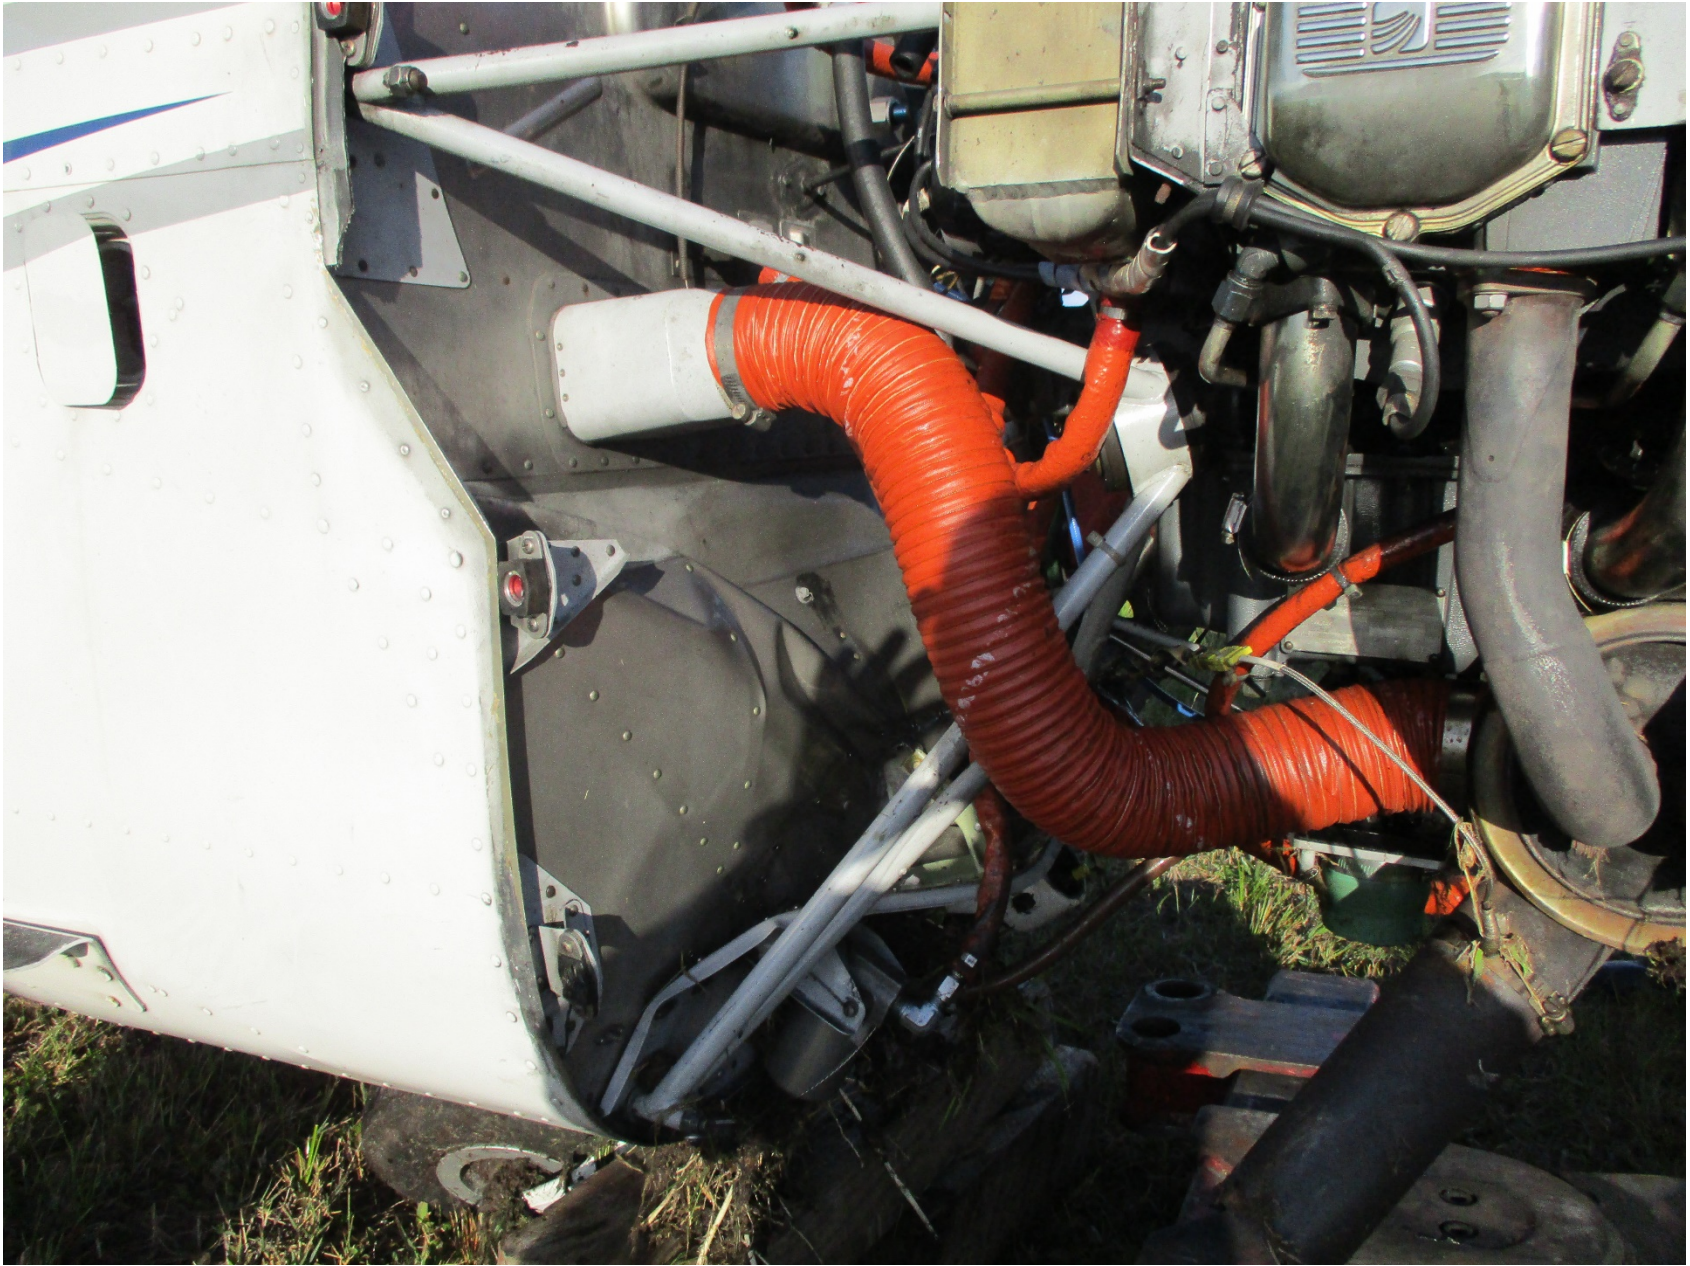
**Photo 2 – View of buckled firewall**

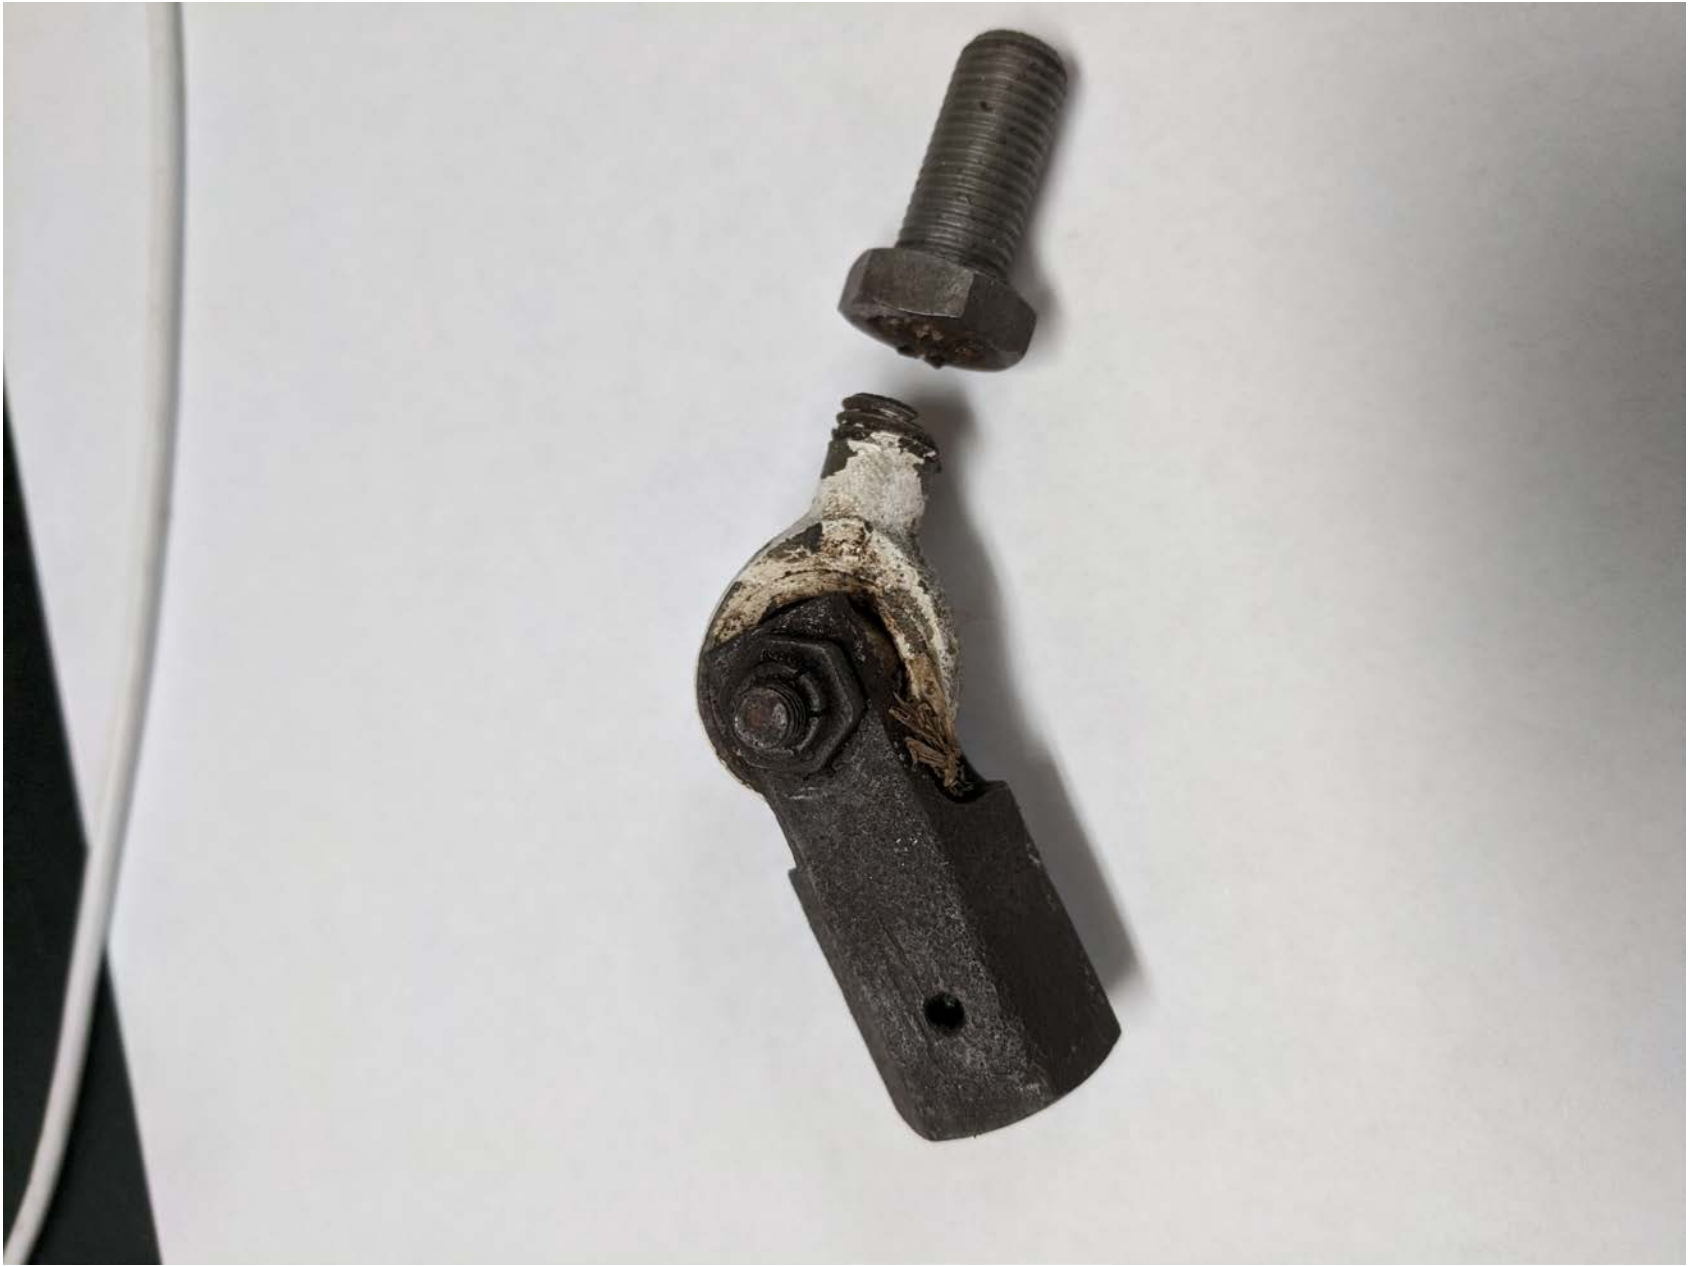
**Photo 3 – View of failed nose steering rod end**

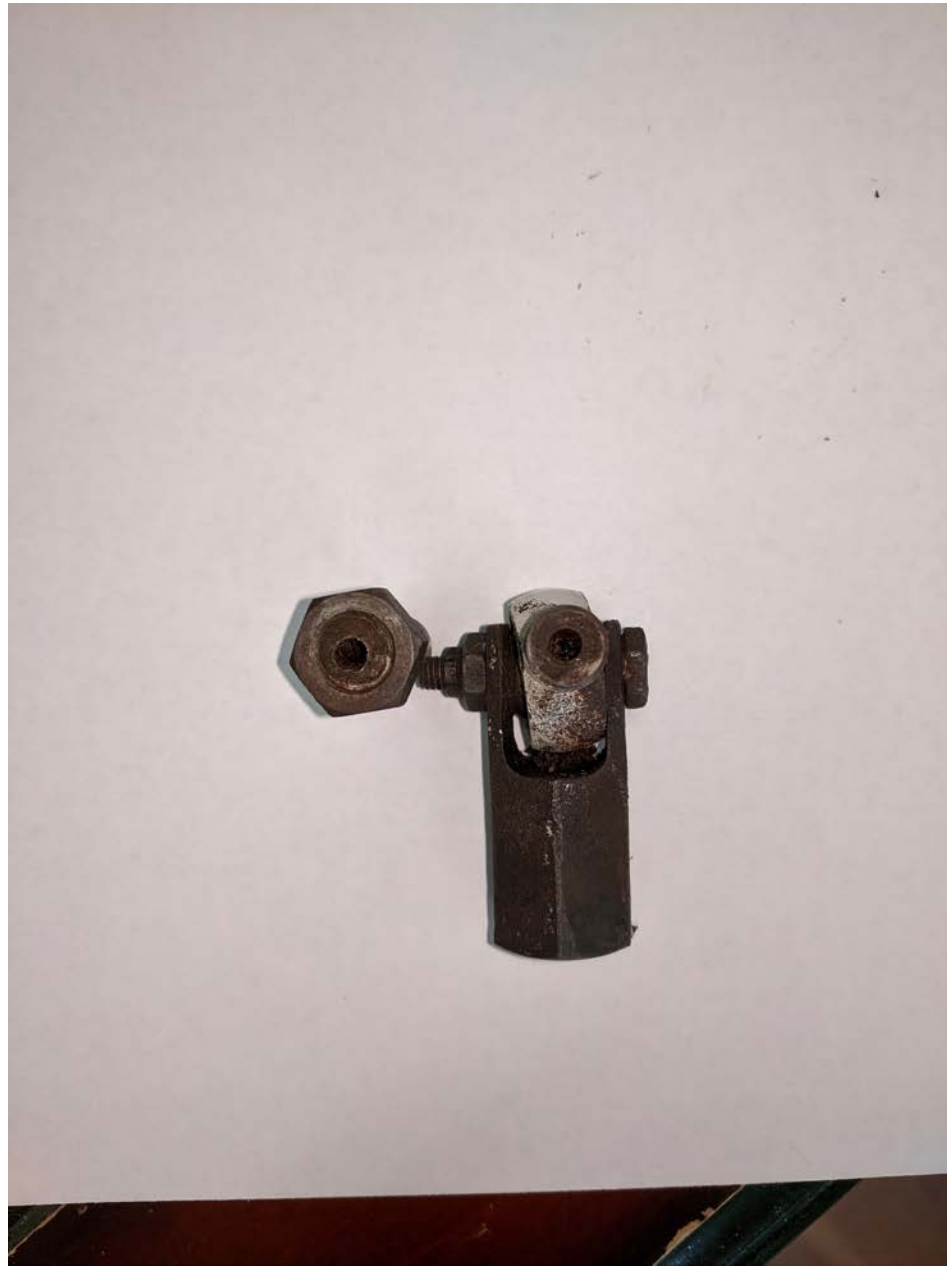
**Photo 4 – View of failed rod end threads showing rust**
