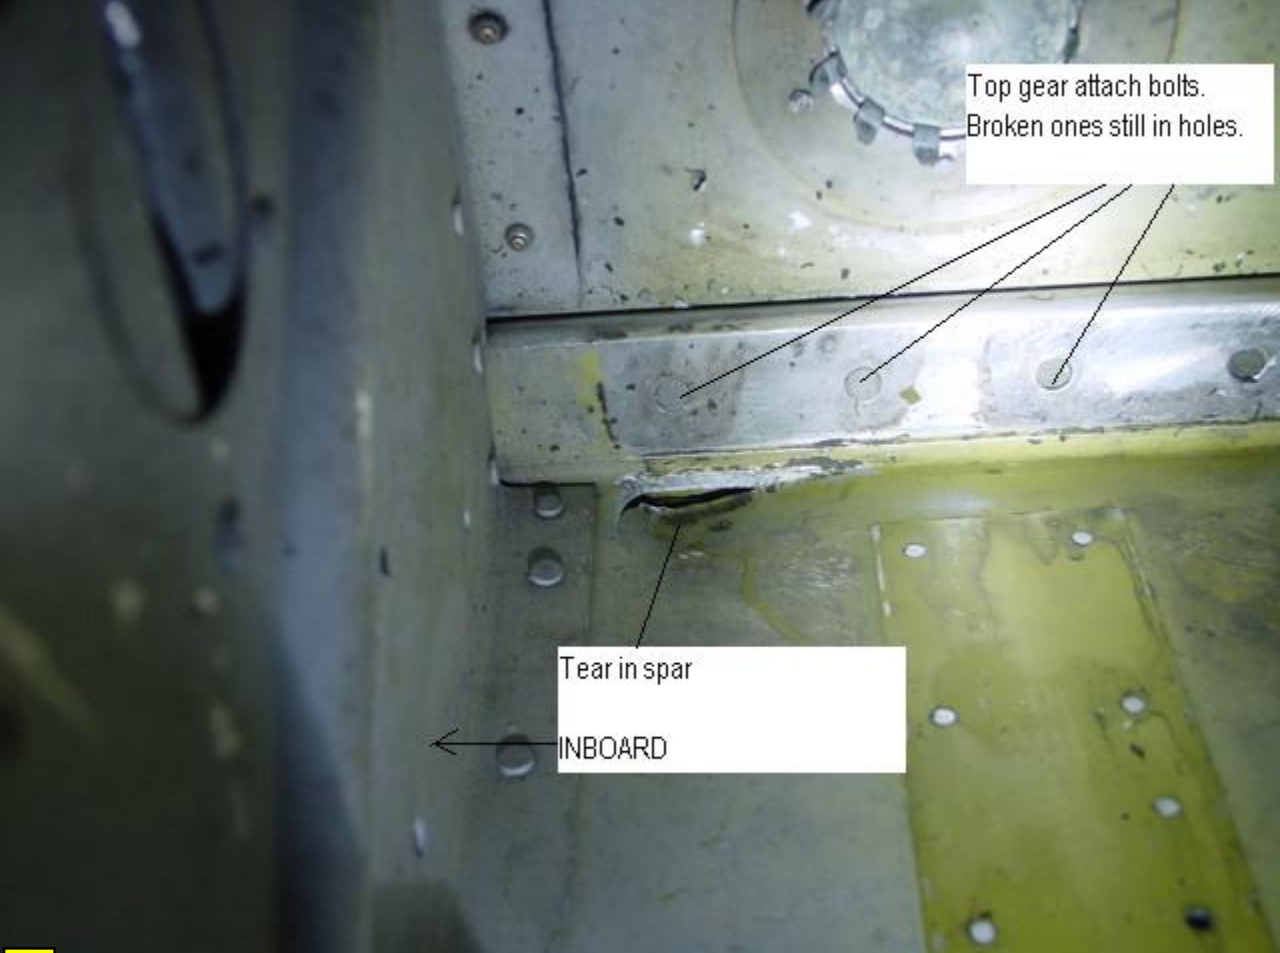
Photograph #2: Interior View of Right Wing (Courtesy of FAA)

Top gear attach bolts.
Broken ones still in holes.

Tear in spar

INBOARD
