Gate City - Services Layout

ACCIDENT NUMBER:

DCA 14MP001

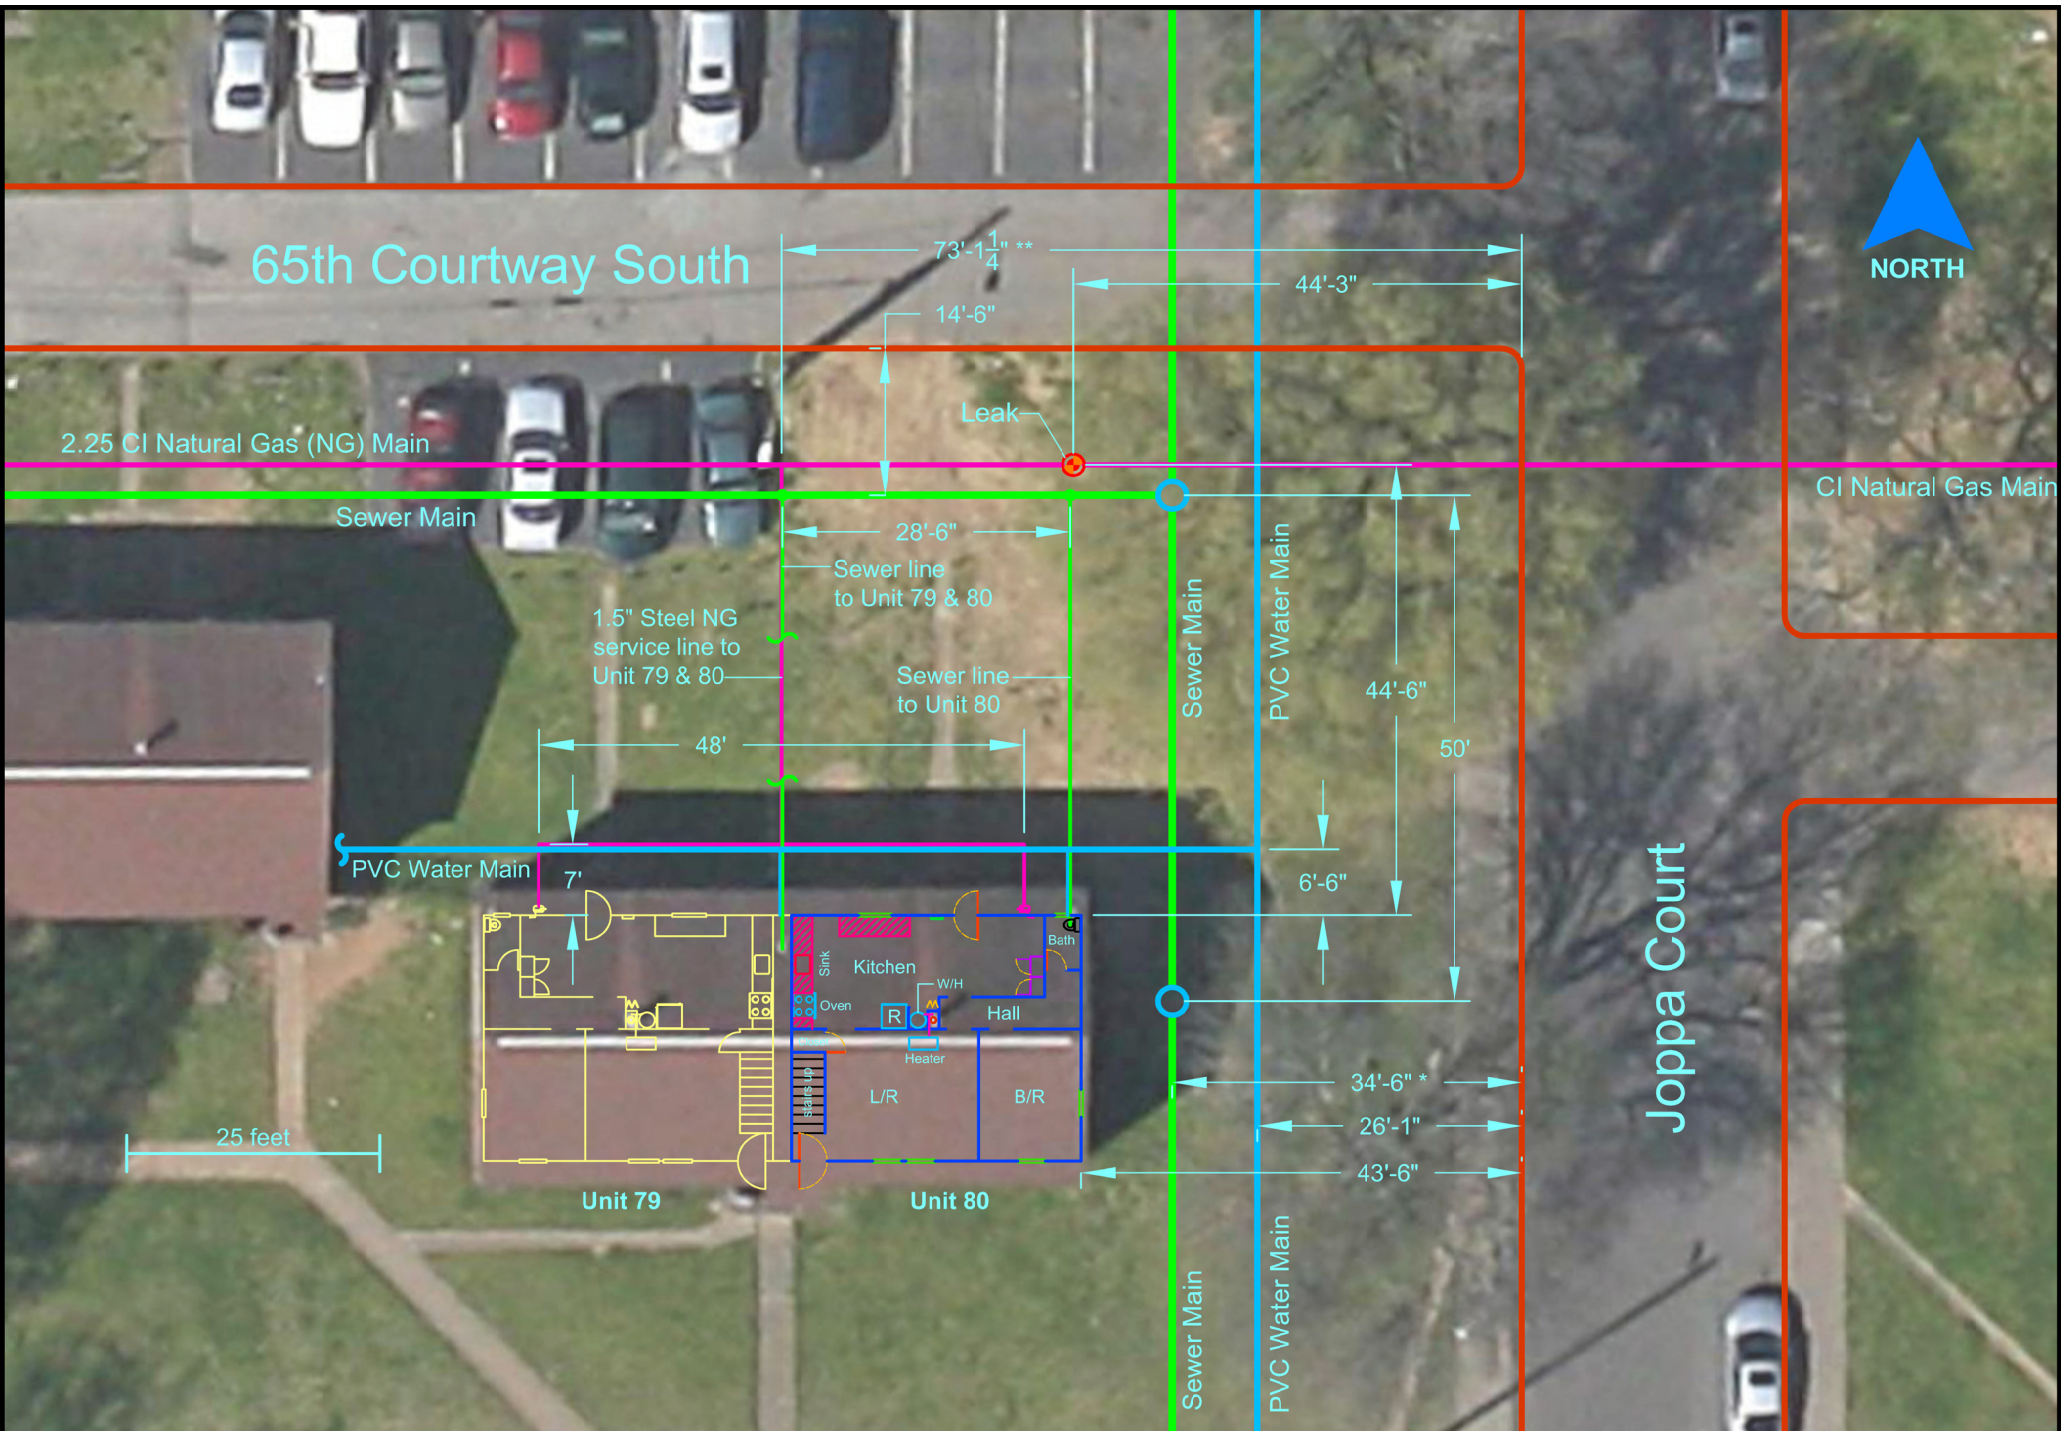
1. Apartment layout was aligned with satellite image at flue stack location

2. Dimensions were pulled from multiple field note sources

\* Dimension averaged from two sources (9'-9" relative to structure and 35'-3" from Joppa Ct.)

\*\* Estimated dimension - no measurement provided

R = refrigerator; W/H = Water Heater
