ERA17FA195

N21WW/Air America 303
June 3, 2017
San Juan, Puerto Rico

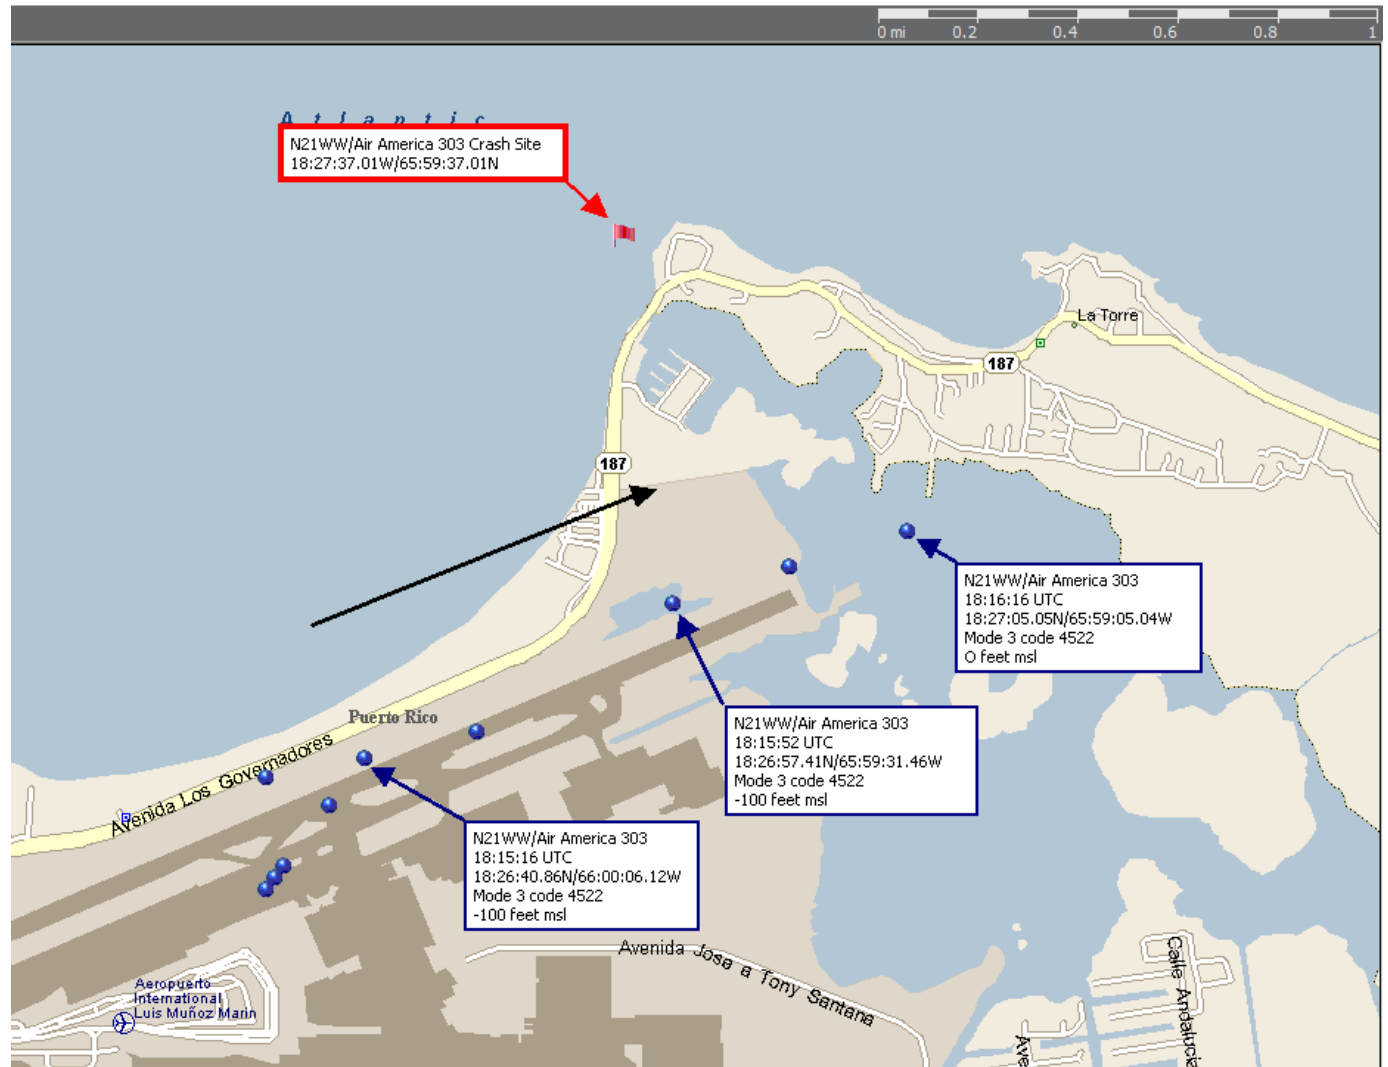
Radar flight track of N21WW/Air America 303 is indicated by blue dots.

Direction of flight is indicated by black arrows.

The crash site location is indicated by a red flag

Radar data was derived from the AN/FPS-67 long range general surveillance radar located at Pico del Este on Puerto Rico at 18:16:08.71N/065:45:32.29W

The airport surveillance radar at located at the Luis Munoz Marin International Airport (SJU) San Juan, Puerto Rico was out of service on the day of the accident.
