NTSB Investigation ERA15FA362  
N22721 – Cessna 150H  
Morrisville, New York  
September 20, 2015

ERA15FA362

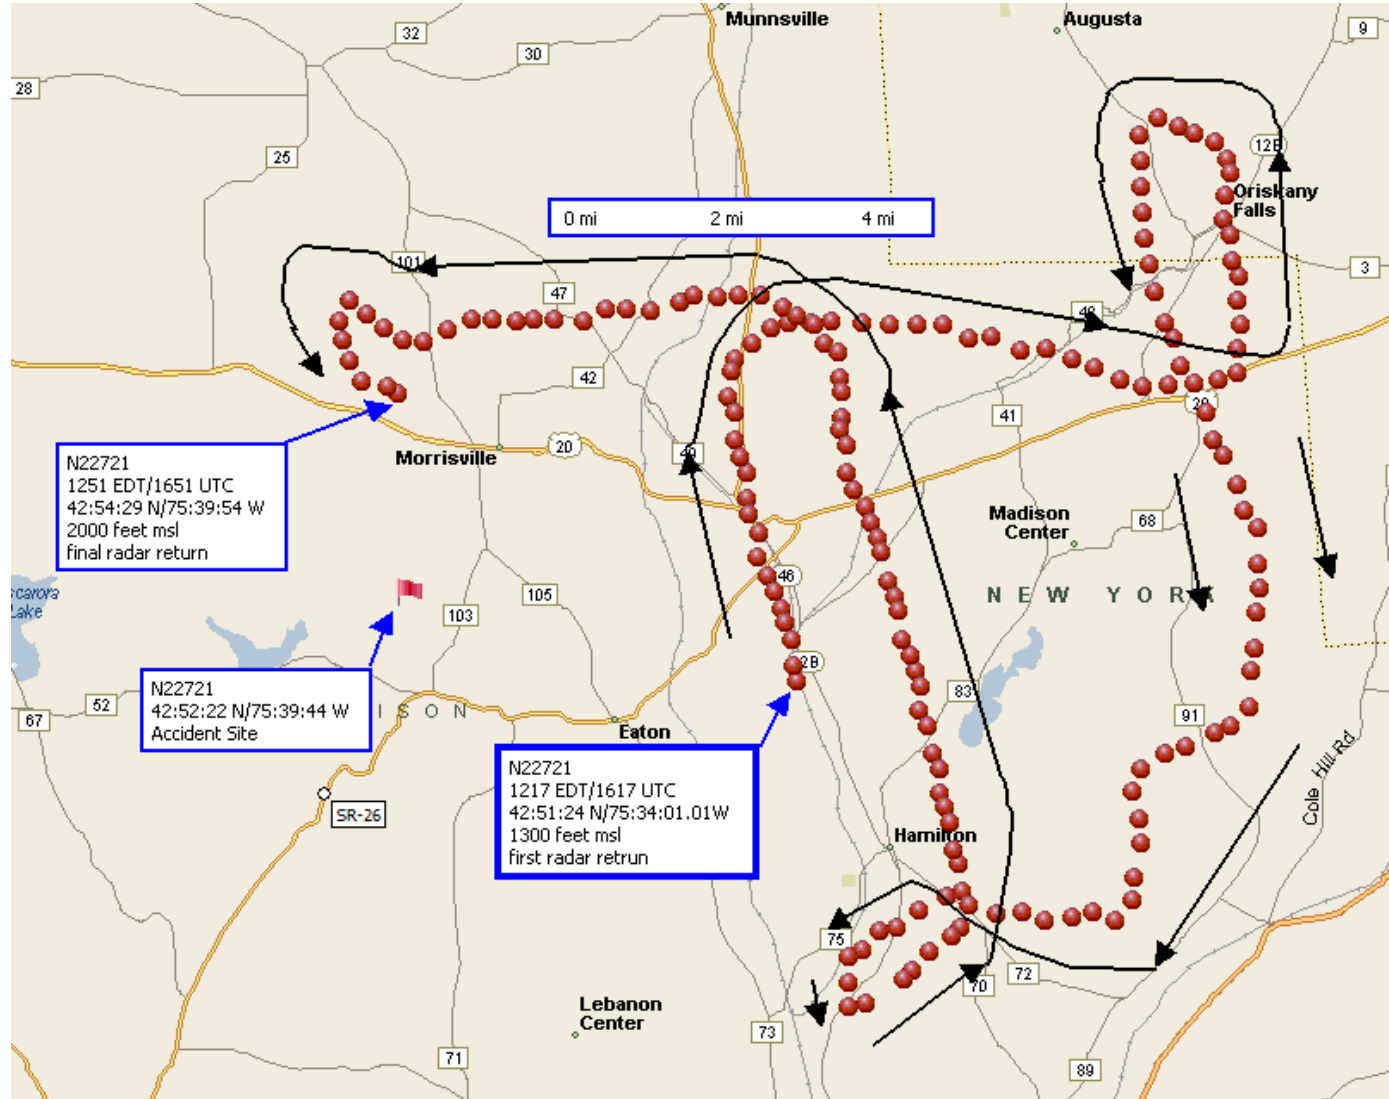
N22721  
September 20, 2015  
Morrisville, NY

The suspected radar flight track of N22721, a Cessna 150H, is indicated by red dots.

The direction of flight is indicated by black arrows.

The accident site is indicated by a red flag.

The radar data was derived from the Ramsen air route surveillance radar located at  
43:20:43.79N/75:14:56.37W  
in Utica, New York.

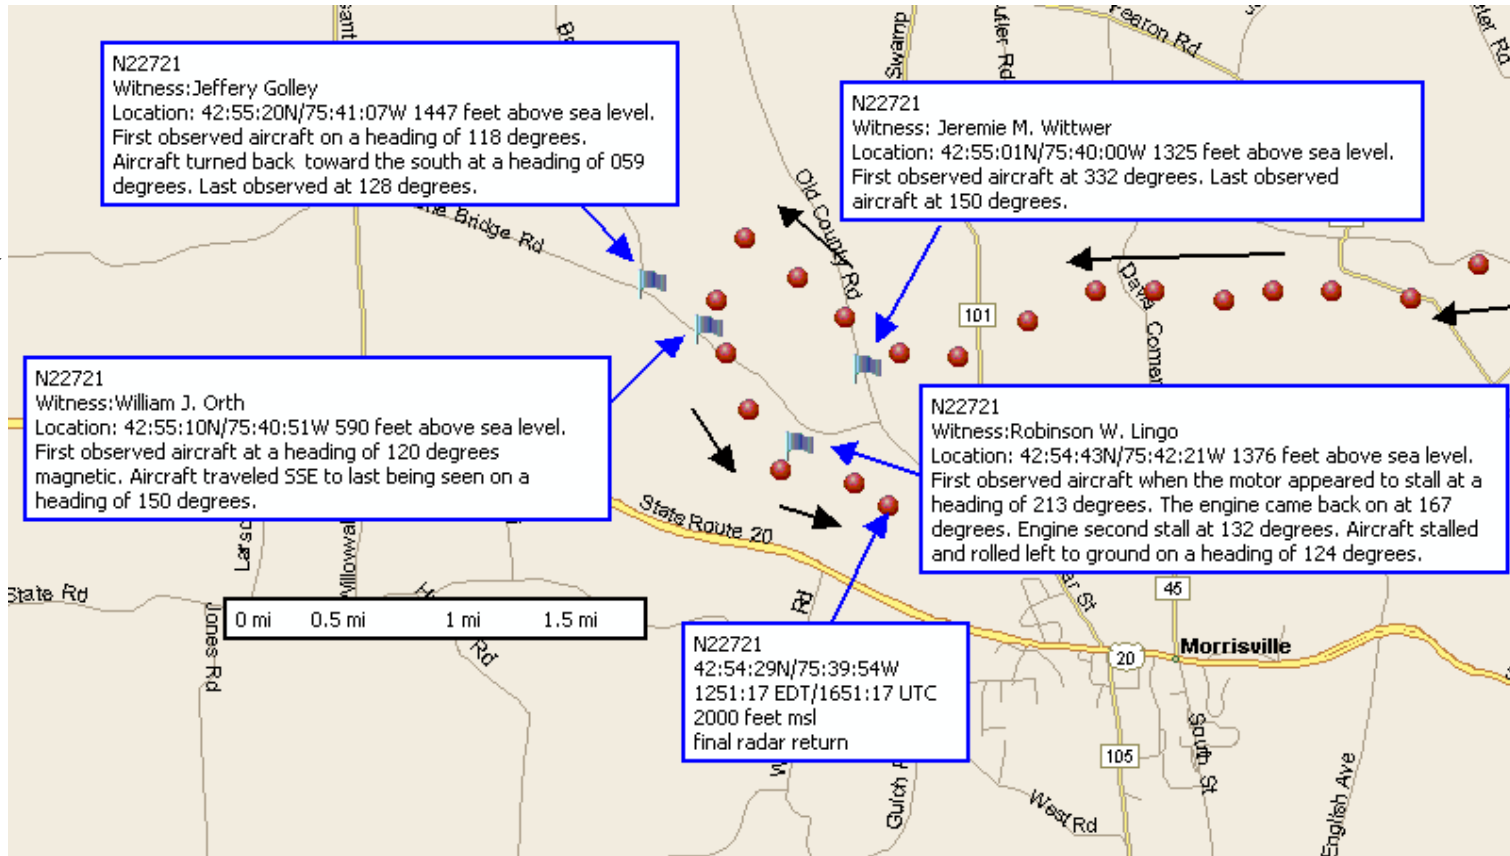
N22721  
September 20, 2015  
Morrisville, NY

The suspected radar flight track of N22721, a Cessna 150H, is indicated by red dots.

The direction of flight is indicated by black arrows.

The witness locations are indicated by blue flags.

The accident site is indicated by a red flag.

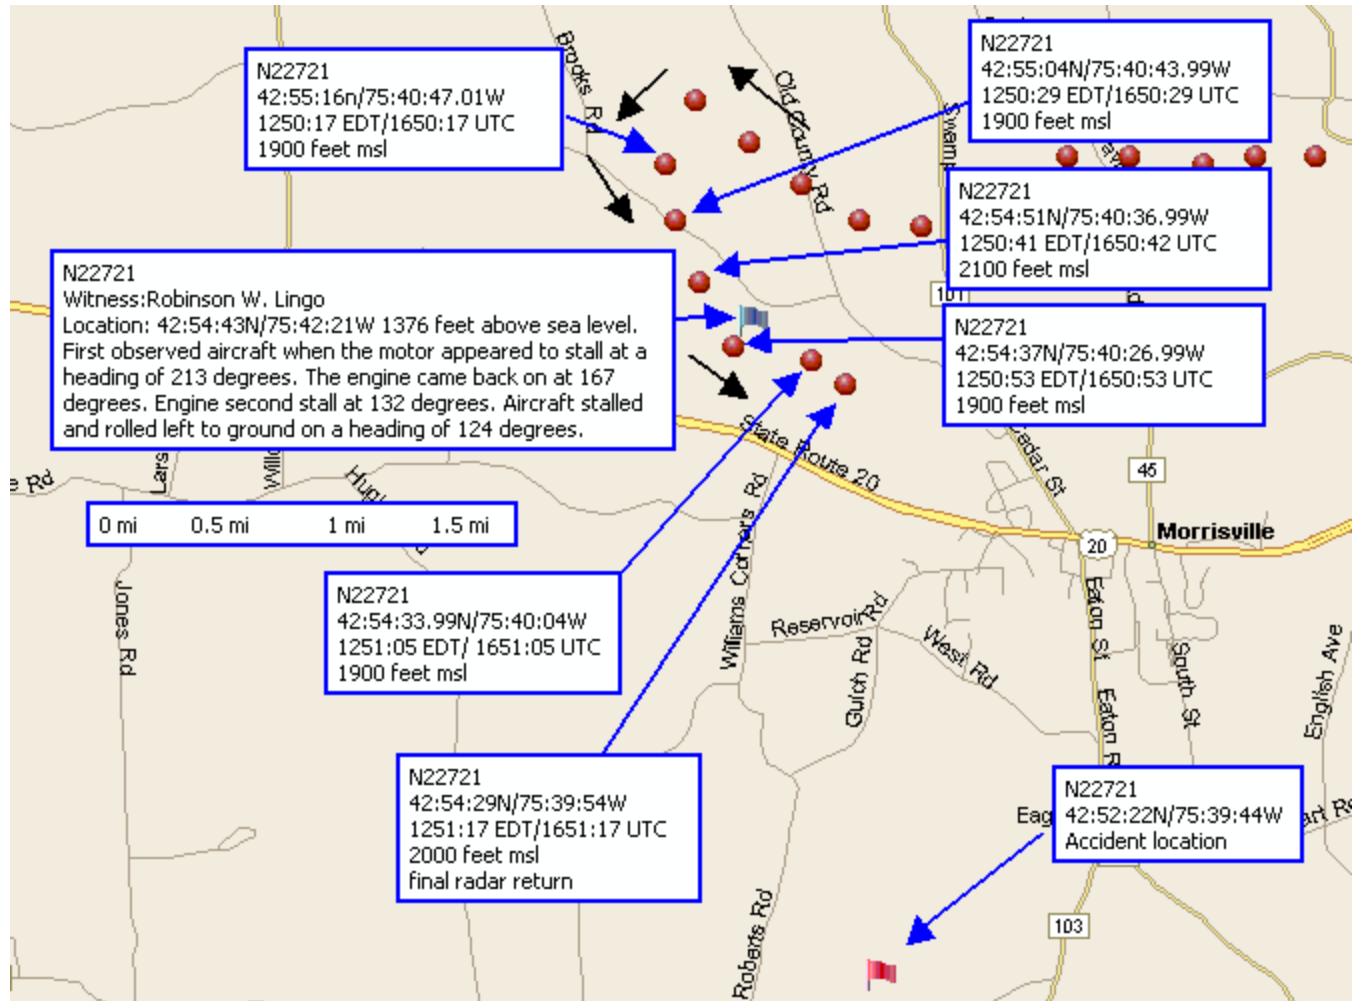
N22721  
September 20, 2015  
Morrisville, NY

The suspected radar flight track of N22721, a Cessna 150H, is indicated by red dots.

The direction of flight is indicated by black arrows.

The witness location is indicated by a blue flag.

The accident site is indicated by a red flag.

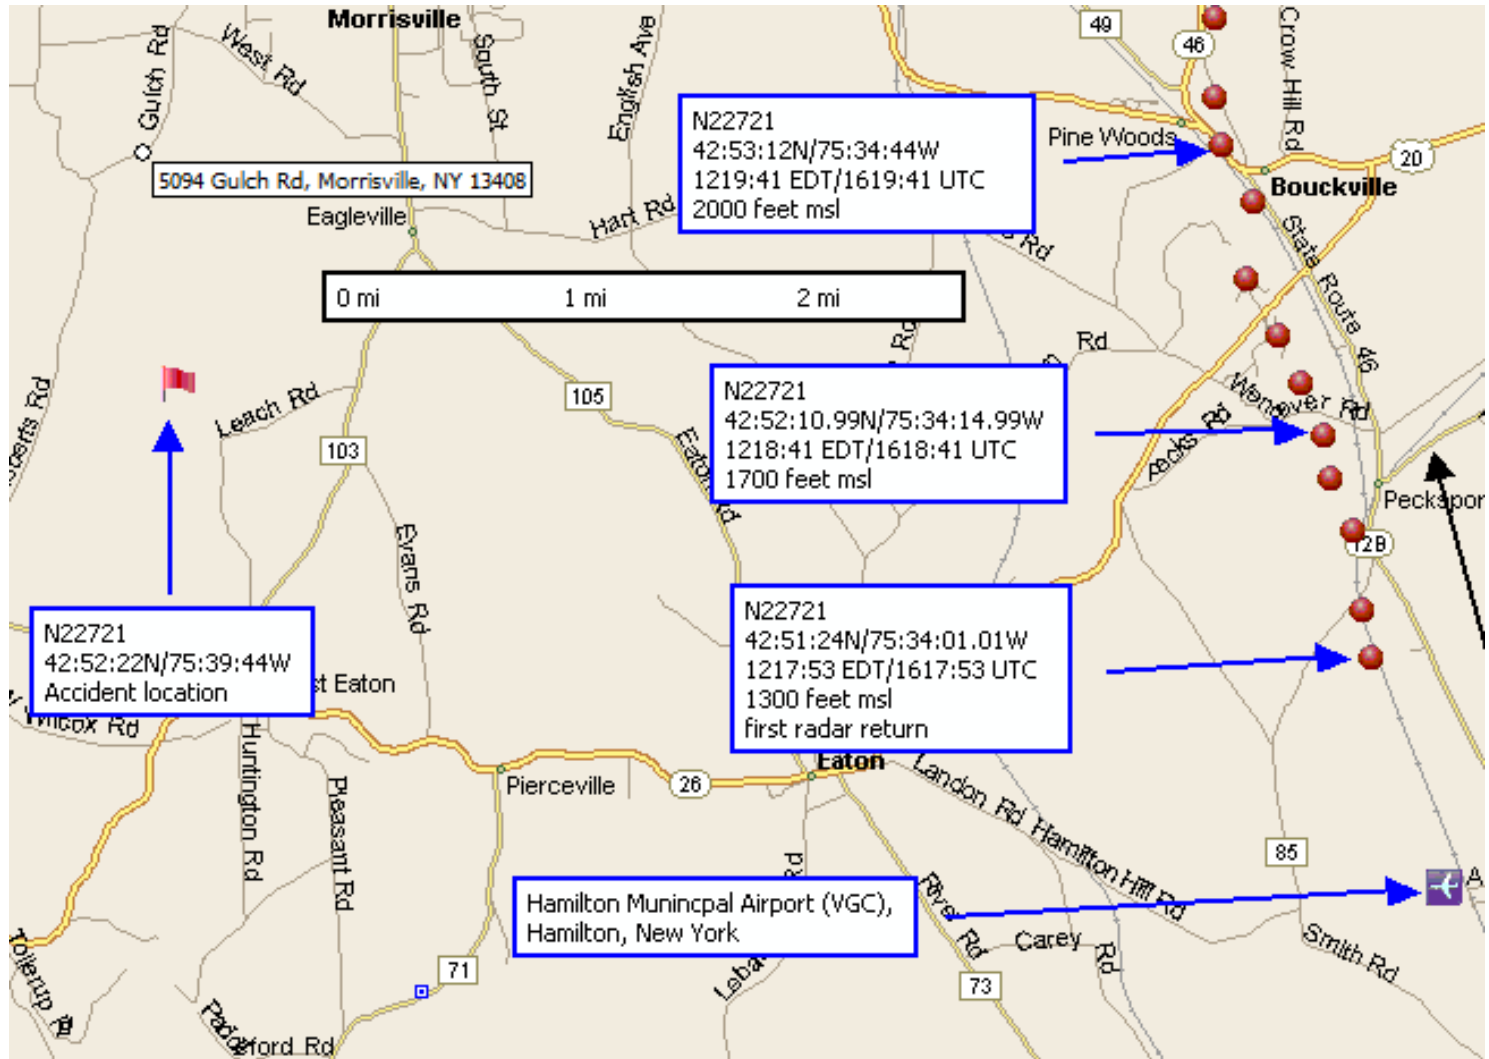
N22721  
September 20, 2015  
Morrisville, NY

The suspected radar flight track of N22721, a Cessna 150H, is indicated by red dots.

The direction of flight is indicated by black arrows.

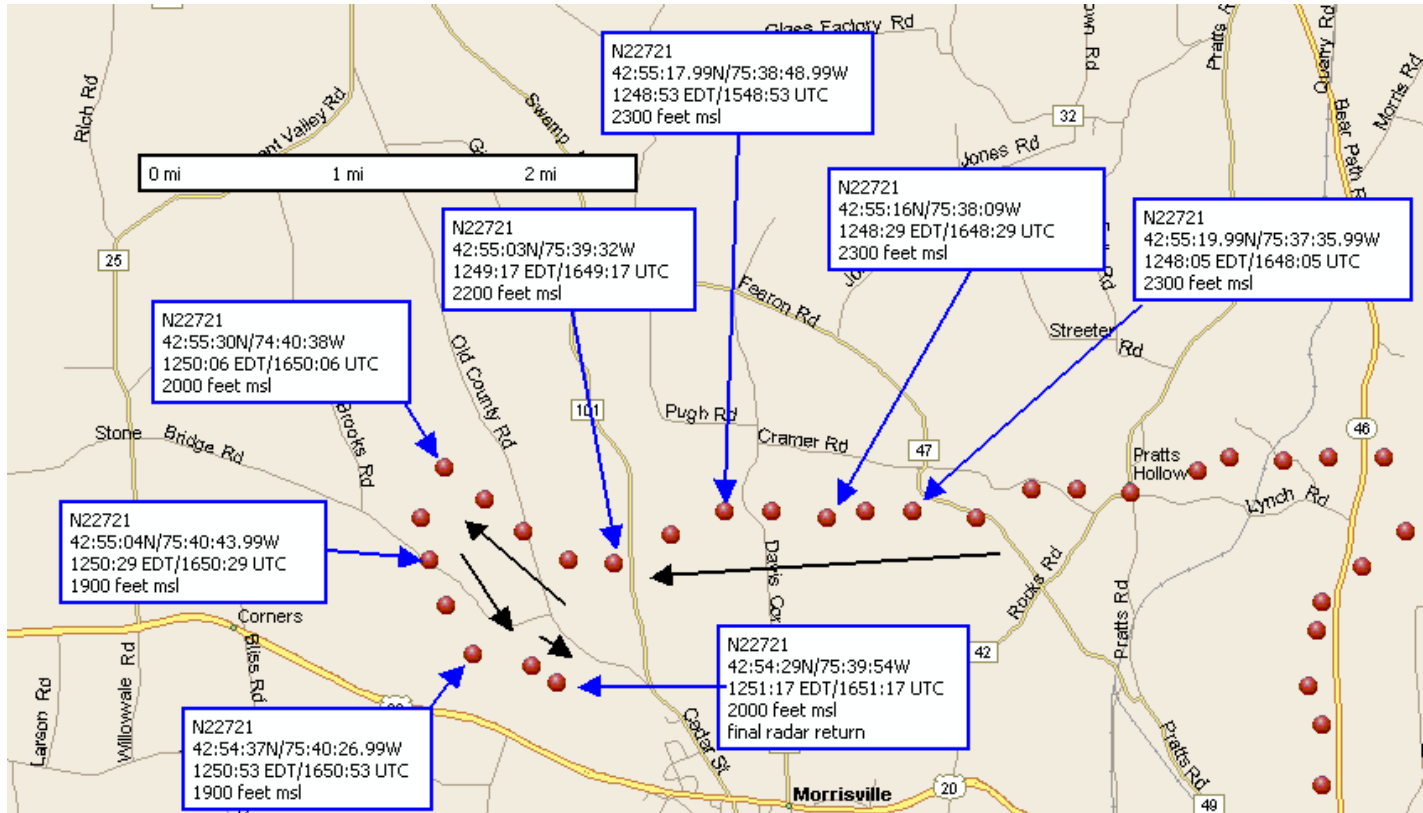
N22721  
 September 20, 2015  
 Morrisville, NY

The suspected radar flight track of N22721, a Cessna 150H, is indicated by red dots.

The direction of flight is indicated by black arrows.
