Review of 80-0689 Cockpit Display System Serial Number 0174

Overview of the 80-0689 Cockpit Display System:

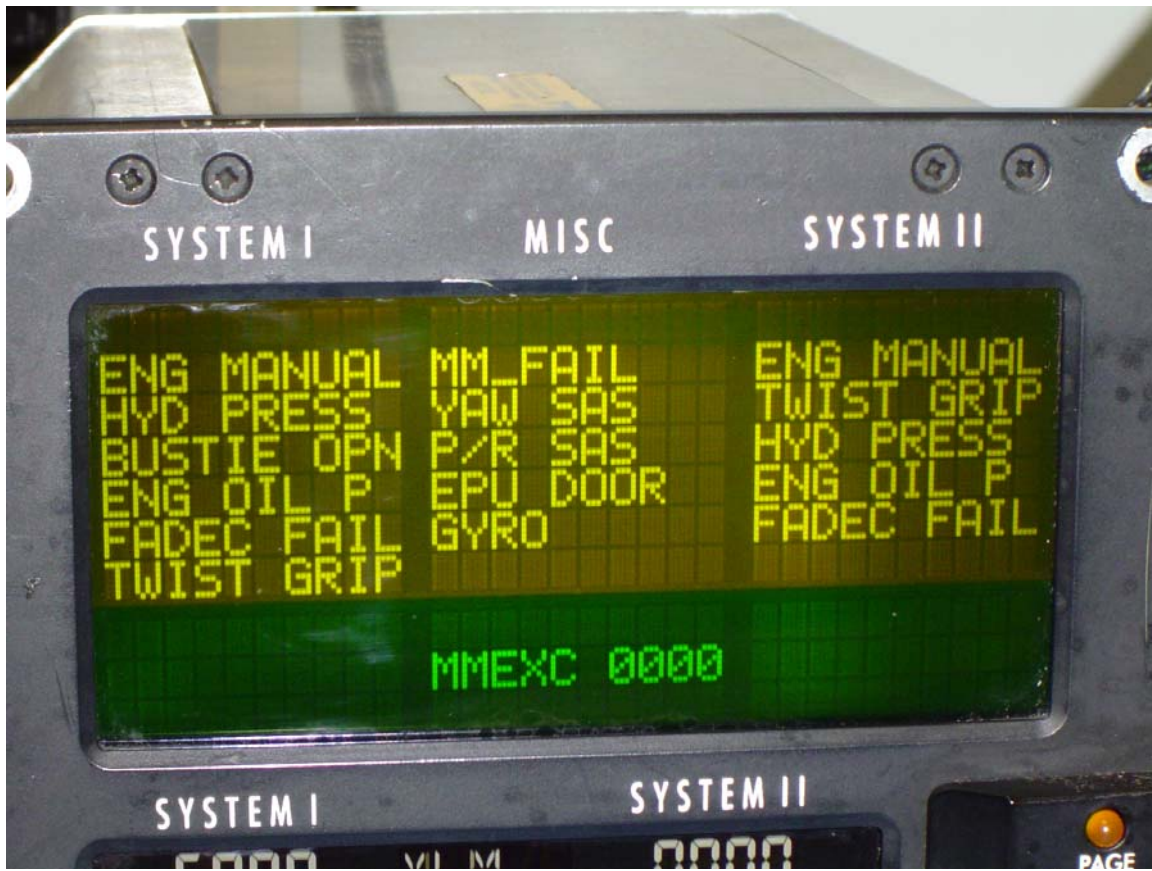
As can be seen above, the upper display reveals a number of cautions that were present during the last 60 seconds of operation. It is important to note the 60 second period is prior to both Systems I and II XMSN Oil Pressure failing or the CDS having had power removed, whichever ever occurred first.

The order the cautions appear on the screen is chronological from top to bottom, with the oldest caution on the top and the most recent caution on the bottom. This order is based on when the caution is received. If more than one caution is received in the same data packet, those cautions will be listed in bit order, which may differ from the true chronological order.

The MMEXC indication lists the number of occurrences where the MM Limit was exceeded.

The information found on the display, indicates that both engines were placed into Manual mode. There were then several other cautions recorded. The data appears to be valid for the last 60 seconds of recorded time, but there is no way to correlate that time span to the time of the impact.

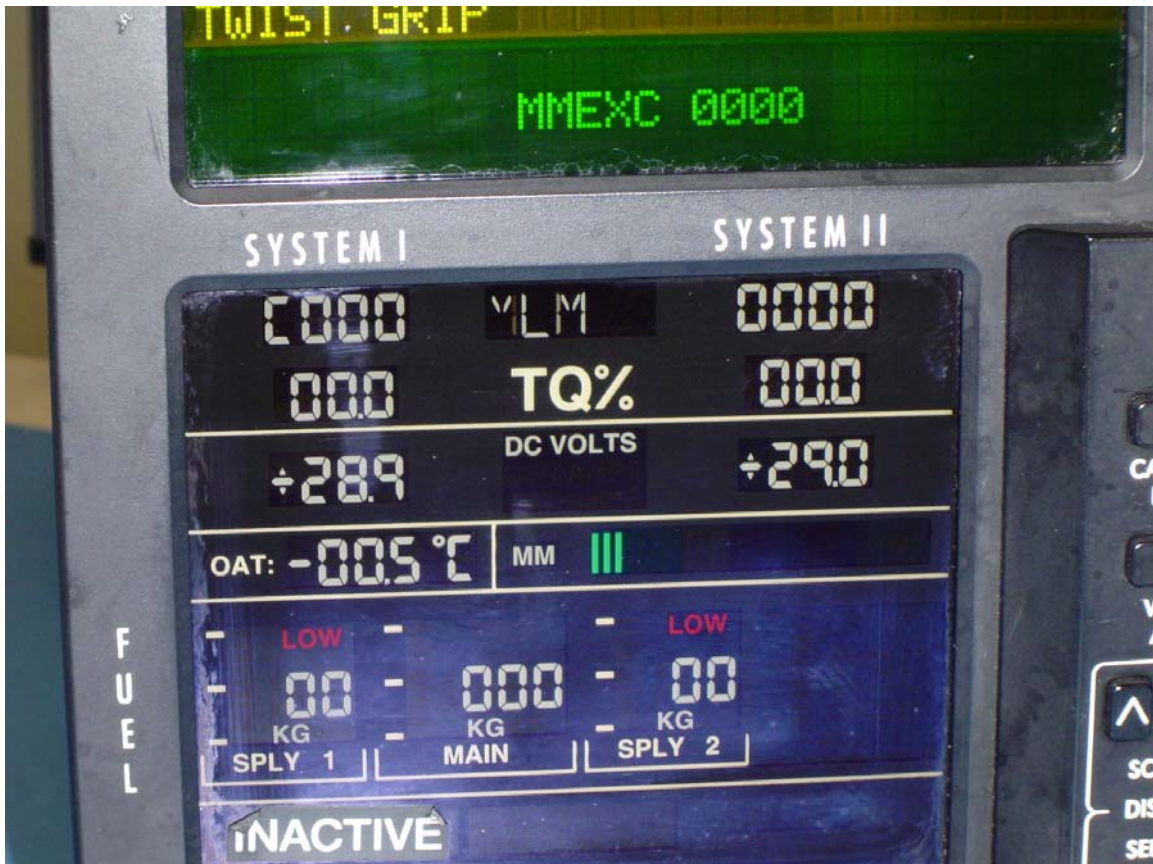
The top line of the lower display is used to review the FADEC failure codes. These are cycled through by pressing the Scroll Up/Down buttons. This unit did not have any recorded FADEC failure codes.
