# Stabilized Approaches Lead to Safe Landings

## The problem

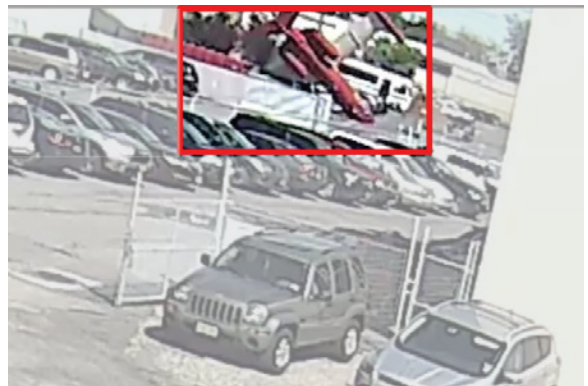
- A Learjet 35A airplane departed controlled flight while on a circling approach and impacted a commercial building and parking lot. The two pilots died. Because neither pilot realized that the airplane's navigation equipment had not been properly set for the instrument approach clearance they received, the flight crew improperly executed the vertical profile of the approach. When the crew initiated the circle-to-land maneuver, the airplane was so close to the airport that it could not be maneuvered to line up with the landing runway under the company's stabilized approach criteria. Neither pilot called for a go-around, and the pilot-in-command continued the approach by initiating a steep turn to align with the landing runway. Radar data indicated that the airplane's airspeed was below the approach speed dictated by company standard operating procedures (SOPs). During the turn, the

airplane stalled and crashed about 1/2 nautical mile south of the landing runway threshold. ([CEN17MA183](#))

Security video image of the accident airplane at ground impact ([CEN17MA183](#)).

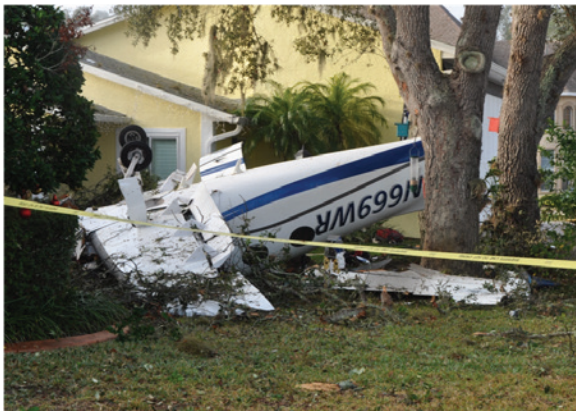
- An experimental, amateur-built Epic LT airplane sustained substantial damage when it impacted terrain during an instrument approach. The private pilot and passenger were fatally injured. Based on radar information and witness statements, the airplane's approach to the airport was unstabilized; the airplane was far left of the runway centerline and had descended below the minimum descent altitude of 440 ft. After breaking through fog about 100 ft above ground level, the airplane reentered the fog and completed a 360° right turn near the approach end of the runway, during which its altitude varied from 100 ft to 300 ft. The airplane then climbed to about 800 ft before radar contact was lost. The airplane stalled and came to rest inverted, consistent with one witness's statement that it descended through the clouds in a spin before impact. (ERA17FA074)

Postcrash photograph of Epic LT airplane (ERA17FA074).

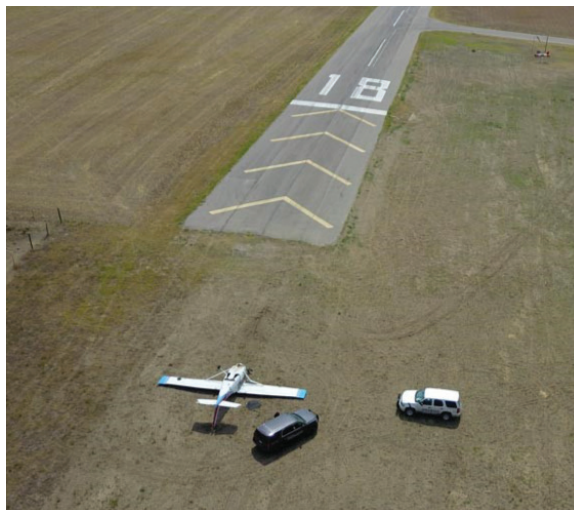
- A Cessna 210 airplane sustained substantial damage during a runway excursion. The pilot reported that he "didn't get the flaps down" before landing. He further reported that the airplane "didn't want to stop" and it then "ran off the runway." During the runway excursion, the nosewheel collapsed, and the airplane nosed over. A witness reported that the airplane was "high, fast, and downwind." (GAA17CA531)

Overhead view of Cessna 210 and runway (GAA17CA531).
