**NATIONAL TRANSPORTATION SAFETY BOARD**  
Vehicle Recorder Division  
Washington, D.C. 20594

## **17 - Video Factual Report**

**Specialist's Factual Report  
by Bill Tuccio, Ph.D.**

Location: Eden Prairie, Minnesota  
Date: August 5, 2013  
Aircraft: Embraer S.A. EMB-505, N327FL  
Operator: Flight Options, Flight 327  
NTSB Number: CEN13LA462

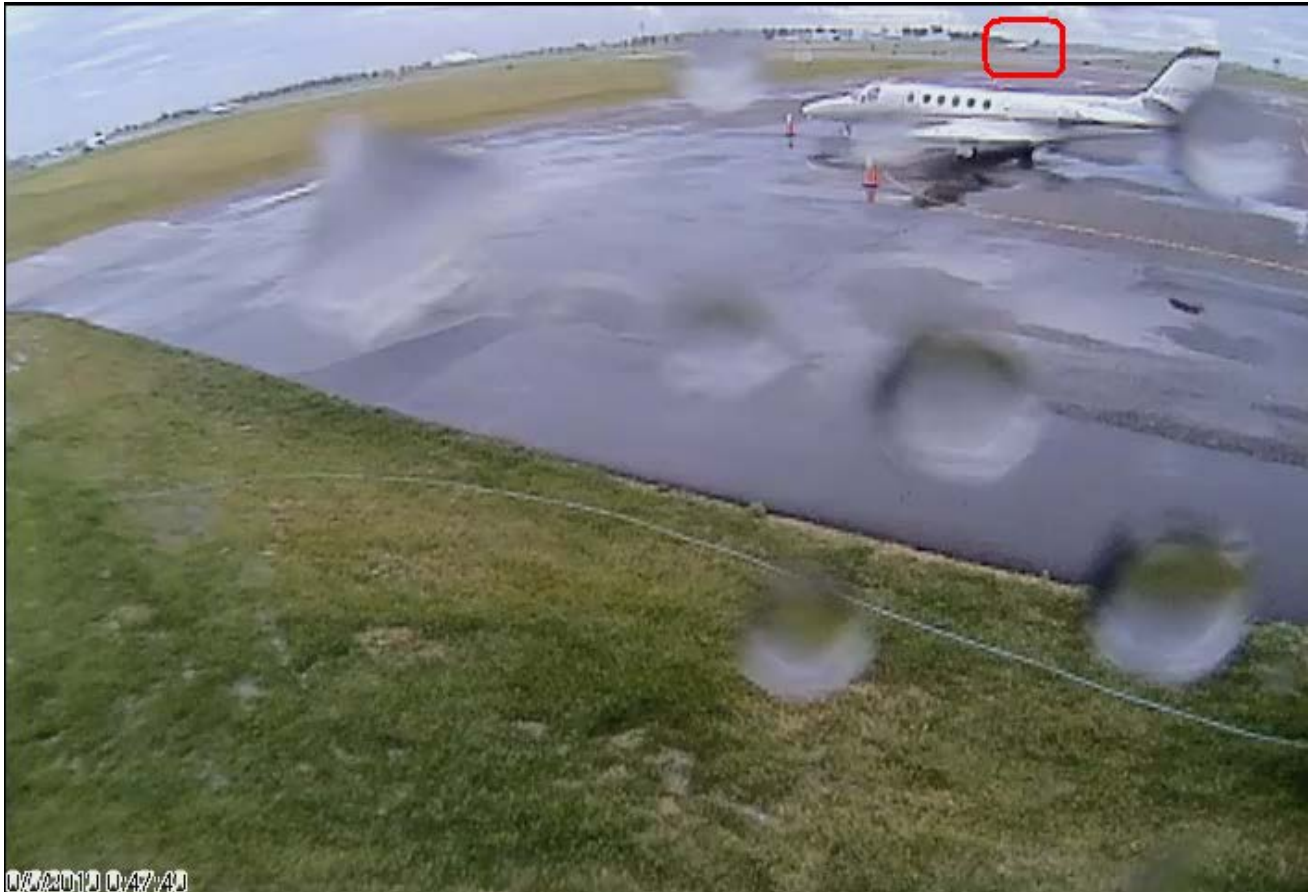
Figure 1. Video frame at 8:47:43.

Figure 1 shows a video frame capture at 8:47:43, with the aforementioned aircraft annotated in red moving from right to left. The FBO ramp is damp, with pools of standing water.

The FBO security video was oriented generally towards the south, as shown in figure 1. A timestamp was in the lower left of the video with a date of 8/5/2013. According to the unverified timestamp, an aircraft entered the right field of view of the video at 8:47:41<sup>1</sup>. The aircraft continued across the field of view, from right to left. Motion was no longer visible once the aircraft approached the far left field of view of the video recording at about 8:48:09.
