UPPER SKIN PANEL - WING CENTER TANK

CENTER SECTION UPPER STRINGERS # 2, 3, 4, & 9  
 VIEW LOOKING FWD AND DOWN

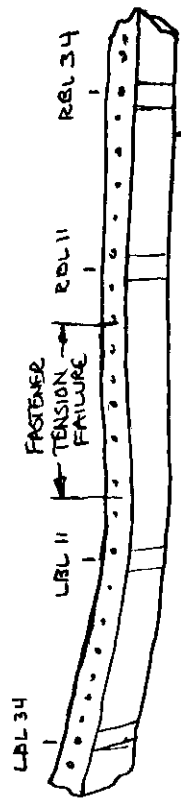
These are four portions of stringers of various lengths that are separate from the skin panel. CW-116 is a portion of S-2. CW-117 is a portion of S-3. CW-118 is a portion of S-4. CW-119 is a portion of S-9. The fasteners remaining in the stringers generally exhibit shear failures except in those areas indicated on the sketch.

STRINGER #9  
 CW-119 C-2167  
 HEAVY SOOT ON ENTIRE PART  
 LBL 38 END HEAVILY BURNED

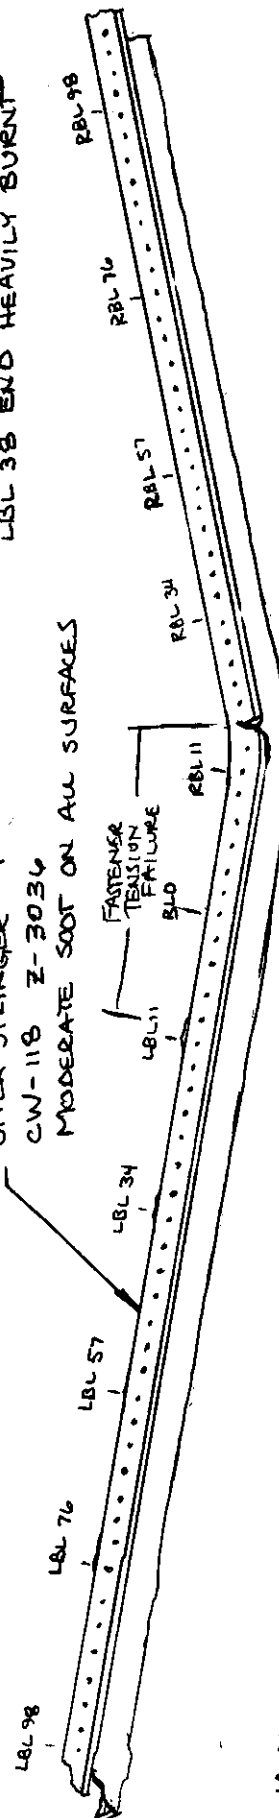
UPPER STRINGER #4  
 CW-118 Z-3034  
 MODERATE SOOT ON ALL SURFACES

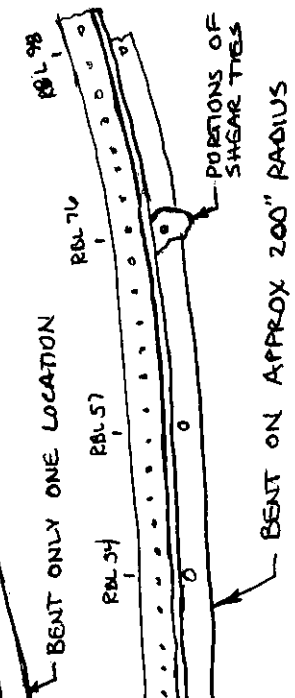
UPPER STRINGER #3  
 CW-117 Z-3035  
 LIGHT SOOT EXCEPT AS NOTED

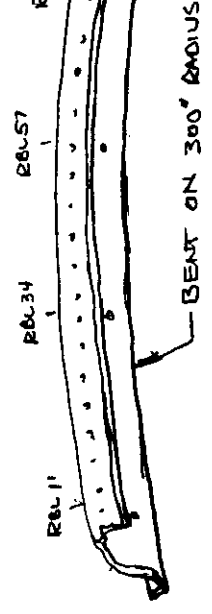
STRINGER #2  
 CW-116 C-2166  
 HEAVY SOOT
