CW 248  
 Lot # 2-13-97-112  
 Dredged Z-4085

Wing Center Section  
 Lower skin segment  
 RBL 3 to 13 At Mid Spar

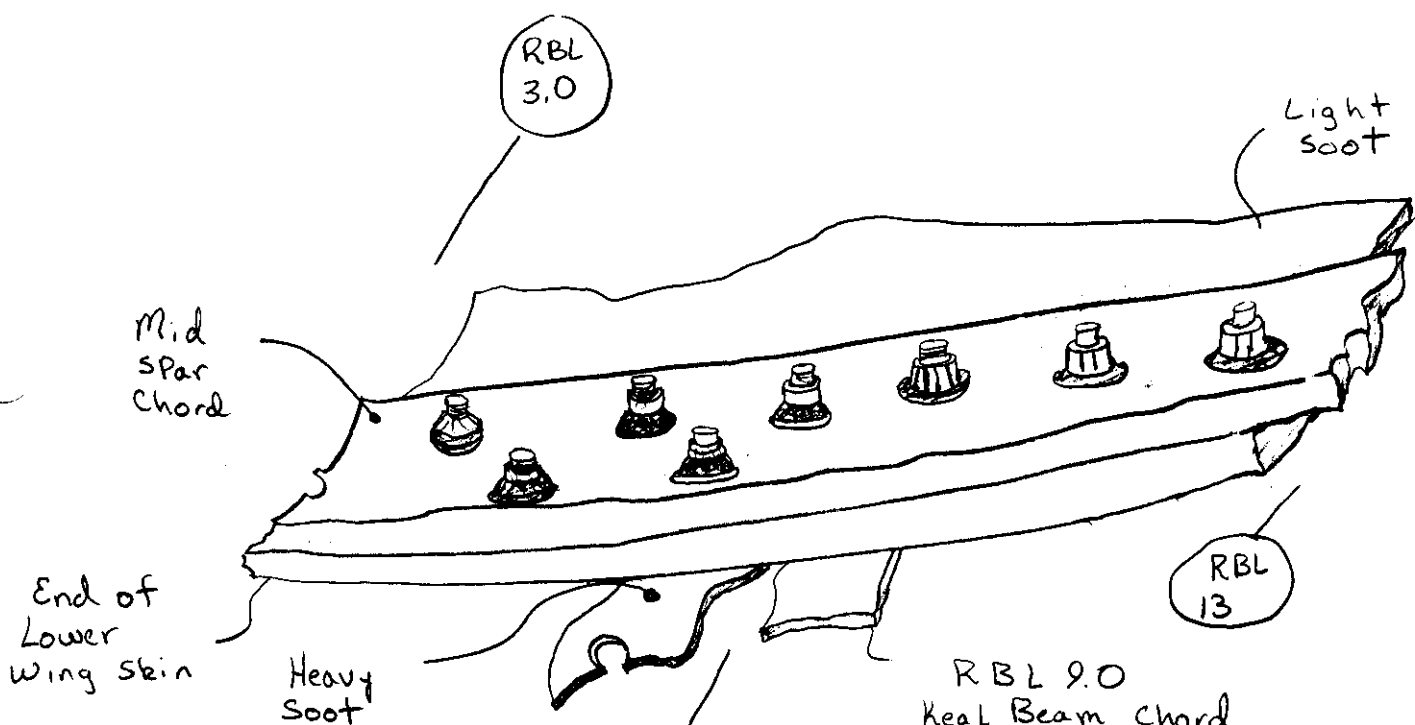
- Mates to all surrounding surfaces
- Light Areas of Soot on inside Surface
- Heavy Soot on exterior surface.
- Soot on exterior surface of skin in the area that the RBL 9.0 Keel Beam Chord would normally Cover
- Fracture Surfaces are either sooted or oxidized
- No slow growth fracture surfaces
