SIDE OF BODY RIB - RIGHT WING - WING CENTER TANK

CW-309

Z-2727

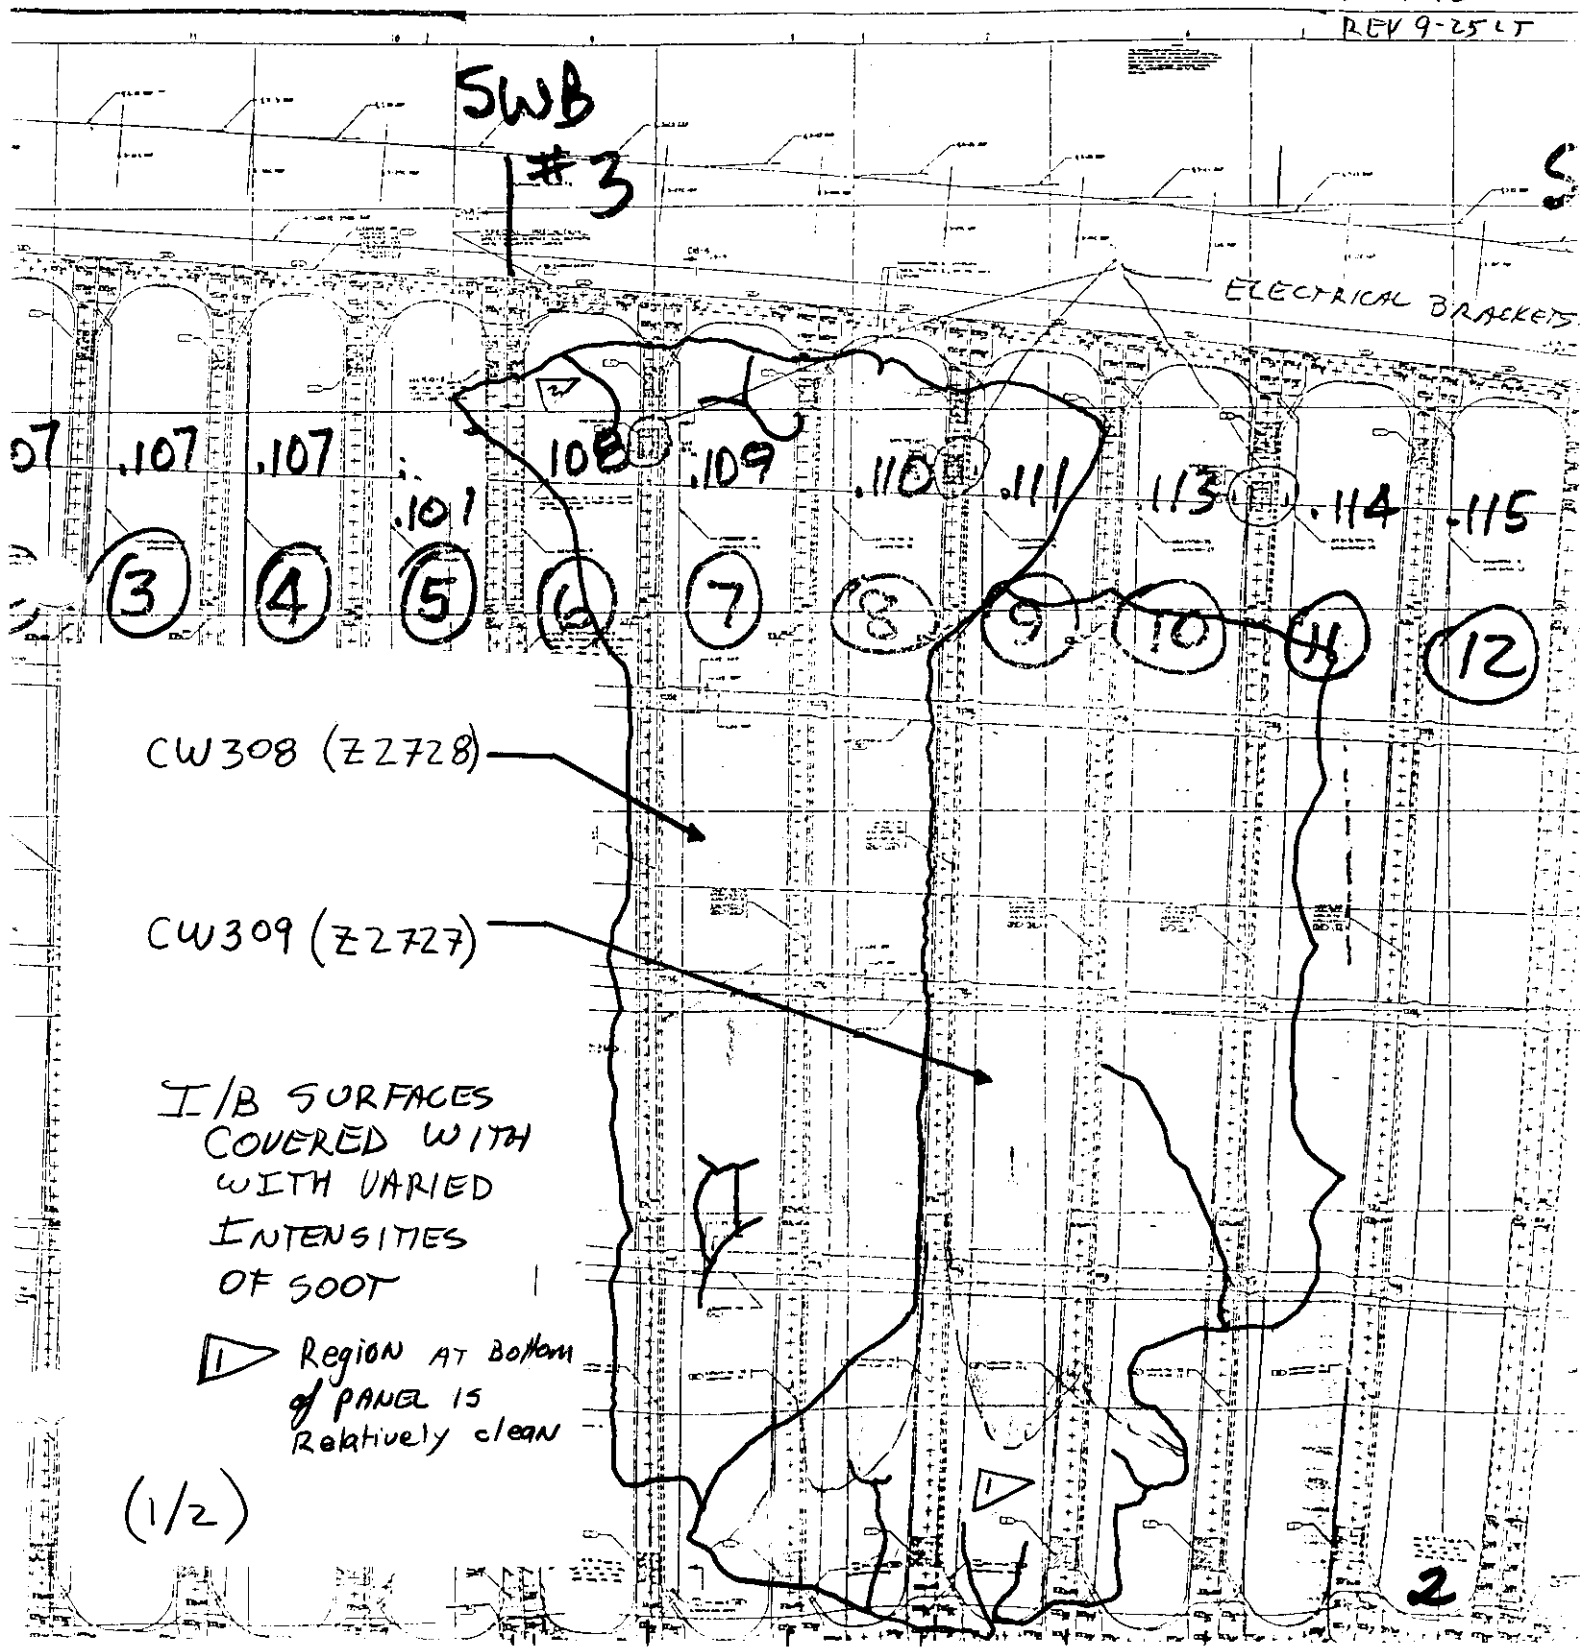
SIDE OF BODY RIB- RIGHT SIDE
(9-22-96-1) CW309 (Z2727) } GREEN
CW308 (Z2728) } TAG

This segment is a 17" x 47" portion of side of body rib web. The aft edge of this segment is located 14" fwd of SWB #2. The fwd side of this segment has a mating fracture with CW-308. There are no stiffeners that remain attached.

The section has a small curvature fore/aft with web fractures and local bending on the lower edge. See the following sketch for complete description.

This part is sooted on the inbd side. See the fire and explosion group notes for complete documentation.

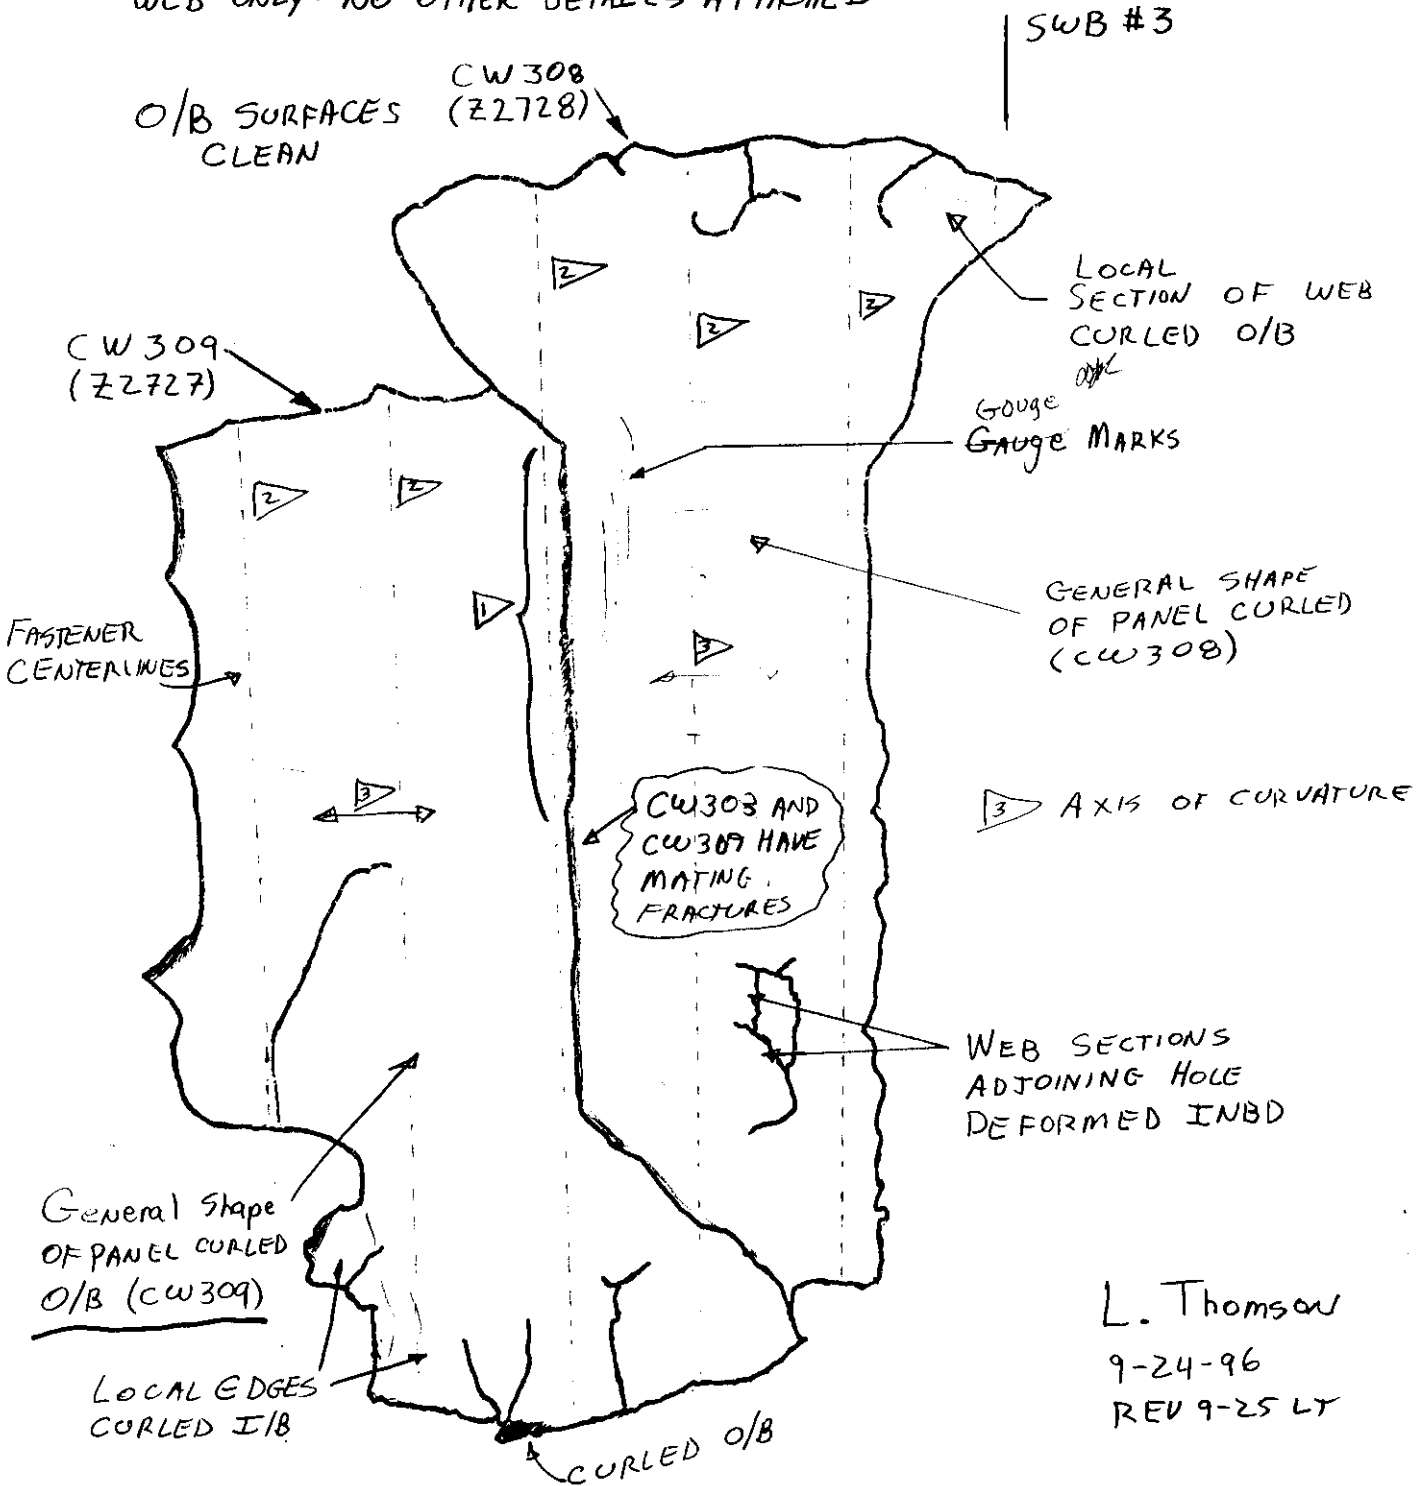
SIDE OF BODY RIB - RIGHT SIDE
 VIEW OF O/B SURFACE
 WEB ONLY - NO OTHER DETAILS ATTACHED

FRACTURE FACES (ALL LOCATIONS) - FREE OF SOOT

1 ▷ FASTENERS THIS REGION MISSING - REMAINING HOLE SHAPES ROUND WITH CLEAN EDGES

(2/2) 2 ▷ FASTENERS FRACTURED FLUSH WITH RIB SURFACE. SOME FASTENER FRACTURES ARE ANGLED AND PROTRUDE BEYOND RIB SURFACE.
