SIDE OF BODY RIB - RIGHT WING - WING CENTER TANK

CW-330	CW-331	CW-332
Z 4001	Z 4002	Z 4003
GREEN	GREEN	GREEN

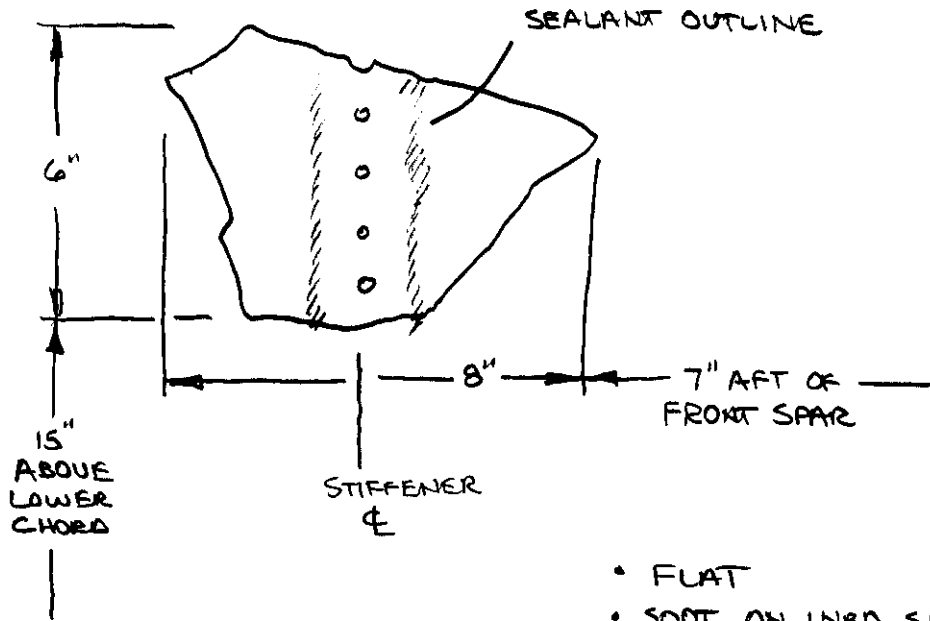
CW-330
#4001
GREEN

These are all portions of side of body rib ^{SDS} ~~rib~~ that have no stiffeners attached. See the attached sketch for periphery definition and location. The parts are generally flat and there is no evidence of fatigue.

There is soot on CW-332 and CW-330. See the fire and explosion group notes for complete documentation.

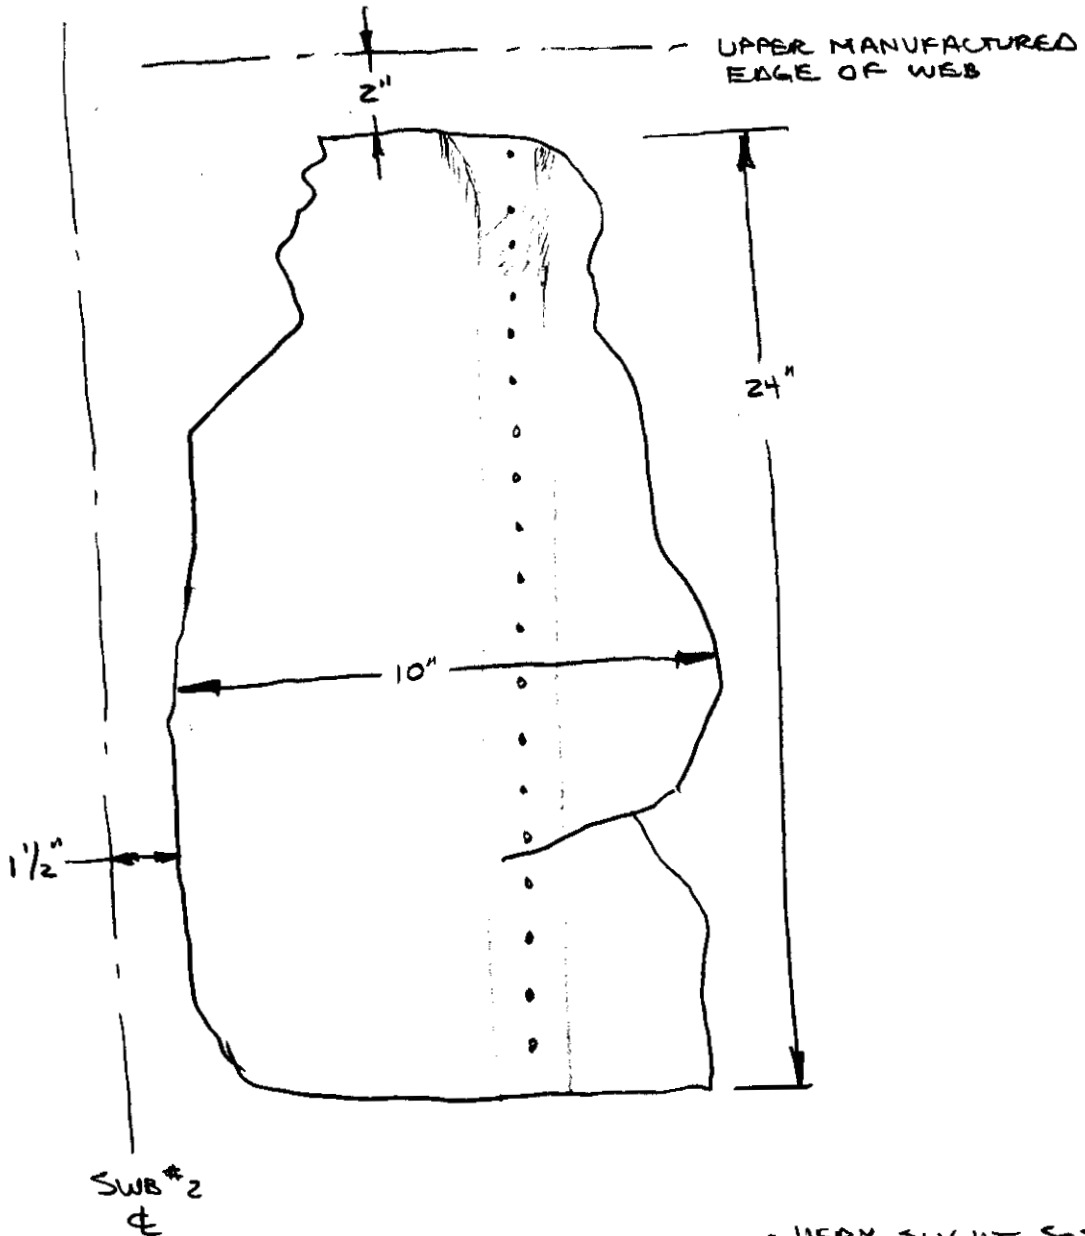
CW-332
E4003
GREEN

- VERY SLIGHT S-SHAPE
- LIGHT SOOT INBO SIDE
