CW 523
Lot # 11-20-96-82
Dredged Red Debris field
X-4021

Wing Center Section front spar upper chord segment
RBL / 08

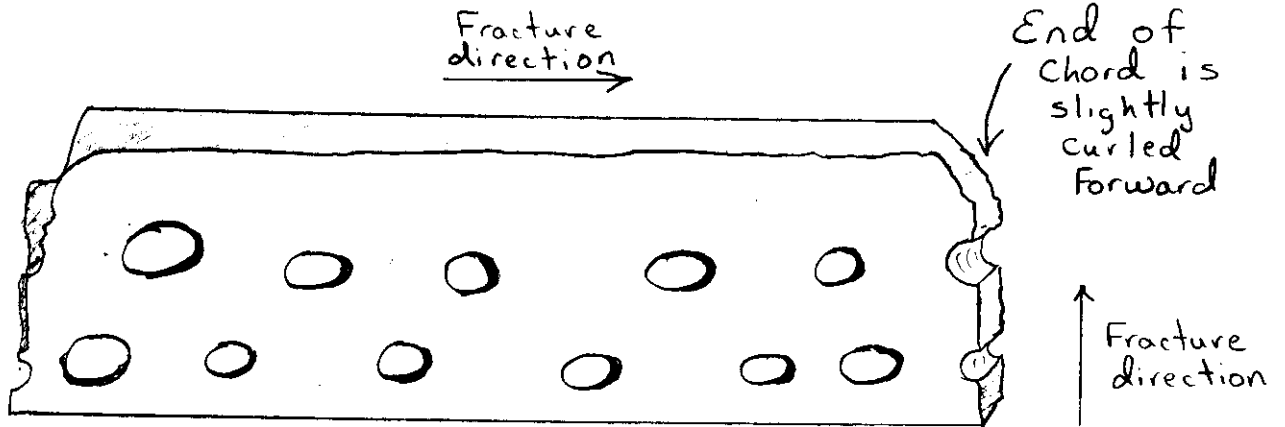
UP
Inbd ←

View Looking Forward

- ALL fasteners common to front spar web are sheared off and show the chord segment, relative to the web, moved outboard.
- Either dirty or has a light layer of soot; more so on the inside surface
- No evidence of slow growth fractures.

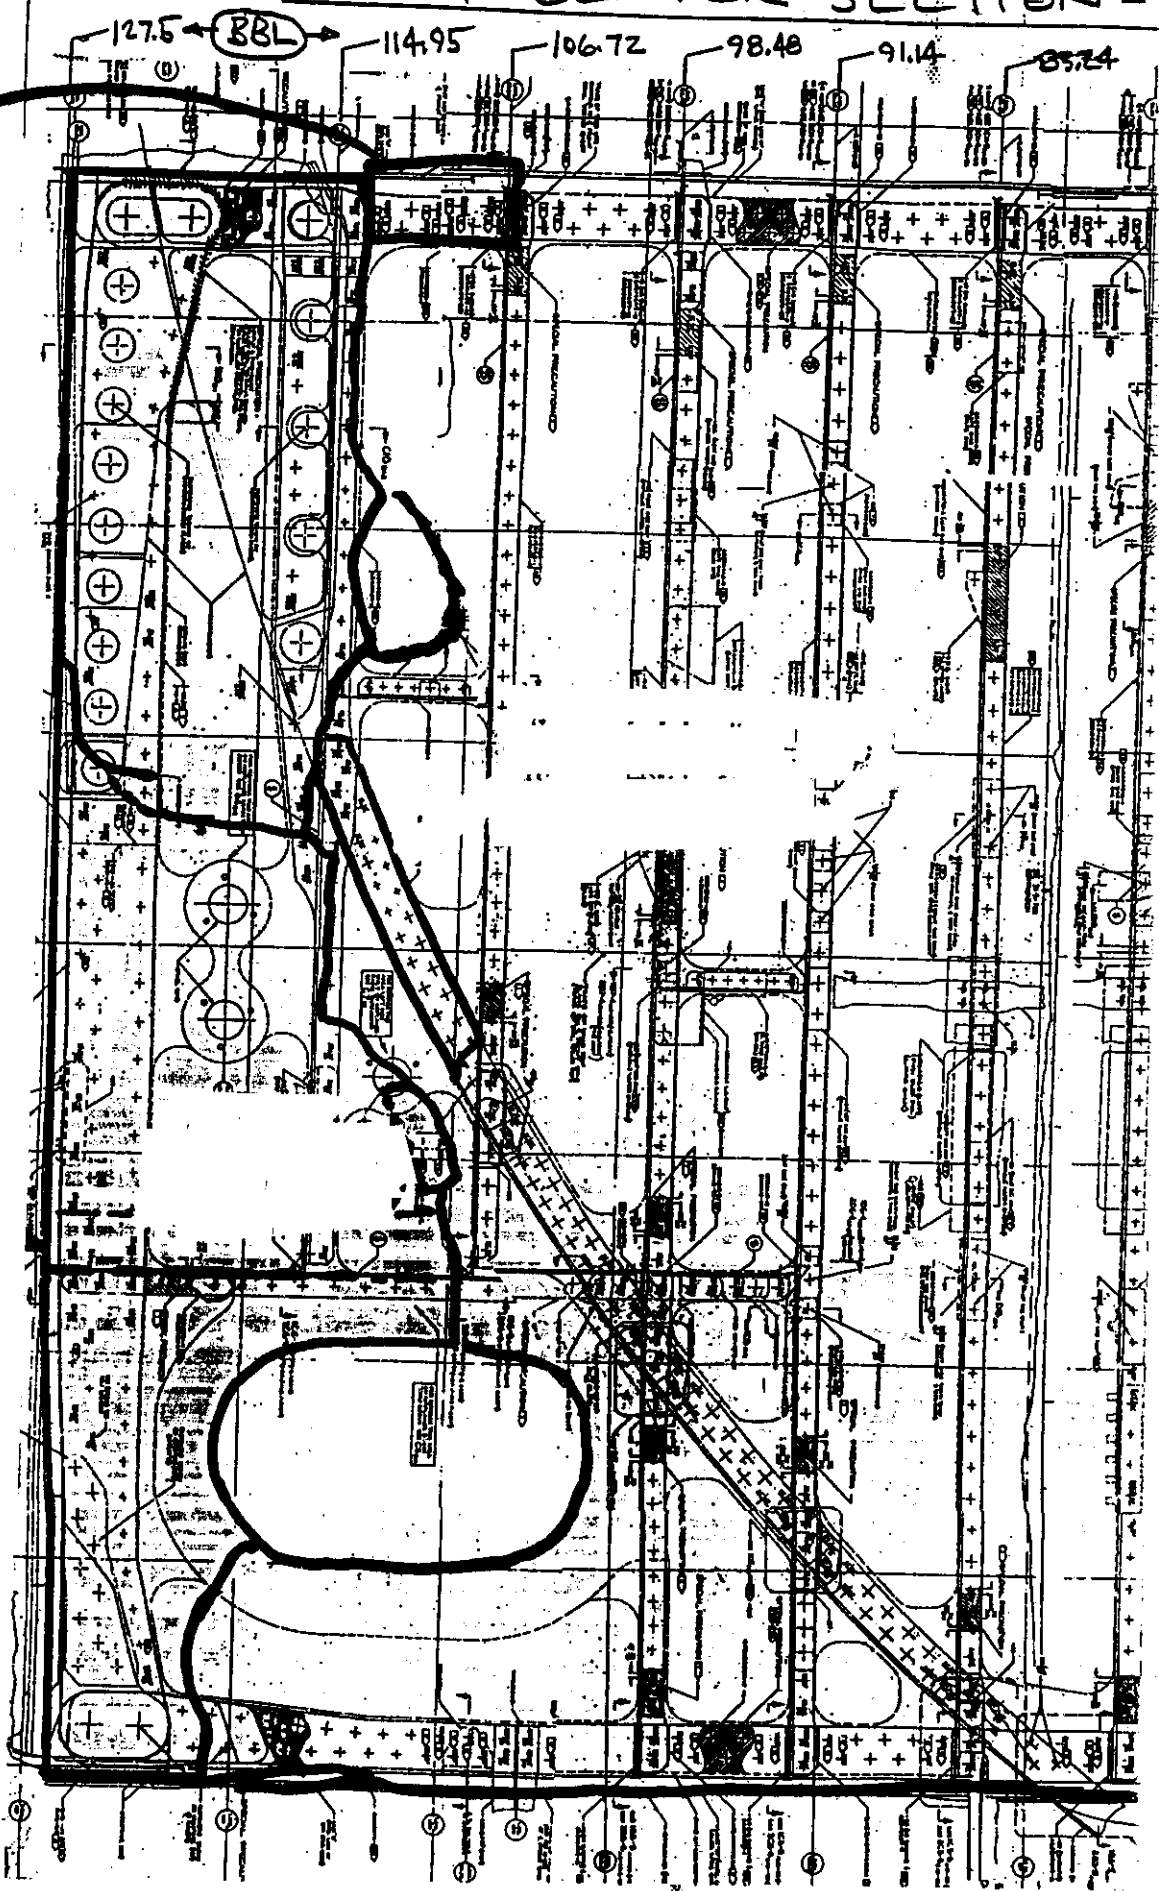
Red
CW 523

WING CENTER SECTION -
