SPANWISE BEAM # 3

CW-607

Z-2506

SPANWISE BEAM # 3 STIFFENER

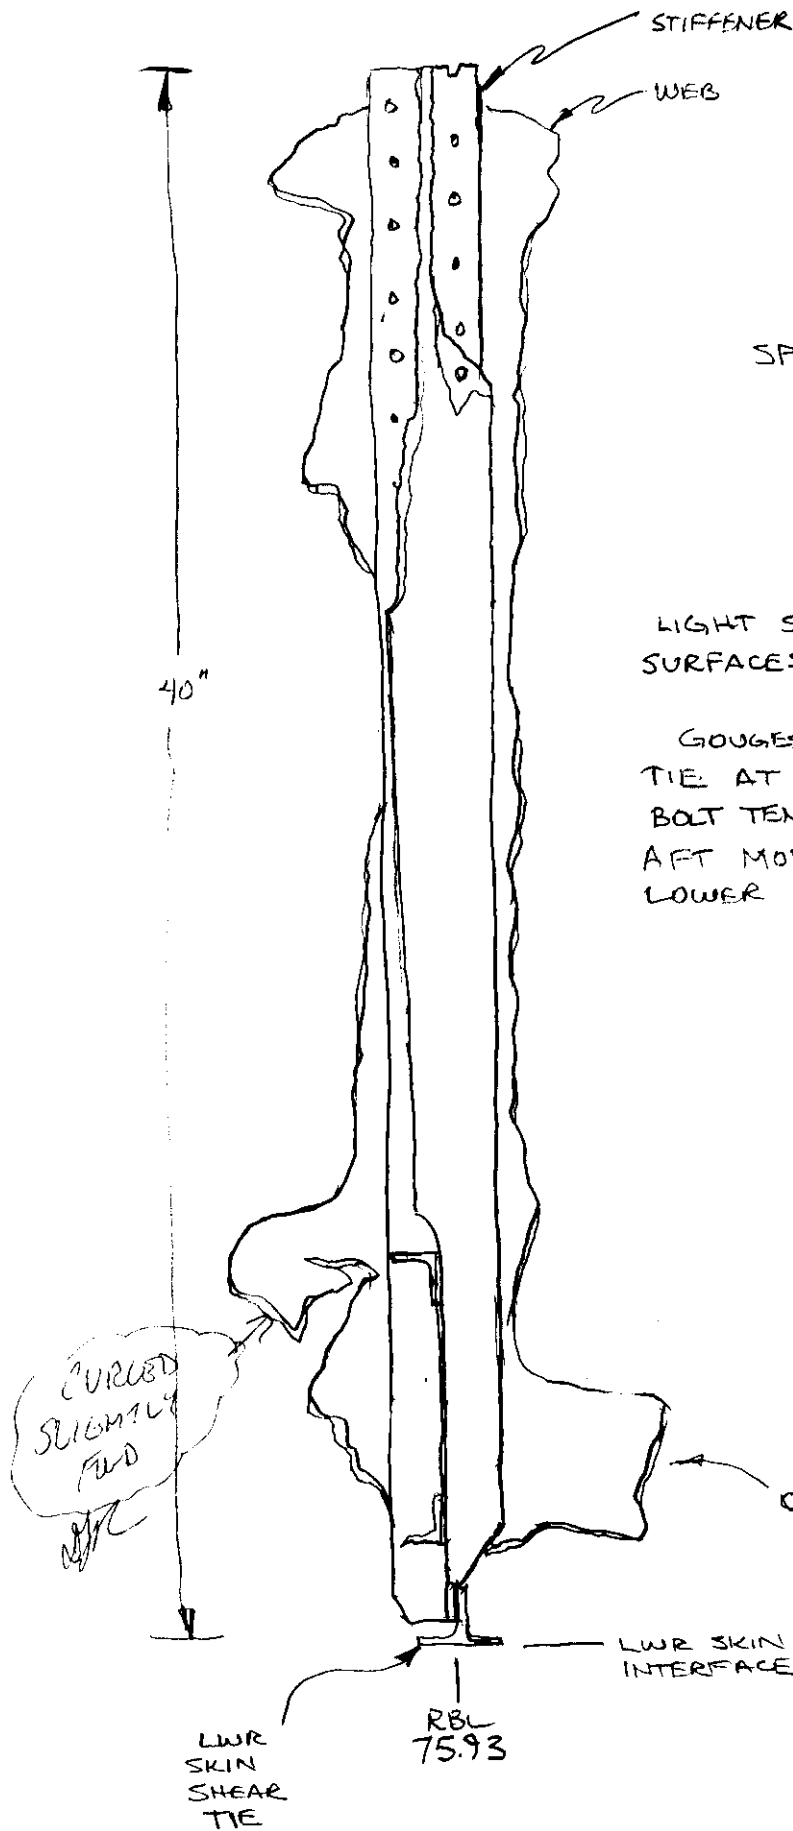
CW-607
 Z-2506
 GREEN TAG

This item is the lower 40" of the RBL 75.90 stiffener with a width of 4" to 11" of web attached for its entire length. The lower end has the shear tie intact. The web is torn and slightly bent both fwd and aft.

VIEW LOOKING FWD

LIGHT SOOT PREDOMINANTLY ON AFT SURFACES (SIMILAR TO CW602)

GOUGES IN LWR SURFACE OF SHEAR TIE AT LWR SKIN INTERFACE INDICATES BOLT TENSION FAILURE WITH SUBSEQUENT AFT MOVEMENT RELATIVE TO THE LOWER PANEL

CURLED SLIGHTLY FWD

CURLED SLIGHTLY AFT

LWR SKIN SHEAR TIE

LWR SKIN INTERFACE

RBL 75.93
