SPANWISE BEAM # 3

CW-609 C-2671 GREEN

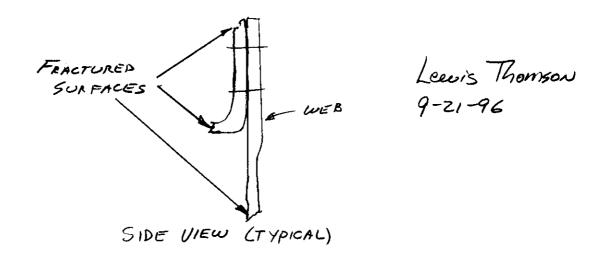
Rear View

This is a small section of the web which attaches to the upper corner of CW601. This section experienced heavy fire damage and the web is bent slightly aft.

PART HEAVILY

SOOTED ALL

SIDES

WEB FRACTURE-

AND BENT

AFT

UNIQUE FRACTURE

FRACTURE FACE

ON C868

DETAIL MATCHES
