CW637

Id No: 11/11/96-53

Tag No: Z-4017 Green

Spanwise Beam 3 - Lower web & stiffener segment, RBL 66.71

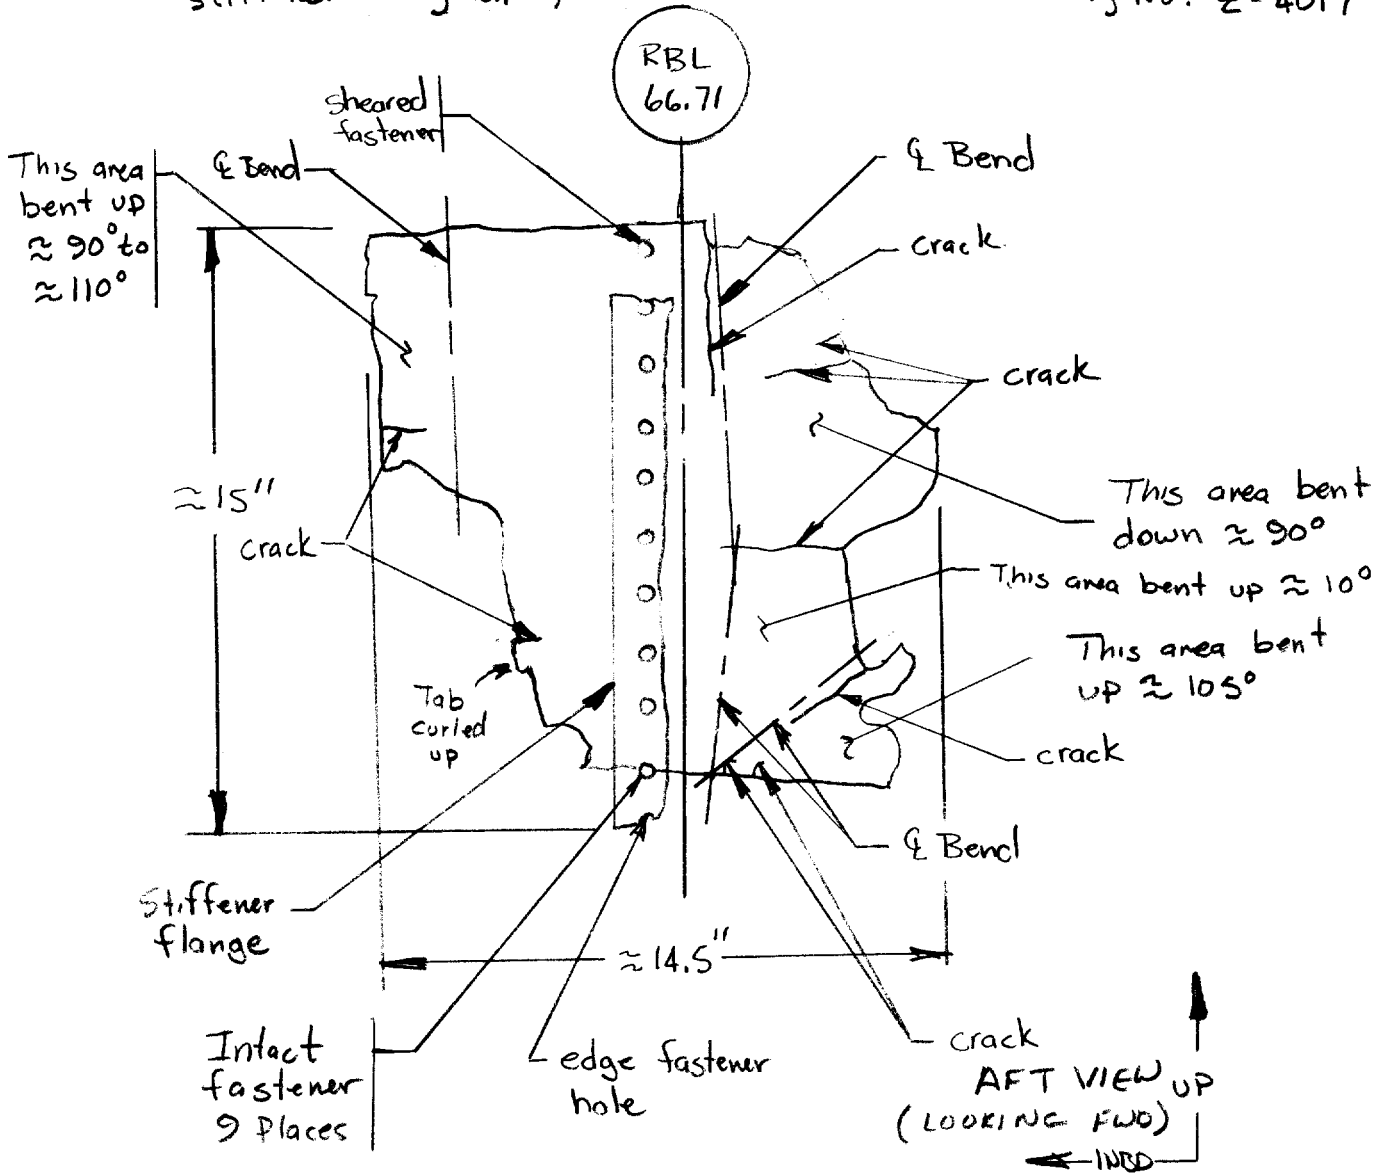
Segment is distorted and shows sign of salt water corrosion.

Part is sooted.
