SPANWISE BEAM #1 - WING CENTER TANK

SW-B*1 WEB SEGMENTS

ALL RH SIDE CLOSURE PANELS

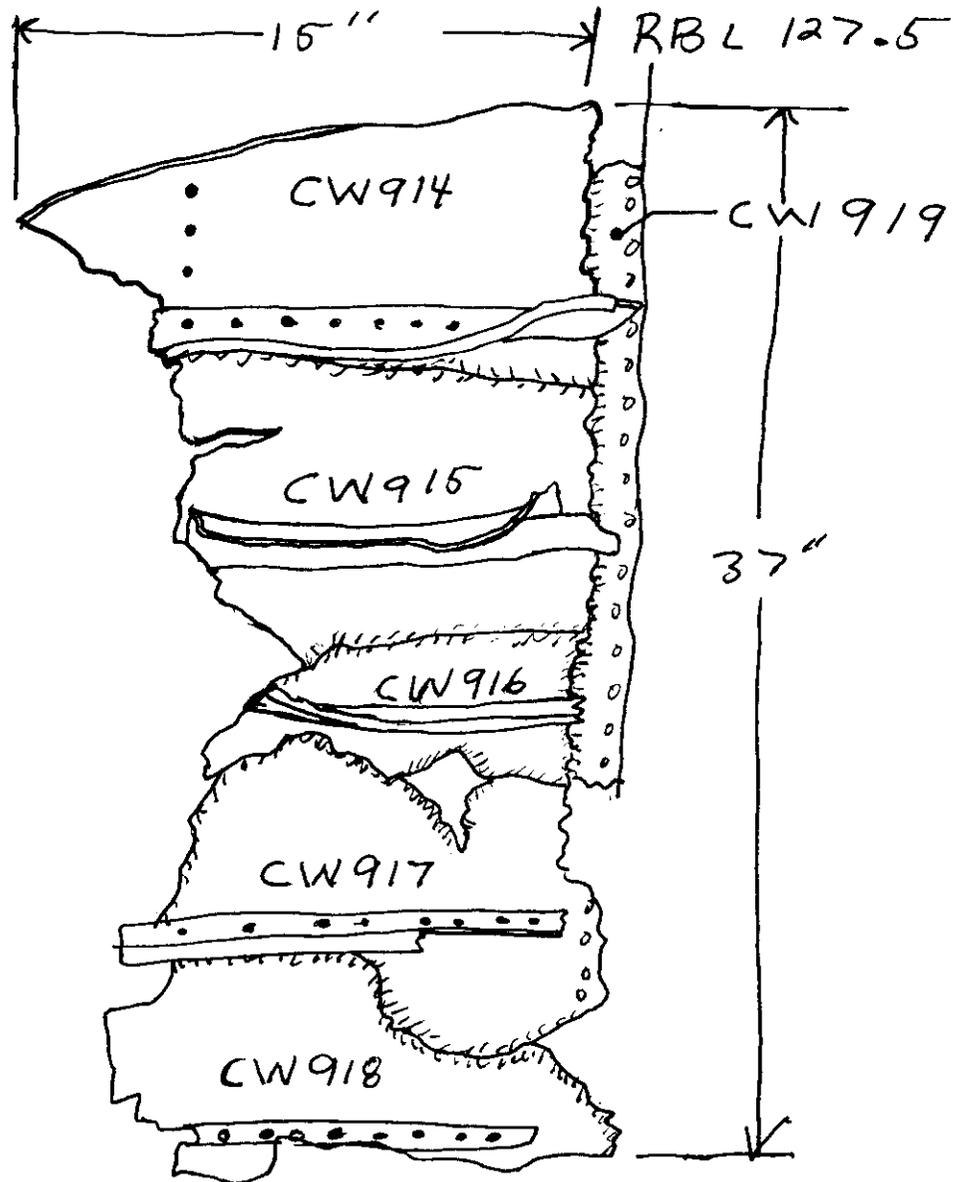
SPANWISE BEAM #1
RIGHT SIDE

THIS GROUP OF SMALL SEGMENTS OF THE SPANWISE BEAM #1 EXTENDS FROM RBL 127.5 15" INBOARD, AND FROM THE UPPER CHORD DOWN 37"

THE PIECES ARE MOSTLY FLAT. THE FRACTURE FACES MATCH EXCEPT BETWEEN CW916 AND CW917 WHERE THERE IS A 2" X 3" HOLE,

THERE IS NO SOOTING ON THE PARTS OR THE FRACTURE SURFACES.

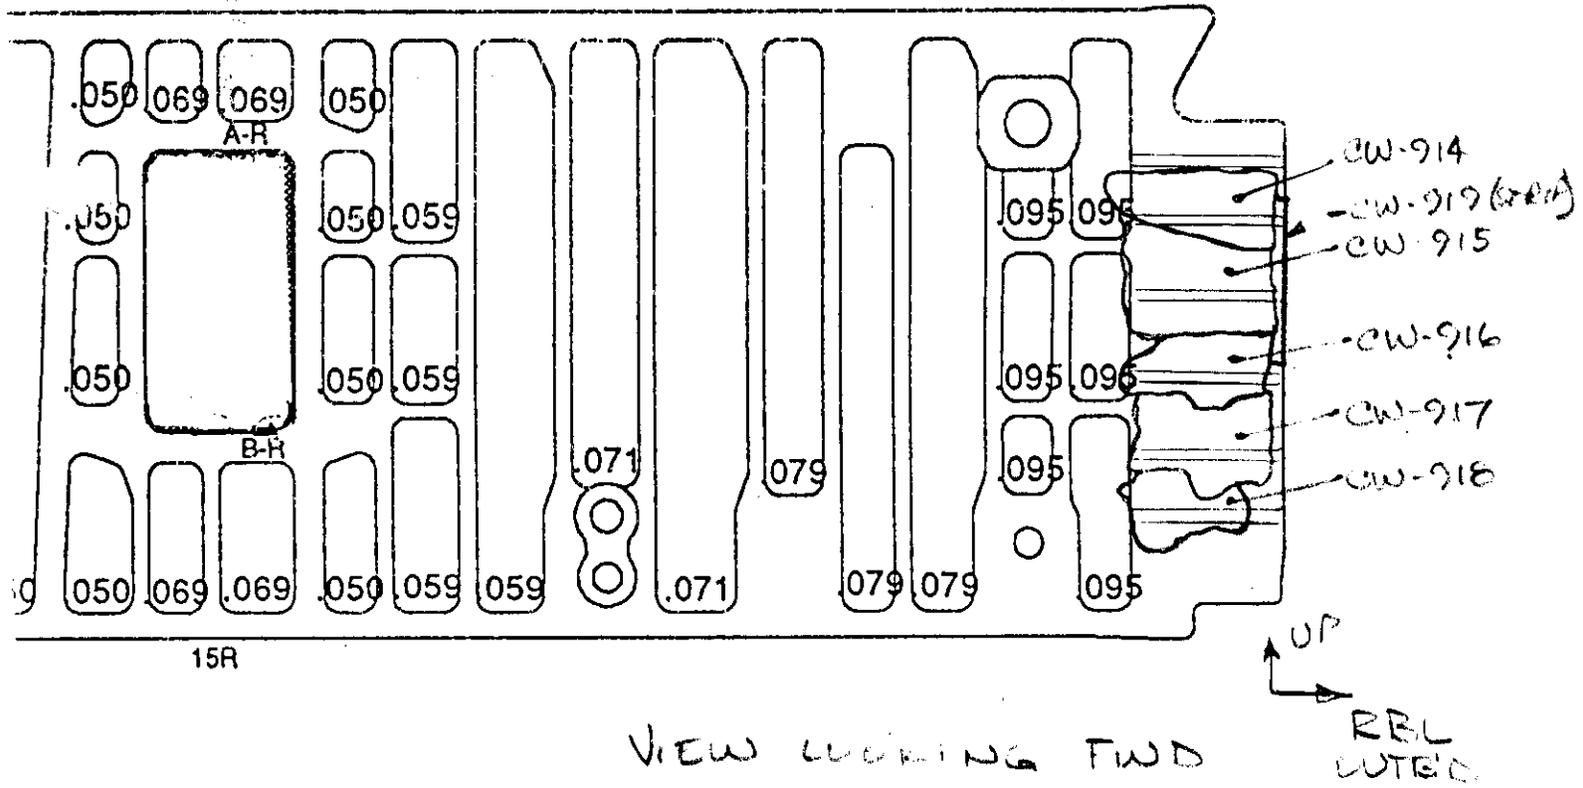
AM #1 ASSEMBLY 65B01108-2 ASSY

SEE GENERAL DESCRIP.
SEPARATE PAGE
