LOG # FBM-27

DEBRIS FIELD \_\_\_\_\_  
 27A NO TAG 8/10/96-9

FLOOR PANEL ASSORTMENT STA 700 TO STA 800 WITH FLOOR BEAM CHORDS ATTACHED.

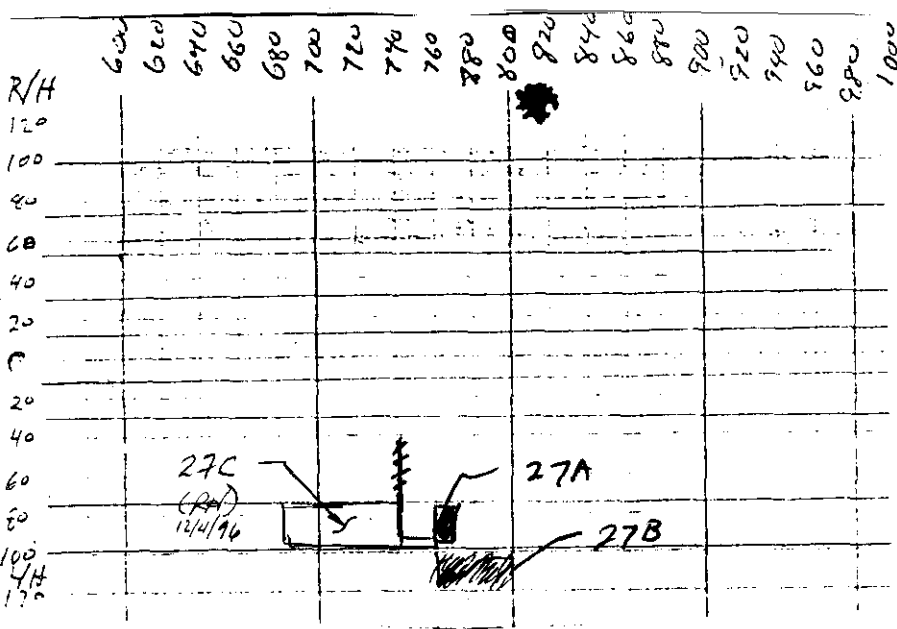
27A STA 760 TO STA 770, LBL 76 TO LBL 99

F/P FRACTURED AT DECOMPRESSION VENT CUTOUT.  
 CONTAINS F/B UPPER CHORD @ STA 760

27B F/P # 89 FROM STA 760 TO 800, LBL 98 TO 117  
 PART 1 CUTOUTS FOR DECOMPRESSION PANELS. F/B UPPER CHORDS  
 & PART 2 FOR STA 760 & 780 FROM LBL 97 TO 117 ARE CONNECTED.  
 BL 98.56 S/C FROM STA 758 TO 800. FRACTURED @ 781 ALSO.

27C F/P # 75 FROM STA 680 TO STA 740  
 F/B 700 UPPER CHORD FROM LBL 73 TO LBL 94  
 F/B 740 UPPER CHORD FROM LBL 45 TO LBL 98  
 (SEE F/B DWG). FLR PNL EXTENDS TO STA 760, BTWN LBL 93 & 99
